Aircraft proximity event between a Bell 206, VH-WCS and a PZL Bielsko 51, VH-XOP

Gympie (ALA), Queensland, 4 December 2013

ATSB Transport Safety Report
Aviation Occurrence Investigation
AO-2013-220
Final – 25 February 2014

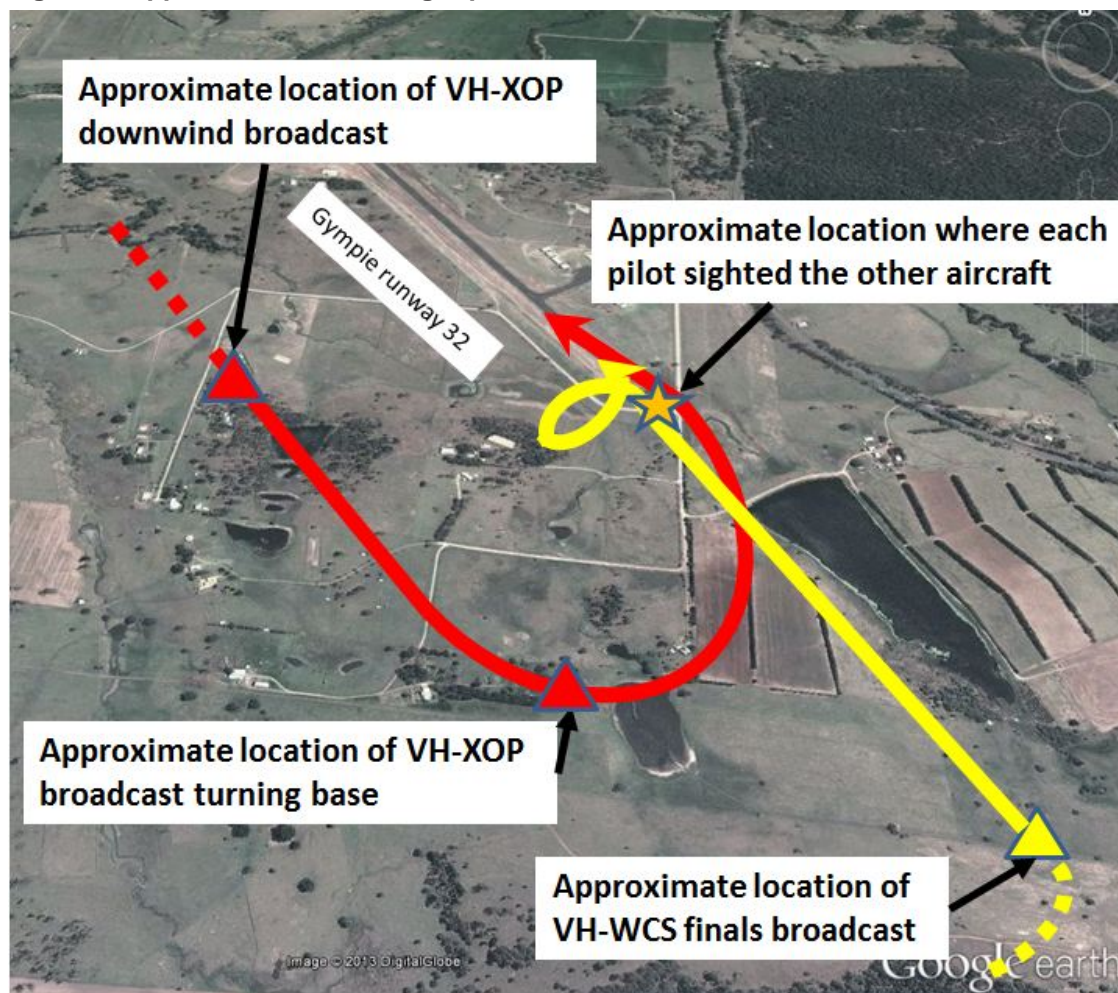
Figure 1: Approximate aircraft flight paths and broadcast locations

The instructor of WCS broadcast on the CTAF when turning base and subsequently heard the downwind call of XOP. At that time he sighted the glider on mid-downwind. Soon after, the pilot of XOP broadcast turning base.² The glider pilot then commenced a diagonal base leg, on about a 45° angle from the downwind leg (Figure 1).

The Gliding Federation of Australia reported that the helicopter may have been in the glider pilot's blind spot during the diagonal base leg and turn onto final. If the glider turned onto final above, and in front of the helicopter, the pilots of each aircraft would not have been able to sight the other. The glider pilot had then applied the airbrakes, steepening the approach path.
