# VFR flight into dark night conditions and loss of control involving Piper PA-28-180, VH-POJ

31 km north of Horsham Airport, Victoria | 15 August 2011

## ATSB Transport Safety Report

AO-2011-100

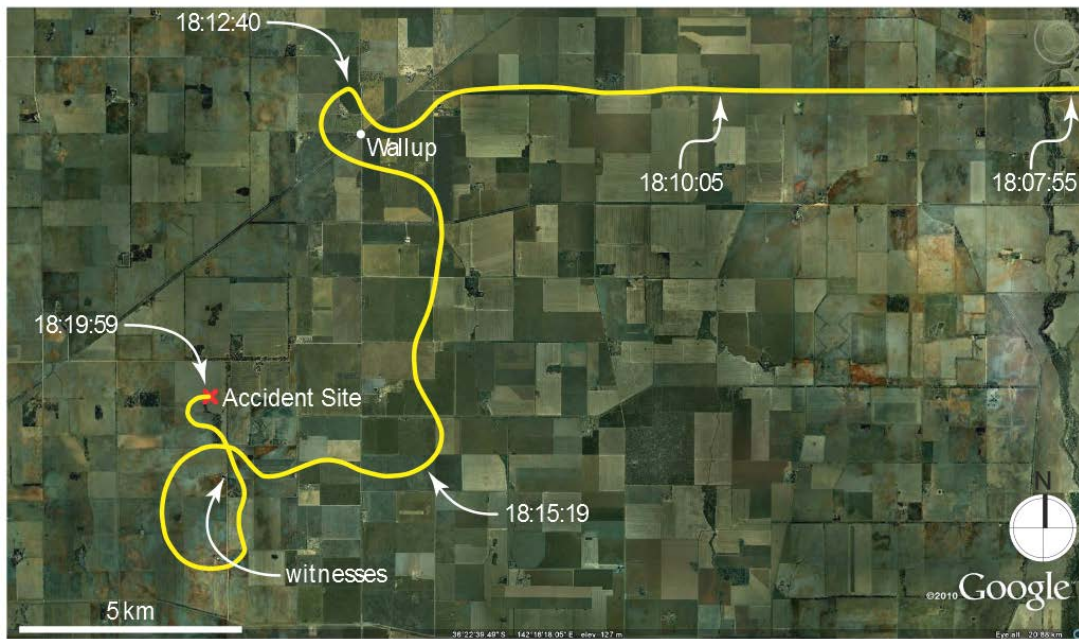
**Figure 3: Aircraft's track near Wallup**

Recovered GPS data from the tablet computer showed that just before arriving in the vicinity of Wallup, the pilot initiated a series of manoeuvres before turning towards the south for about 7 km and then resuming a westerly track for about 5 km (Figure 3). The aircraft's track changed abruptly after Wallup, with variations in altitude, heading and speed that were not apparent during the earlier part of the flight (Figure 4).

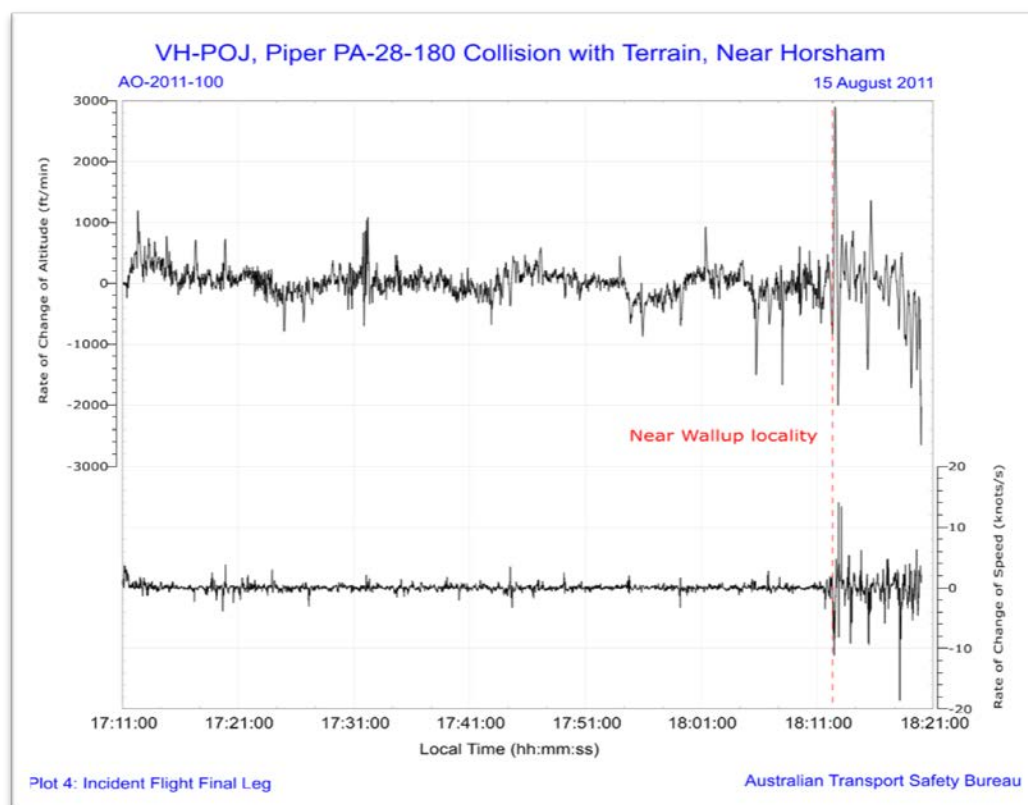
**Figure 4: Variations in airspeed and altitude rate of change after Wallup**

The recorded data from the tablet computer showed that at 1817 a 360° left turn was initiated, followed by a descending right turn. The aircraft impacted the ground about 31 km north of Horsham Airport, Vic. at 1820, 23 minutes after sunset and about 4 minutes before published last light<sup>7</sup>.

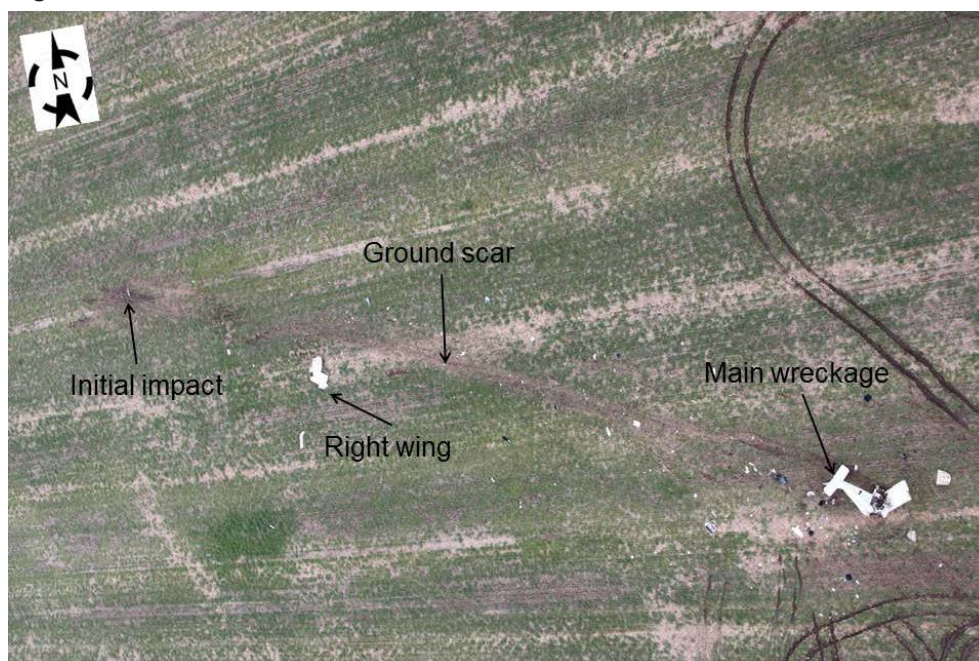
**Figure 5: Ground scar aerial view**

All of the aircraft's primary structure and flight controls were located at the accident site and there was no evidence of fire or pre-impact failure. No anomalies with the aircraft's flight control system were identified. The flap actuator handle was found in the retracted position and there was no damage indicating that the handle had been forced into the retracted position during the impact sequence. The pattern of earth on the upper wing surface was also consistent with the flaps being in the retracted position during the impact sequence. Landing light filament stretch was consistent with it being on at impact.

Three of the aircraft's four seatbelts were found fastened, but two of them had failed due to overstress. Examination of the unfastened, right-rear seatbelt identified that it had not been fastened during the impact. Damage to the aircraft and the location of the occupants at the accident site suggested that the passenger in the right rear position was unrestrained at impact.
