# Wheels-down water landing involving Cessna U206F floatplane VH-UBI

Corio Bay, Vic. | 22 January 2013

## ATSB Transport Safety Report

AO-2013-020

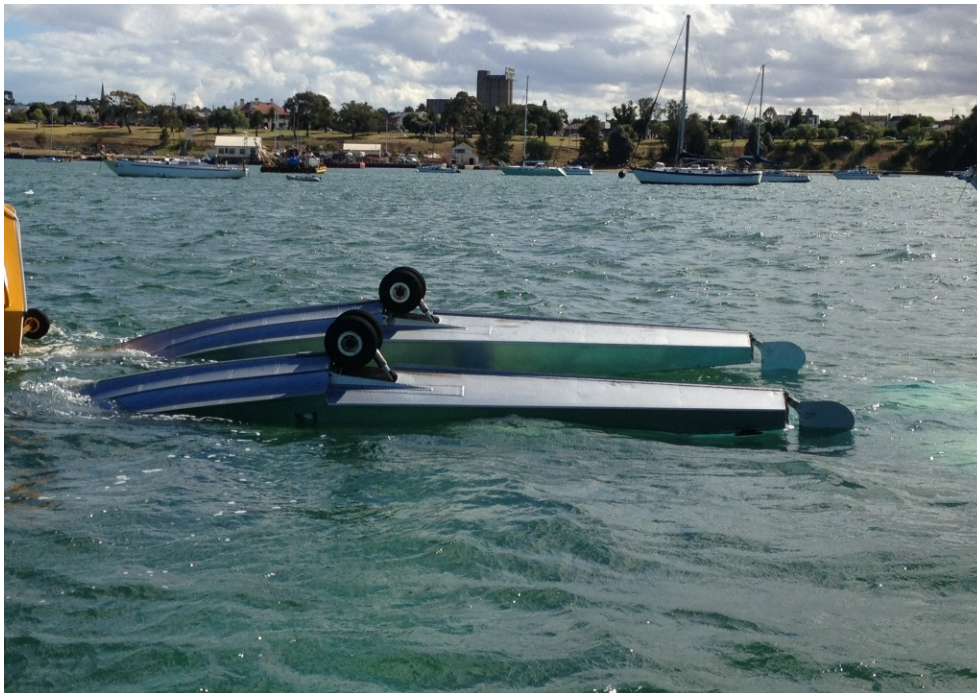
As the aircraft was predominantly above water level, the pilot was able to kick the front left door open and drag the second row passenger out before the cabin started to fill with water through the door opening. Returning to the cabin, the pilot saw the front passenger still seated with their seatbelt secured. The passenger's head was submerged in the increasing water level within the cabin. The pilot released the seatbelt and removed the passenger from the aircraft. Once both passengers were at the water surface, the pilot proceeded to assist them by fitting and inflating their life jackets, which were tied around their waists, and directed them to a position between the aircraft's floats. As the aircraft settled in the water suspended by its floats, the pilot noticed that the aircraft's landing wheels were extended (Figure 2).

**Figure 2: VH-UBI post-accident with the wheels extended**

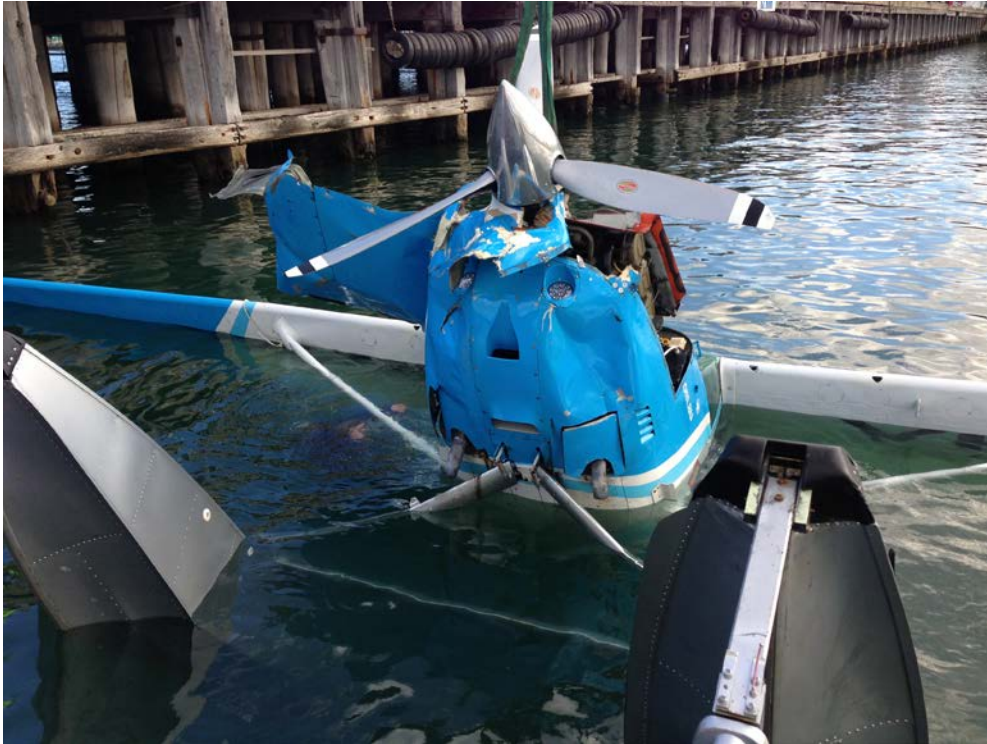
A number of boats approached the aircraft to offer assistance, but were too big to pull alongside the aircraft and safely retrieve the pilot and passengers. Soon after, a smaller fishing boat picked up the passengers and pilot and took them to shore. After an initial medical assessment by paramedics at the wharf, the passengers and pilot were taken to hospital. They reported sustaining minor injuries in the form of cuts and bruising and the effects of shock. The aircraft was substantially damaged (Figure 3).

**Figure 3: VH-UBI damage**
