Aircraft configuration event involving a Robinson R22, VH-ONT

near Armidale Airport, New South Wales, 13 September 2013

ATSB Transport Safety Report
Aviation Occurrence Investigation
AO-2013-152
Final – 10 December 2013

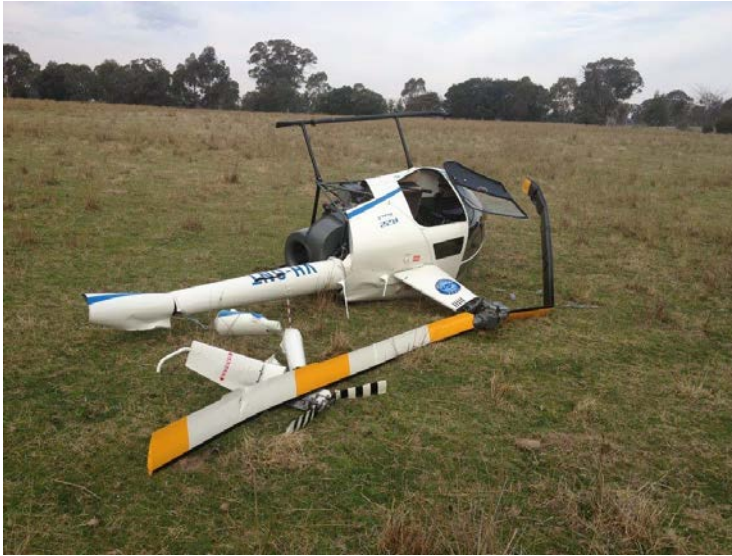
Figure 1: Damage to VH-ONT

The instructor reported that, due to the lack of height available, he elected not to attempt an engine restart. He selected a paddock and focused on the autorotation. Prior to the landing flare,⁸ the low rotor revolutions per minute (RRPM) horn sounded. The instructor held the flare and used the helicopter's tail to absorb the impact with the ground. The helicopter landed and ran on the ground on its skids, before rolling onto its side due to the slope of the paddock. Both occupants sustained minor injuries and the helicopter was substantially damaged (Figure 1).

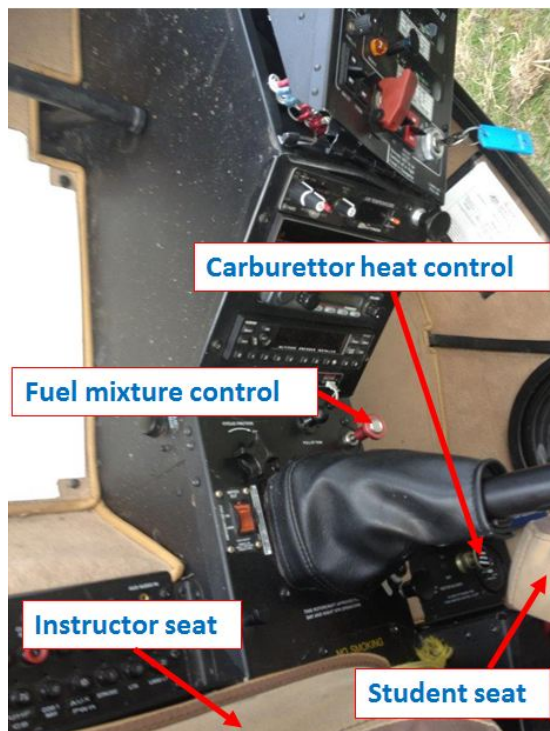
Figure 2: Location of the controls in VH-ONT

² The fuel mixture and carburettor heat controls were positioned on the right side of the cyclic, on the lower centre pedestal near the student's leg. The fuel mixture control was positioned in front of, and about 20 cm, from the carburettor heat control.

The instructor reported that he could not see the fuel mixture and carburettor heat controls from his normal seated position on the left side of the helicopter as the controls were obscured by the cyclic (Figure 2). He believed that he had observed the student reach down (toward the carburettor heat control) not forward (toward to fuel mixture control), prior to looking outside to check for traffic.

- he had inadvertently pulled the fuel mixture control instead of the carburettor heat
- he had not previously used the carburettor heat control
- the fuel mixture control was positioned forward of the carburettor heat control
- given his low amount of flying hours, he suggested that he should have confirmed where the carburettor heat control was, before pulling it out.

- devising a procedure, and determining limits, that do not allow a student to operate the carburettor heat until a certain number of flying hours and recency have been achieved
- placing an increased emphasis on secondary control awareness
- students will be required to verbally confirm 'carby heat identified' prior to pulling the control and then saying 'carby heat off'
- increasing the frequency of emergency procedures training.
