Wheels up landing involving a Cessna 441, VH-SMO

Honeymoon (ALA), South Australia, 3 September 2013

ATSB Transport Safety Report
Aviation Occurrence Investigation
AO-2013-143
Final – 10 December 2013

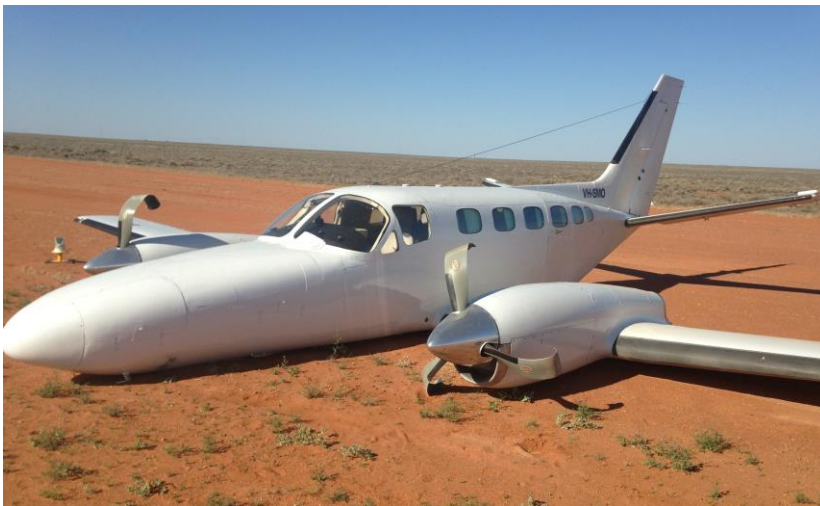
Figure 1: VH-SMO after landing

When about 500 ft above ground level (AGL), the pilot commenced his pre-landing checklist. After selecting full flap, the first item on the checklist, the pilot looked at the windsock to confirm the wind and observed 4-5 emus on the right side of the airstrip. He watched them run away from the airstrip and then continued the approach, but inadvertently omitted to complete the remaining checklist items, which included confirming the landing gear had been extended. The aircraft subsequently landed with the landing gear retracted.

The pilot reported that, as some engine power had been applied during the landing, the landing gear warning horn did not sound.³
