Runway incursion involving a De Havilland DH-82, VH-BJE and a Piper PA-34, VH-SEN

Redcliffe (ALA), Queensland, 8 September 2013

ATSB Transport Safety Report
Aviation Occurrence Investigation
AO-2013-148
Final – 10 December 2013

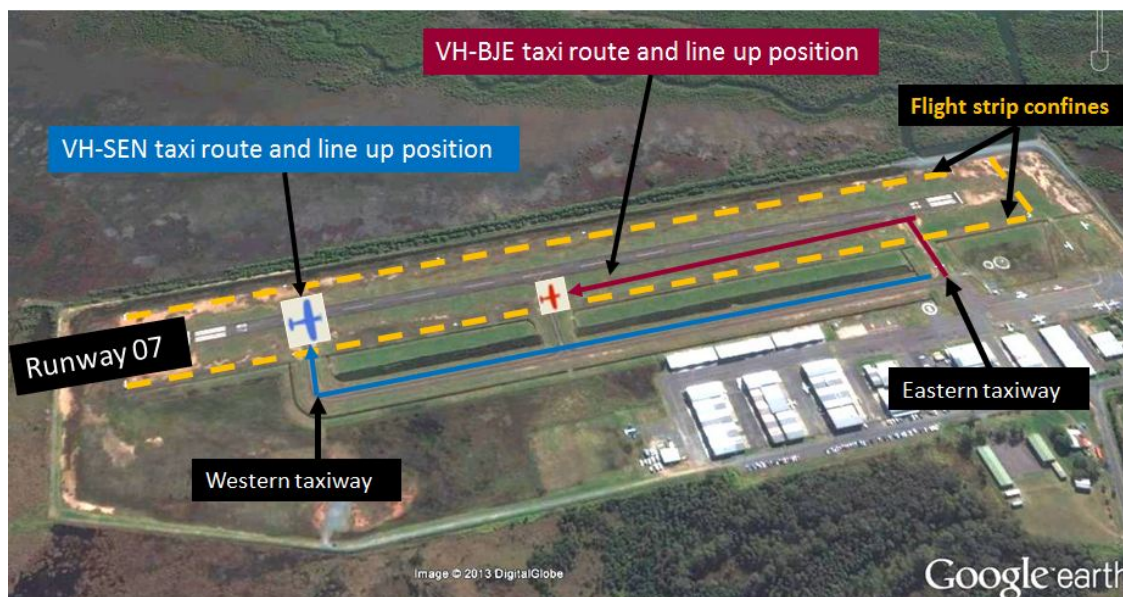
Figure 1: Approximate positions of VH-BJE and VH-SEN

At about 1615 Eastern Standard Time,¹ the pilot broadcast a taxi call on the common traffic advisory frequency (CTAF) and commenced taxiing via the eastern-most taxiway toward runway 07 (Figure 1). The pilot then reported broadcasting a call advising that he was entering and backtracking runway 07. The aircraft was backtracked on the grass on the southern side of the sealed runway.

At the same time, the pilot of a Piper PA-34 aircraft, registered VH-SEN (SEN), broadcast a taxi call on the CTAF and taxied from the eastern taxiway behind BJE, then turned onto the sealed taxiway to runway 07. When SEN arrived at the intersection between the western taxiway and runway 07, the pilot reported that he broadcast his intention to line up after an aircraft on final had landed.

The pilot of BJE reported taxiing off the flight strip, outside the gable markers, to allow the aircraft on final to land and vacate the runway. He then reported broadcasting a lining up and rolling call and lined up on the grass to the right of the sealed runway.

At about the same time, the pilot of SEN also broadcast a call advising he was entering, lining up and rolling on runway 07. The pilot of BJE heard the pilot of SEN broadcast the call. He looked back and observed SEN lined up on the sealed runway. He immediately broadcast a call requesting the pilot of SEN delay his take-off as BJE was within the confines of the flight strip. The pilot of SEN had also observed BJE about 100 m ahead on the grass, to the right, and reported rejecting the take-off and making a call to the pilot of BJE requesting his intentions. The pilot of BJE then commenced a turn towards the gable markers.

Shortly after, SEN recommenced the take-off. When SEN passed BJE, the pilot of BJE reported that his aircraft was still within the flight strip and estimated that the aircraft came within 10-15 m of each other.

While aircraft operating at the Redcliffe ALA are not required to have a radio, this incident highlights the importance of employing both unalerted and alerted see-and-avoid principles. Pilots should maintain a vigilant lookout for other aircraft, both airborne and on the ground, and maintain an awareness of other aircraft operating in the area. If an aircraft is fitted with a radio, pilots should broadcast their intentions clearly and communicate with others if they are unsure of their intentions.
