# Engine fire involving a Beech A36, VH-FFY

near Caloundra (ALA), Queensland, 6 September 2013

**ATSB Transport Safety Report**  
Aviation Occurrence Investigation  
AO-2013-147  
Final – 10 December 2013

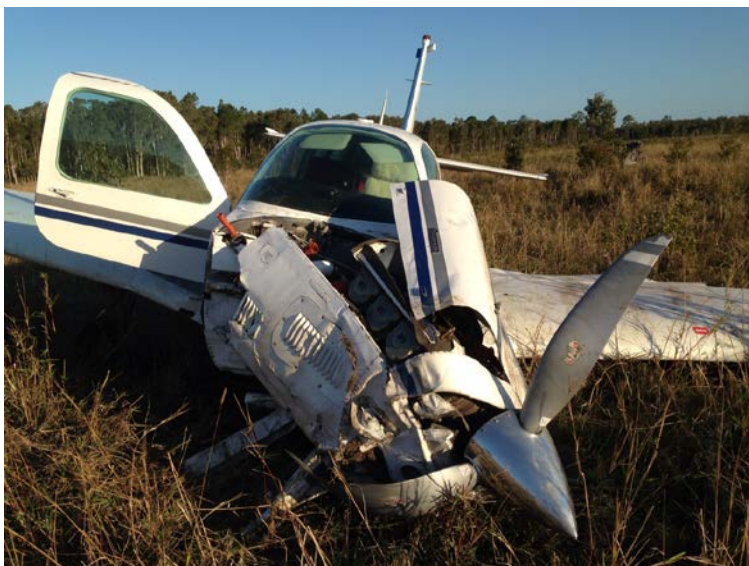
**Figure 1: Damage to VH-FFY**

During the landing roll, the nose landing gear separated from the aircraft due to the uneven terrain and the propeller subsequently contacted the ground (Figure 1). One passenger sustained minor injuries.

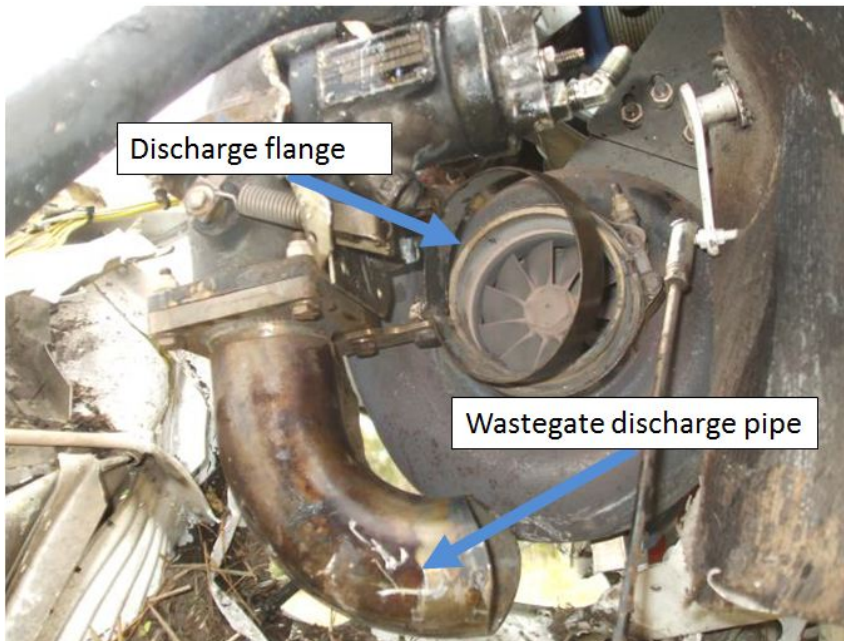
**Figure 2: Turbocharger outlet and wastegate**

- the turbo-normalizing modification required a redesign of the aircraft's exhaust system to incorporate the turbocharger
- the separated segment of the exhaust system was the tailpipe, which captured the turbocharger discharge gases and the outflow of the bypass system, and expelled them (Figure 2)

- the hot gas from the turbo-normalizing system was discharged directly onto the wiring, hoses and firewall blanket, which subsequently resulted in the smoke and fumes.

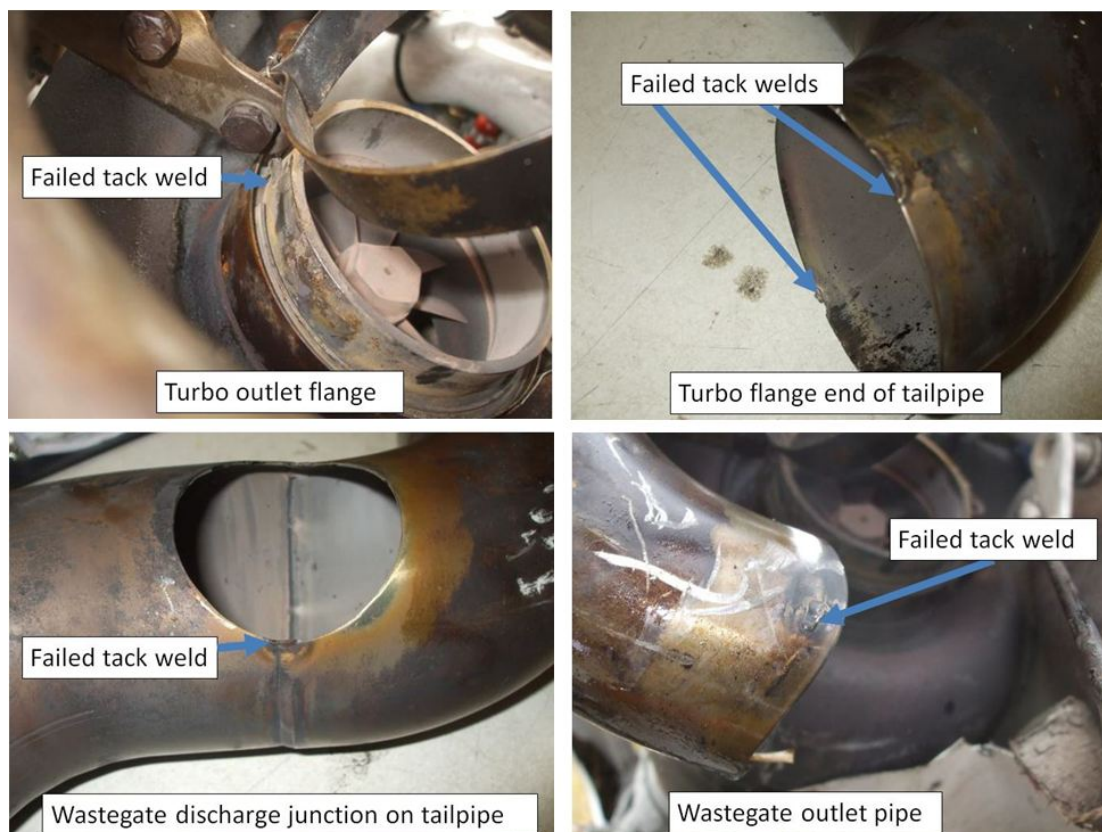
**Figure 3: Failed tack welds**

After the accident, the exhaust tailpipe from the turbocharger assembly was found on the runway at Caloundra. An engineering inspection revealed that the tailpipe had separated at a weld joint.

- the installation instruction, which required the installer to perform the final welding (circumferential) of the flange and pipe, had not been completed. The attachment of the tailpipe was, therefore, reliant on the manufacturer's temporary tack welds

- inspection of the recovered tailpipe, turbo flange, and wastegate discharge pipe showed that the pipe and flange tack welds had failed, allowing the tailpipe to separate from the aircraft (Figure 3)

As a result of this occurrence, the turbo-normalizing system manufacturer has advised the ATSB that the requirement to complete the circumferential weld will be highlighted in the installation instructions. The tailpipe supplied will also be clearly marked as supplied tack-welded, with additional instructions showing the requirement to perform the circumferential weld prior to flight.
