Airspace related event involving a Saab 340B, VH-ZLJ and parachutists

Moruya Airport, New South Wales, 12 September 2013

ATSB Transport Safety Report
Aviation Occurrence Investigation
AO-2013-150
Final

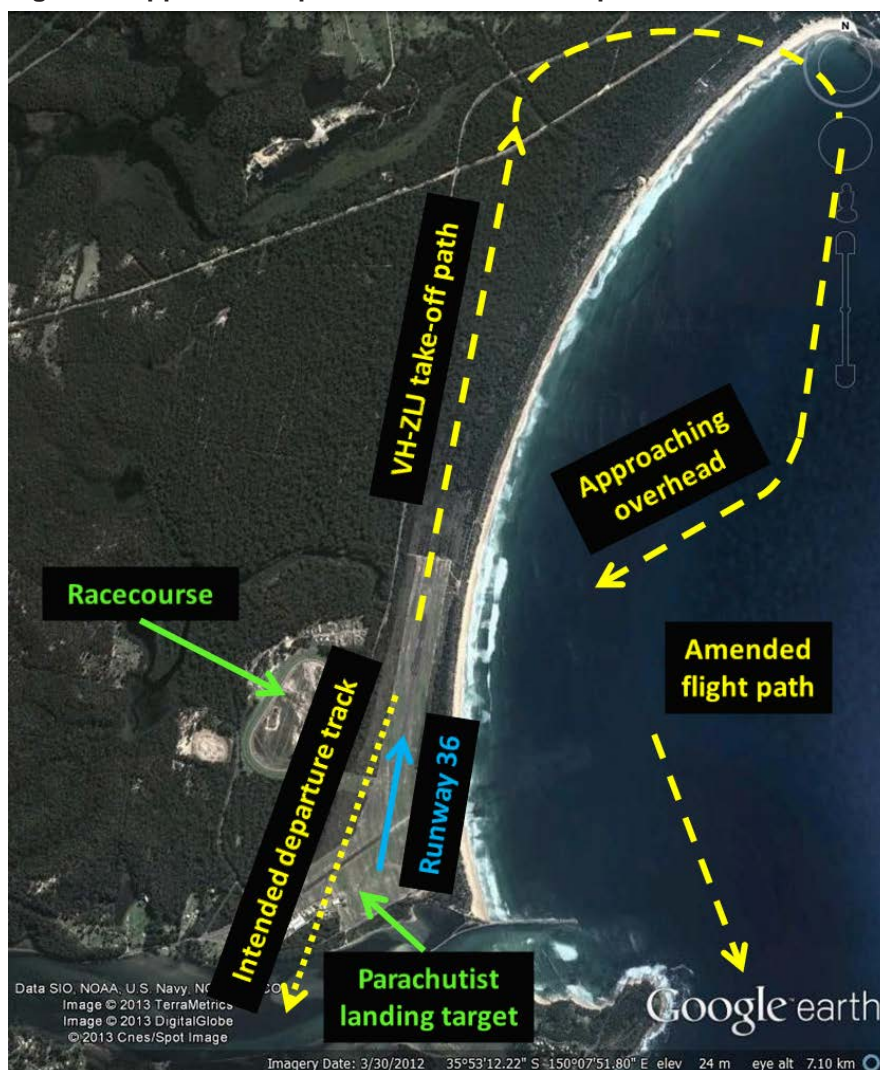
Figure 1: Approximate position of VH-ZLJ and parachutists

At about 1021, the crew of ZLJ asked the pilot of OZA to confirm that the drop had been completed; the pilot replied 'affirm'. The crew then queried whether the pilot of OZA was aware that ZLJ was departing overhead the airport, to which the pilot replied 'negative'. At that time, ZLJ was climbing through 3,500 ft and tracking to overhead the airport (Figure 1).

The crew of ZLJ then questioned the altitude, time and position the parachutists had been dropped. The pilot of OZA advised that they had been dropped about 0.4 NM to the west of the airport, overhead the racecourse, about 30 seconds prior.

The crew of ZLJ immediately turned the aircraft left, attempted to establish the likely position of the parachutists, and advised the pilot of OZA that they would remain over the water. They continued to parallel their intended departure track over water until about 10 NM to the south of the airport. The flight continued without further incident.
