Wirestrike involving an Air Tractor AT-502, VH-CJY

near Temora aerodrome, New South Wales, 15 October 2013

ATSB Transport Safety Report
Aviation Occurrence Investigation
AO-2013-180
Final – 10 December 2013

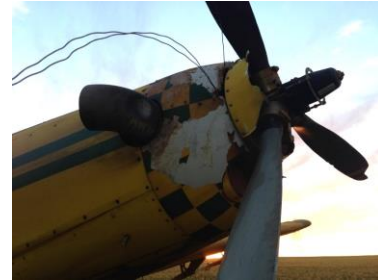
The engine then steadily lost power. The pilot secured the engine and conducted a forced landing in a paddock. During the landing, the aircraft ground-looped and the left wing contacted the ground. The aircraft was substantially damaged and the pilot was not injured.

Damage to VH-CJY

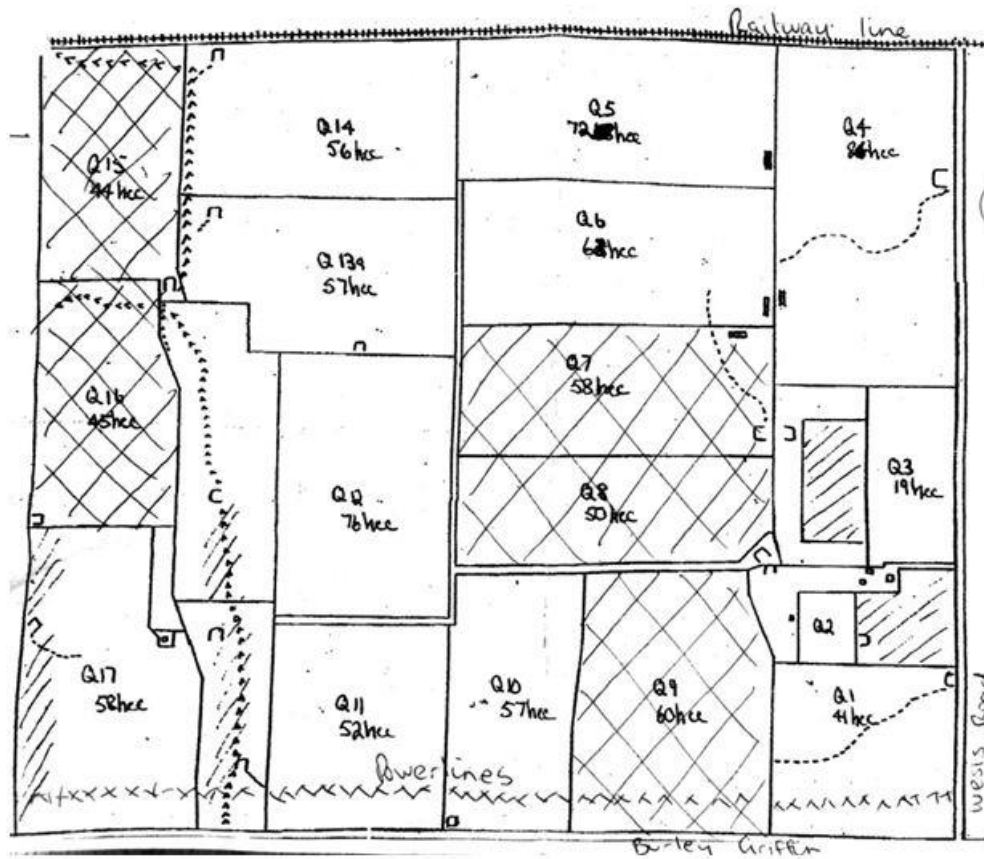
Figure 1: Map of property to be sprayed

The owner of the property had provided the pilot with a map of the area to be sprayed, which included powerlines (Figure 1).

The pilot did not see the wire at any stage, nor was it marked on the map provided by the property owner.

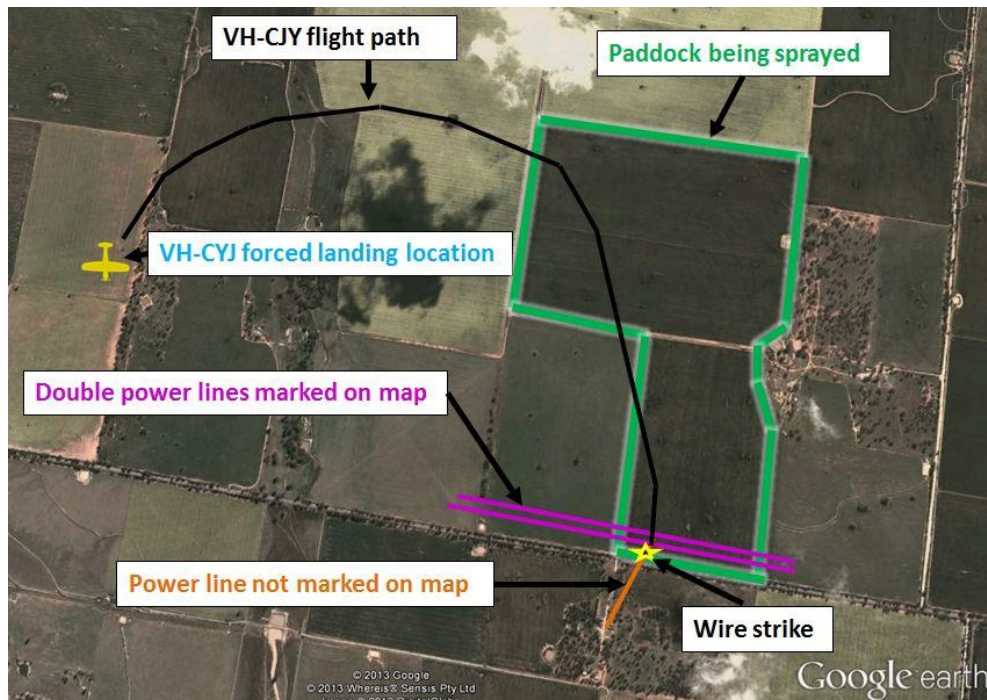
Figure 2: Property, location of wires and flight path of VH-CJY

There was a road and a row of trees to the south of the paddock, with double power lines (as marked on the map) about 130 m north of the tree-line (Figure 2). The pilot planned to fly over the trees and under the power lines on each leg, before turning to commence the next run.

At about 1730 Eastern Daylight-saving Time (EDT),¹ when to the south of the paddock at about 15-20 ft above ground level (AGL), after turning to commence the next run, the pilot saw a cross arm indicating the presence of a wire attached to the derelict homestead (Figure 2). He decided not to climb the aircraft as it would have collided with the larger double power lines. The pilot then heard a bang, with the aircraft's propeller spinner contacting the wire.
