Australian Transport Safety Bureau

Loss of control involving a Piper PA-28R-200, VH-MMU

Birdsville aerodrome, Queensland, 6 September, 2013

ATSB Transport Safety Report
Aviation Occurrence Investigation
AO-2013-146
Final - 10 Decmeber 2013

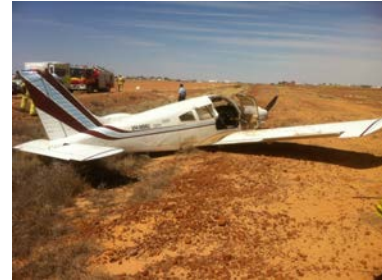
VH-MMU at the accident site

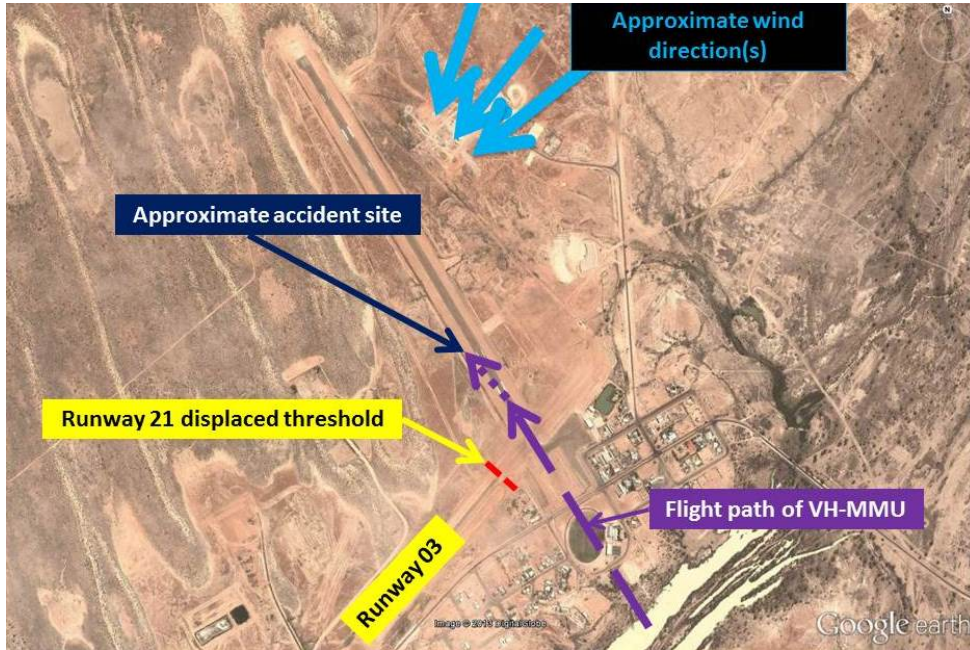
Figure 1: Landing flight path of VH-MMU

He attempted to keep the aircraft aligned with the runway and slow down. To allow for the crosswind, the pilot held the ailerons at full deflection. However, as the aircraft drifted to the left in the crosswind, the left main wheel struck a graded mound on the side of the runway. The aircraft stopped abruptly and rotated in an anticlockwise direction, resulting in the right landing gear entering a ditch. The aircraft continued over the mound for about another 10 ft, before coming to rest (Figure 1).

The NOTAM current for Birdsville on 6 September 2013 also advised that the runway 21 threshold was displaced by 381 m and that this was appropriately marked (Figure 1). This effectively reduced the length of runway 03/21 to 819 m.

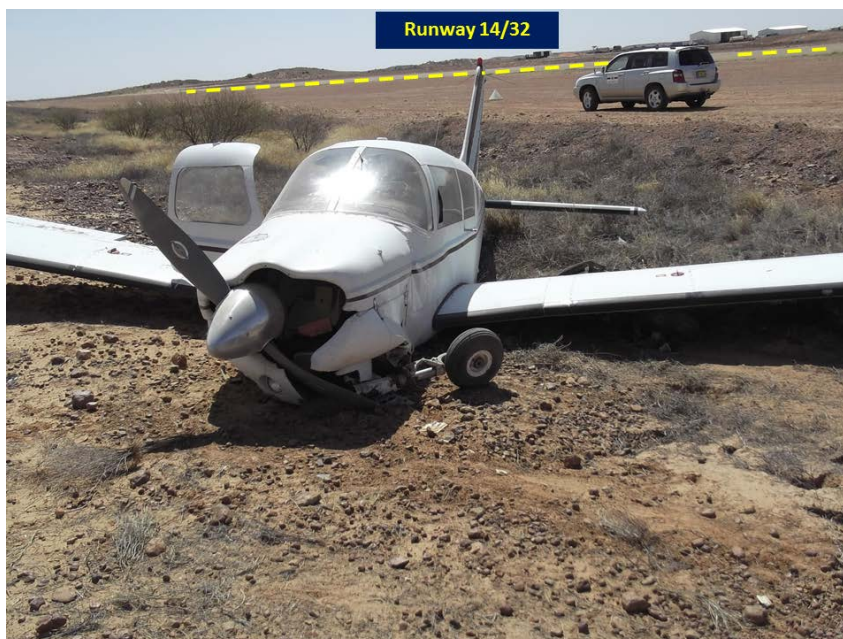
Figure 2: VH-MMU damage

The pilot checked on his passenger before both egressed through the exit door on the passenger side of the aircraft. They remained clear of the aircraft until emergency services arrived. Both the pilot and passenger sustained minor injuries and the aircraft was substantially damaged (Figure 2).

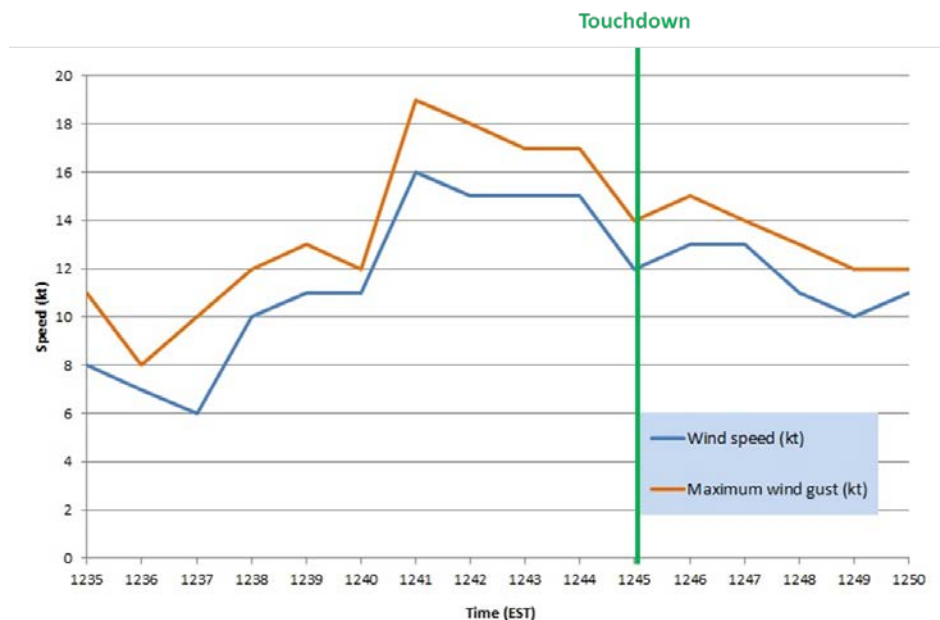
Figure 3: Bureau of Meteorology one-minute data

The Bureau of Meteorology (BoM) provided the ATSB with one-minute interval data recorded by the Birdsville automatic weather station (AWS). A graphical representation of the wind speed (kt) and maximum wind gust (kt) between 1235 and 1250 is shown in Figure 3
