Engine flame-out and ditching involving Bell LongRanger helicopter, VH-RHF

Cone Bay, approximately 98 km north of Derby, WA | 8 June 2013

ATSB Transport Safety Report
Aviation Occurrence Investigation
AO-2013-097
Final – 11 December 2013

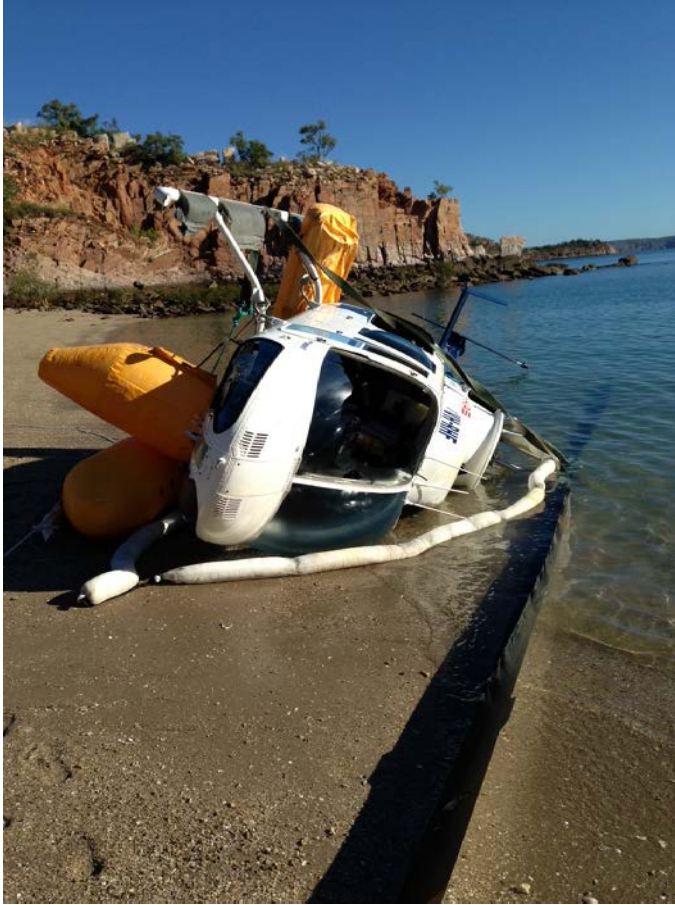
Figure 2: VH-RHF after being towed ashore

The helicopter was substantially damaged and later towed to shore (Figure 2).

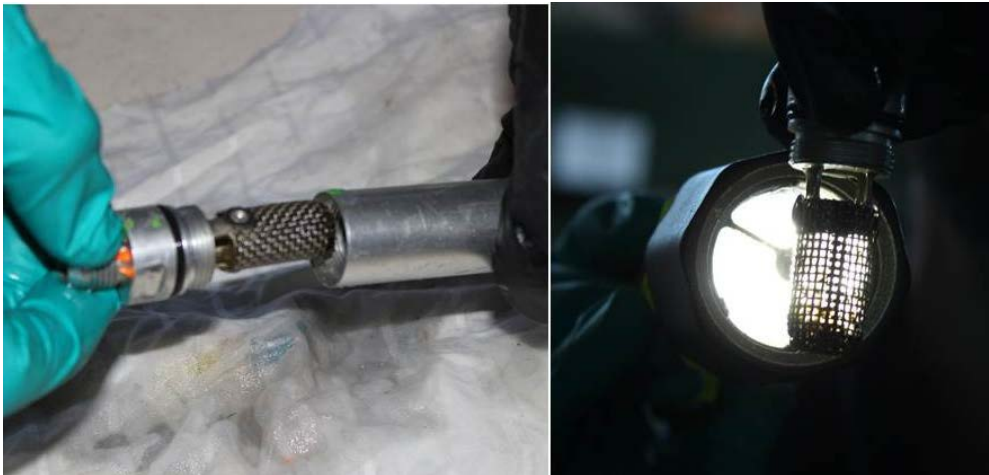
Figure 3: Underfloor fuel strainer

The two electric boost pumps were examined and found to be capable of normal operation. Examination of the under-floor fuel strainers of the ejector pump fuel transfer system found a small amount of contamination but no blockage that might have prevented normal fuel transfer (Figure 3). The two flow switches were capable of normal operation. Based on that information, there was nothing to impede the transfer of fuel from the forward tanks to the main tank.

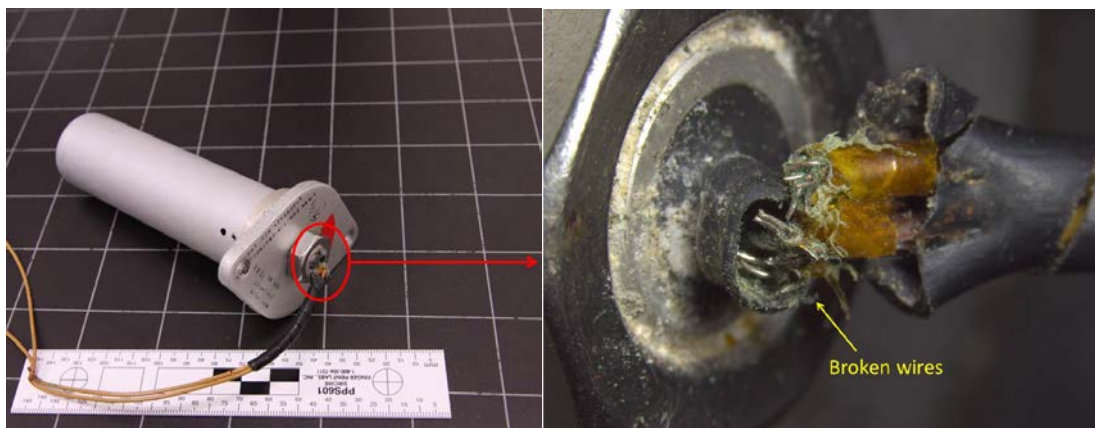
Figure 4: Low fuel float switch and faulty electrical connection

The low fuel float switch was found to have a faulty electrical connection (Figure 4). This compromised the operation of the low fuel caution system such that activation of the caution light at low fuel quantities was not assured.

have illuminated prior to the engine power loss. However, this system was compromised by a faulty electrical connection and had been in this condition for an indeterminate time. As a result, the pilot had nothing other than the FQIS intermittency in the last stages of the flight to indicate that the FQIS might have been inaccurate.

Irrespective of the FQIS indications, the low fuel caution system could be expected to alert the pilot of a critically low fuel state in time for the pilot to land before the engine flamed out. On this occasion a wiring fault prevented any activation of the caution light so the pilot was unaware of the likely low fuel state. This was a latent failure because the system had been compromised for a period of time without pilot awareness. As was common for the type of system, pre-flight testing verified operation of the globe but was not capable of detecting whole-of-system integrity. The only scheduled check of the system was the annual functional check.
