Level crossing collision between train 3PW4 and a motor vehicle

Werribee, Vic | 25 May 2012

ATSB Transport Safety Report
Rail Occurrence Investigation
RO-2012-007
Final – 18 December 2013

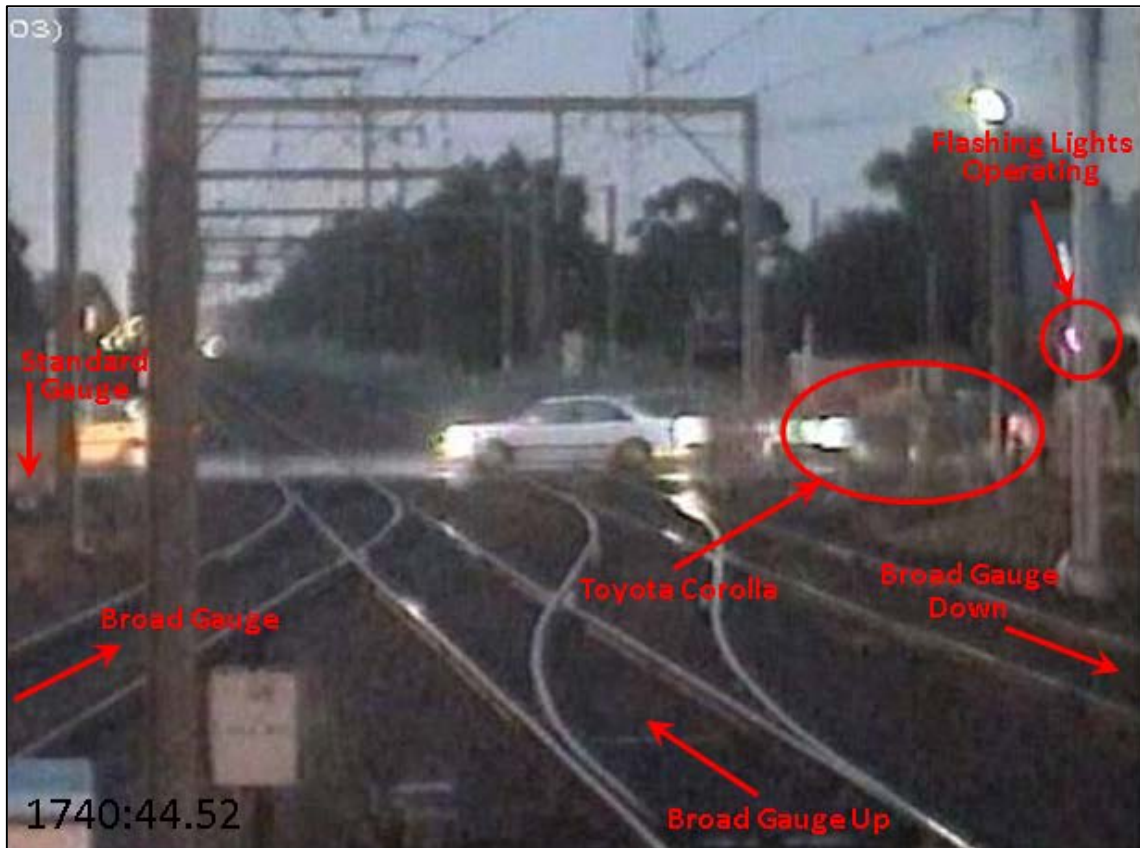
Figure 2: Closed circuit television (CCTV) footage showing the Corolla part way through the level crossing at 1740:44.52 when the level crossing lights begin to operate

The Corolla was following another car in relatively free flowing traffic into the level crossing, unaware that the exit ahead was obstructed by the broken down Barina. Just after the Corolla entered the crossing, the flashing lights and bells activated, warning of the approach of train 3PW4 (Figure 2). No other vehicles followed the Corolla into the level crossing.

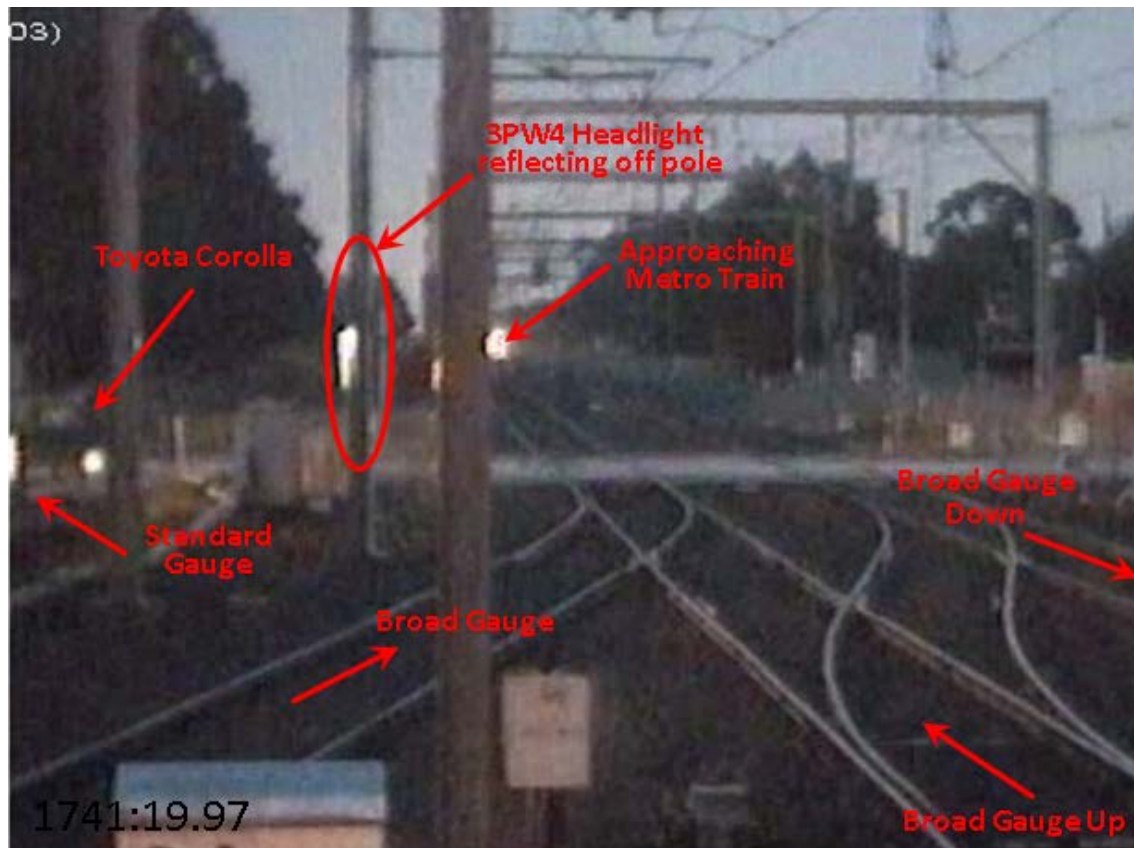
Figure 3: CCTV footage at 1741:19.97 showing Toyota Corolla

The car ahead of the Corolla began slowing because of road congestion ahead and came to a stop in the right-hand lane behind the broken-down Barina but clear of the standard gauge track. The driver of the Corolla then stopped behind the vehicle ahead but was fouling the standard gauge track.

As train 3PW4 rounded the curve adjacent to the Werribee Station, the train crew saw the Corolla fouling the standard gauge track about 150 m ahead (Figure 3). The train driver immediately sounded the horn and made an emergency brake application.

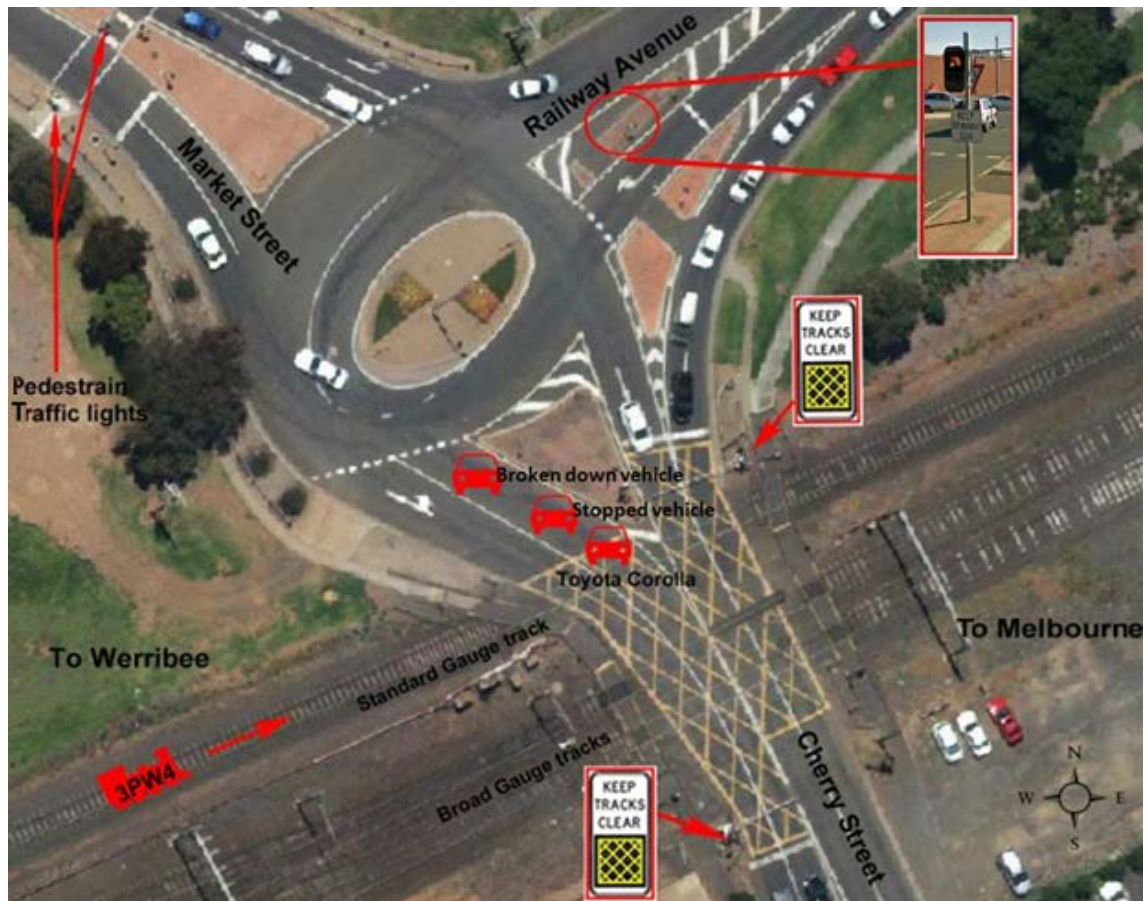
Figure 7: Cherry Street level crossing layout also showing train and vehicle positioning

The pavement markings at the Cherry Street level crossing were generally consistent with the requirements of AS 1742.7–2007. However, the yellow box markings at the northern end of Cherry Street, immediately before the roundabout, finished about 2 m beyond the nearest running rail rather than 5 m as set out in the standard.

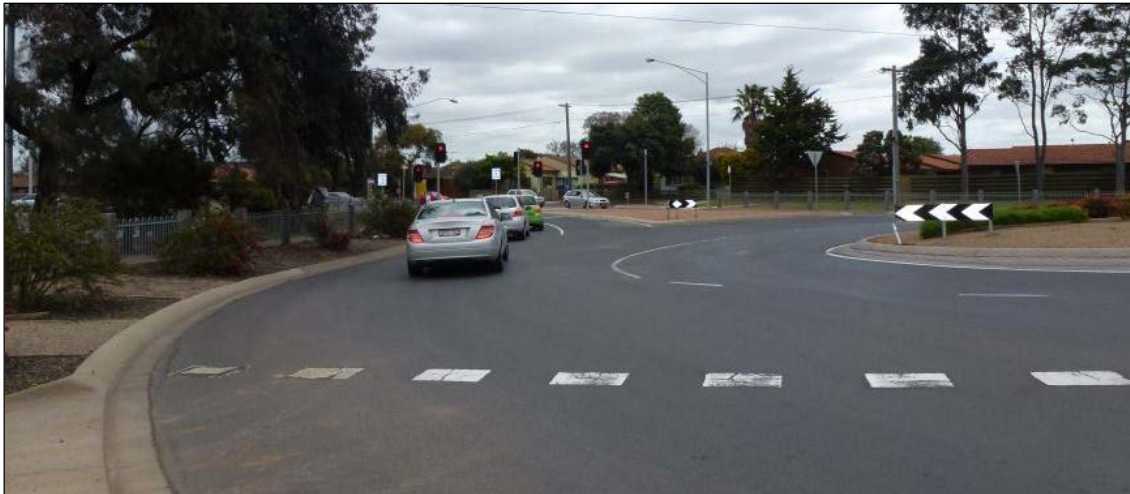
Figure 9: Pedestrian Traffic Lights located on the exit of the roundabout on Market Street showing traffic queuing through the roundabout

Pedestrian operated traffic lights are provided on Market Street approximately 60 m from the exit of the level crossing (Figure 7). The pedestrian traffic lights do not appear to coordinate effectively with the level crossing equipment. As a result, during a train/pedestrian phase, road traffic was observed to queue in advance of the pedestrian traffic lights. This can inhibit the free flow of traffic trying to exit the downstream side (Figure 9) of the Cherry Street level crossing.

Traffic congestion could be eased using the solutions identified at (c), (d) and/or (e) of AS 1742.7–2007, Section 5.2 (above).

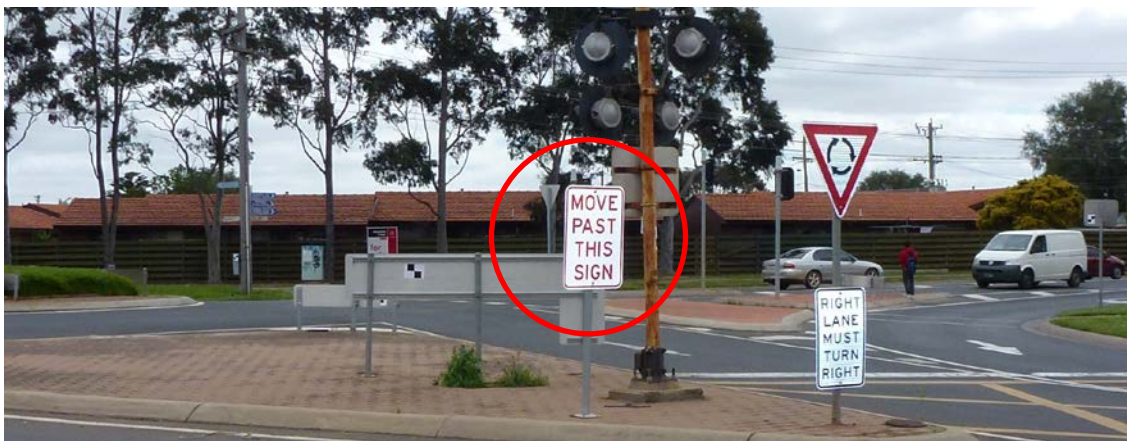
Figure 11: Signage installed by Wyndham City Council post-accident

The investigation also found that post-accident, signage was installed by the Wyndham City Council just beyond the point where the yellow box markings finish on the northern exit of the crossing (Figure 11). Although the sign encourages motorists to move beyond the yellow box markings, the sign is not part of the AS 1742.7– 2007 suite of available signs.
