Loss of control involving a Cessna 172, VH-IGS

93 km SE of Port Pirie aerodrome, South Australia, 31 October 2013

ATSB Transport Safety Report Aviation Occurrence Investigation AO-2013-198 Final – 20 January 2014 Released in accordance with section 25 of the Transport Safety Investigation Act 2003

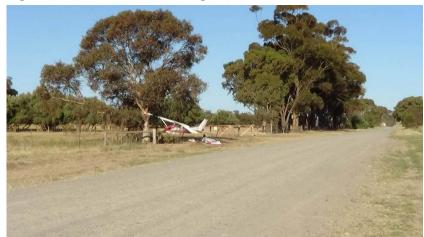
Figure 1: Road used for landing

The pilot felt pressure to repair the broken machine, to allow the harvest to continue, so planned to land on a gravel road in the Gum Creek area, close to the where the hay cutting machine was parked (Figure 1).

At about 1300, when overhead the selected road at Gum Creek, the pilot conducted a couple of precautionary searches at about 500 ft above ground level (AGL) to identify any potential obstacles during the landing. At this time, he also noted the dust from trucks on a nearby road hanging in the air, indicating very little wind. The flight from Parafield to Gum Creek had also been in minimal wind, so the pilot was not overly concerned about which direction to land. He did, however, identify a single powerline spanning the road, almost at right angles to the selected section of road.

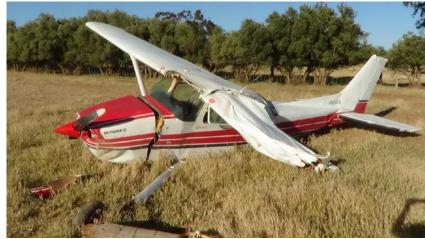
Figure 2: VH-IGS damage

However, IGS continued moving rapidly to the left, and struck a large tree, severing the left wing. The aircraft rotated about 180° and continued for about another 50 m through fences and a gateway before coming to a stop (Figure 2).

The pilot was able to egress the aircraft through the right side. He sustained minor injuries and the aircraft was substantially damaged.
