Mid-air collision involving a Cessna 152, VH-TNV and a Jabiru J160, 19-4430

Tyabb aerodrome, Victoria, 10 November 2013

ATSB Transport Safety Report
Aviation Occurrence Investigation
AO-2013-205
Final – 20 January 2014

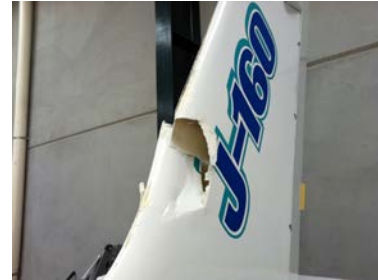
Damage to 19-4430

The Jabiru was substantially damaged and TNV sustained damage to the right elevator and trim tab.

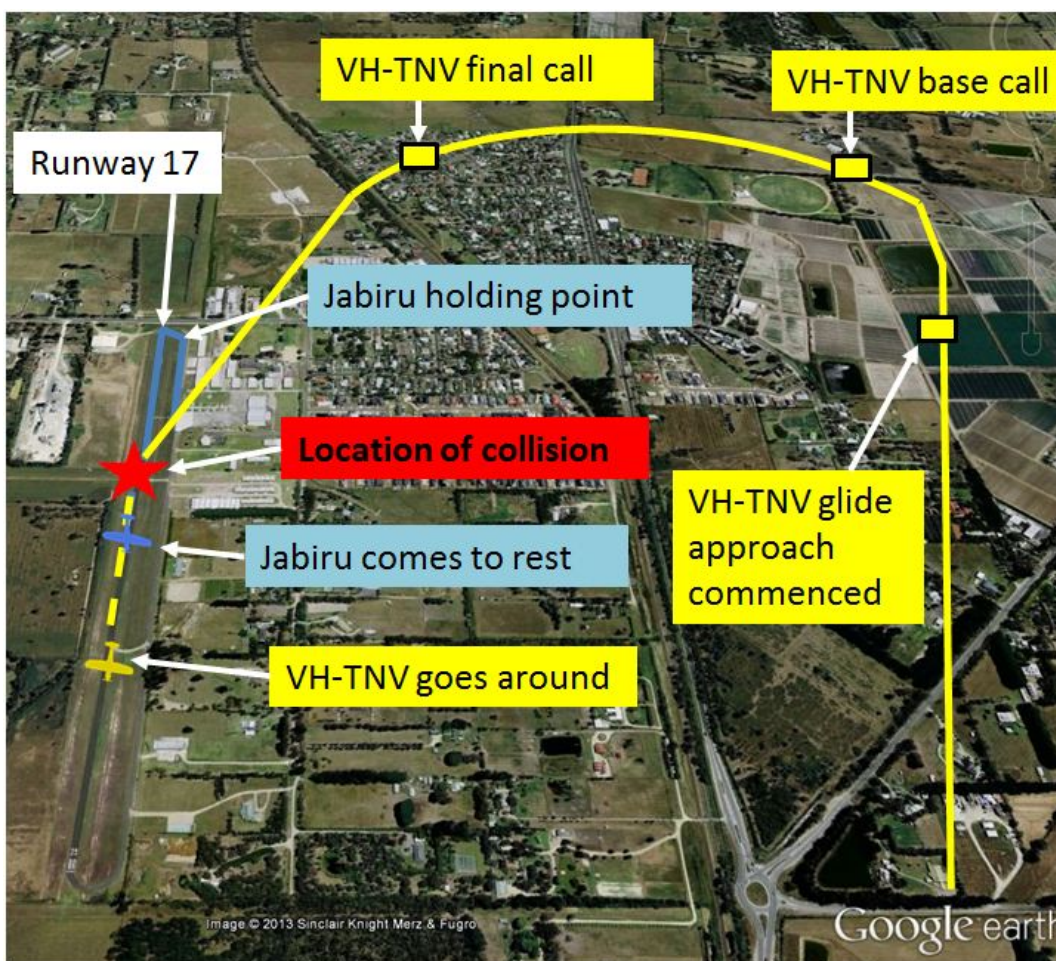
Figure 1: Approximate location of aircraft and radio broadcasts

At about the same time, the pilot of a Jabiru J160 aircraft, registered 19-4430 (Jabiru), taxied for a local flight with one passenger on board. The pilot broadcast a taxi call on the common traffic advisory frequency (CTAF) and commenced taxiing to the runway 17 holding point. The pilot stopped the aircraft short of the marked holding point and turned at an angle to maximise his view of the base and final legs of the circuit (Figure 1).

The pilot of TNV reported that, when on a closer downwind leg than normal, in line with the runway 17 threshold, he reduced the engine power to idle and commenced a glide approach. He broadcast that TNV was turning base for a glide approach and commenced a continuous turn towards runway 17.

At about the same time, the pilot of TNV reported that he was on a high, close final, had sighted the Jabiru at the holding point, and reported broadcasting on the CTAF that he was turning final. Neither pilot heard the other pilot's broadcast and both reported that they may have transmitted their calls simultaneously.
