Total power loss involving a Robinson R22, VH-STK

155 km SSW of Normanton aerodrome, Queensland, 13 November 2013

ATSB Transport Safety Report
Aviation Occurrence Investigation
AO-2013-211
Final – 20 January 2014

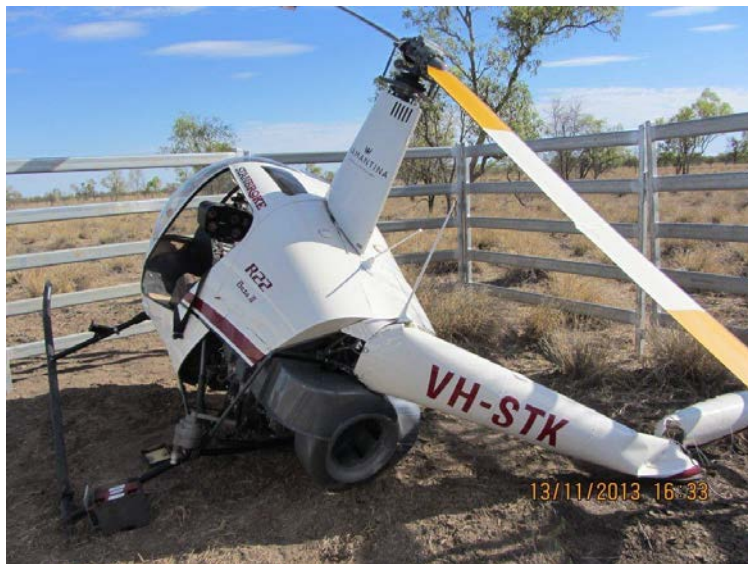
Figure 1: Damage to VH-STK

At about 20 ft above ground level, the engine stopped. The pilot lowered the collective² and flared³ the helicopter for landing. On impact, the helicopter spun around 180° (Figure 1). The helicopter was substantially damaged and the pilot was uninjured.

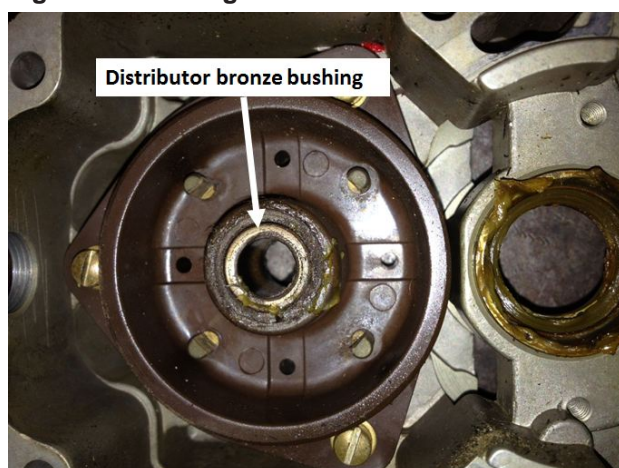
Figure 2: Left magneto distributor

An engineering inspection of the left magneto revealed that the distributor bushing was loose (Figure 2) resulting in 6 mm of movement in the plastic gear wheel (Figure 3). This resulted in the magneto providing the ignition spark to an incorrect engine cylinder at the wrong time.

The magneto previously had a 500 hourly inspection carried out on it 80 hours prior to the accident.

As a result of this occurrence, the operator has advised the ATSB that they have requested all company pilots review the New Zealand Civil Aviation Authority's (CAA) publication *Magneto Checks Basics* and the Robinson R22 Flight manual safety notices (see safety message below for links).
