Australian Government
Australian Transport Safety Bureau

Aviation Short Investigation Bulletin

Issue 25

AB-2013-215

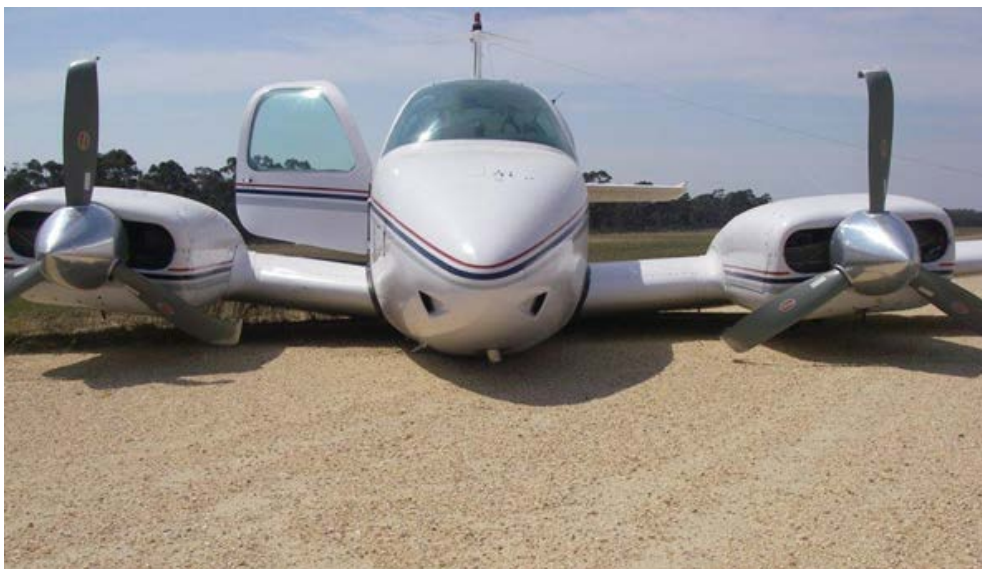
Figure 1: Aircraft damage

As the aircraft touched down, the pilot realised that the landing gear was retracted. The aircraft slid along the runway and came to rest about 600 m from the runway end. The aircraft sustained substantial damage (Figure 1).

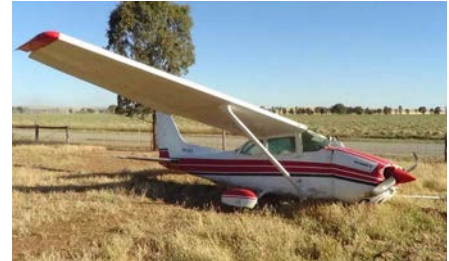
VH-IGS at the accident site

The pilot was able to egress the aircraft through the right side. He sustained minor injuries and the aircraft was substantially damaged.

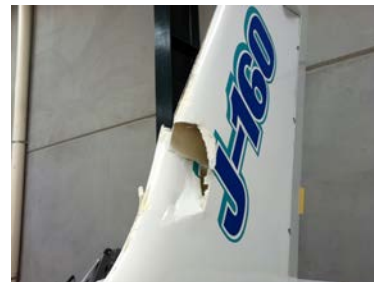
Damage to 19-4430

The Jabiru was substantially damaged and TNV sustained damage to the right elevator and trim tab.

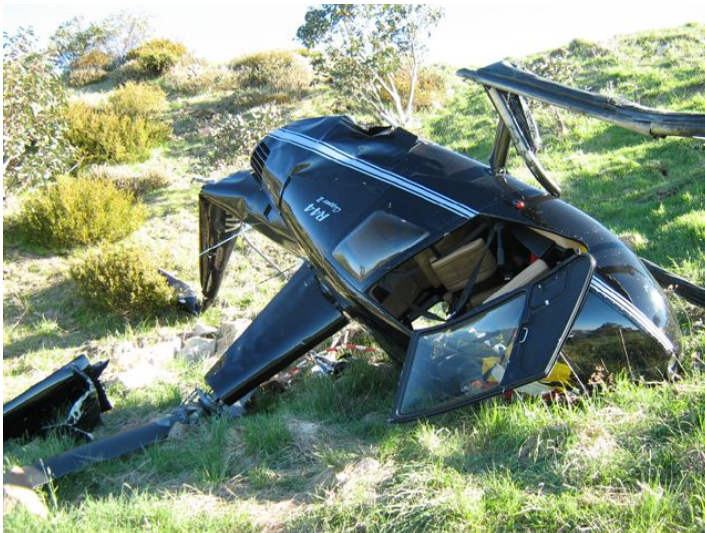
Figure 1: Damage to VH-UGC

As the front of the helicopter's skids were about to touch down, the pilot applied full forward cyclic,⁴ and reported experiencing mast bump.⁵ In response, he raised the collective. The low rotor revolutions per minute (RRPM) horn then sounded and the pilot reported that the helicopter felt as if it was going to fall backwards. The helicopter rolled onto its side and came to rest about 9 m down an embankment. The helicopter was substantially damaged⁶ (Figure 1) and the pilot and passengers were able to exit the helicopter uninjured.

Mount Buller helipad was at an elevation of 5,400 ft above mean sea level. The pilot reported that the helicopter was at a gross weight of about 1,048 kg when it landed. When the pilot attempted to increase power, the engine was already producing the maximum continuous power available for the altitude and prevailing conditions.

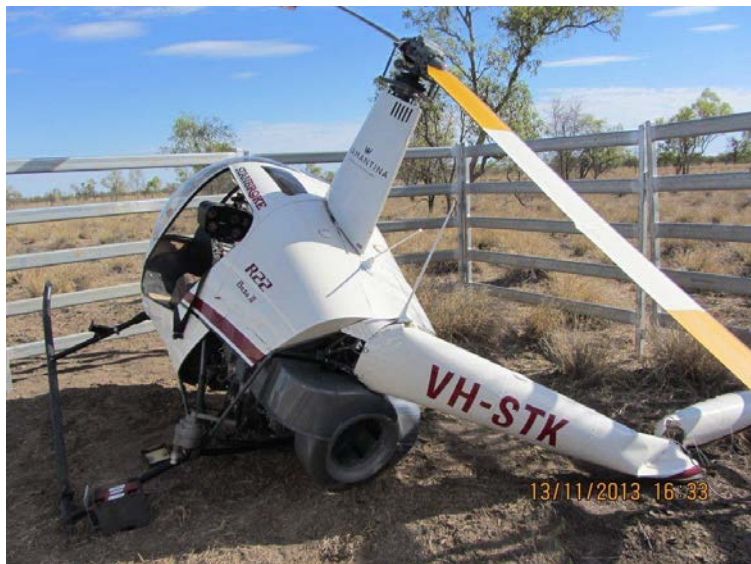
Figure 1: Damage to VH-STK

At about 20 ft above ground level, the engine stopped. The pilot lowered the collective² and flared³ the helicopter for landing. On impact, the helicopter spun around 180° (Figure 1). The helicopter was substantially damaged and the pilot was uninjured.

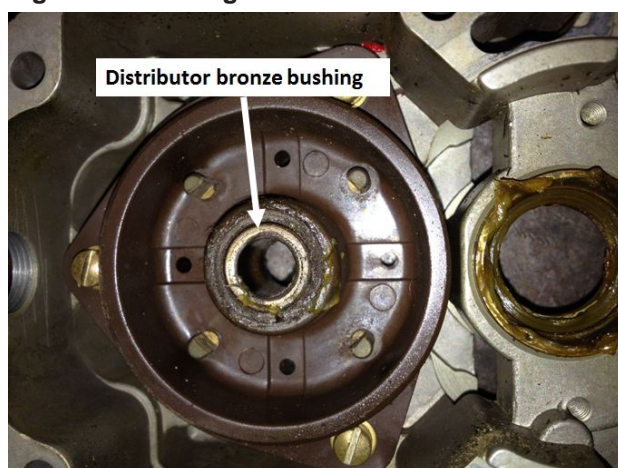
Figure 2: Left magneto distributor

An engineering inspection of the left magneto revealed that the distributor bushing was loose (Figure 2) resulting in 6 mm of movement in the plastic gear wheel (Figure 3). This resulted in the magneto providing the ignition spark to an incorrect engine cylinder at the wrong time.

The magneto previously had a 500 hourly inspection carried out on it 80 hours prior to the accident.
