# Embrittled nut and related failures Robinson R22 Beta helicopter, VH-JNP

22 km N of Saxby Downs, Qld | 12 October 2011

**ATSB Transport Safety Report**  
Aviation Occurrence Investigation  
AO-2011-135  
Final – 22 January 2014

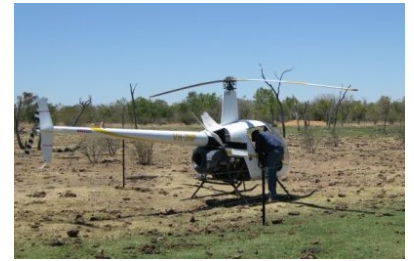
VH-JNP post-landing

On 12 October 2011, the pilot of a Robinson R22 helicopter, registered VH-JNP, was performing aerial work near Saxby Downs in Queensland, when he heard a rattling noise behind the cabin and noted that the clutch light had illuminated. The pilot opened the clutch actuator circuit breaker and, at the same time, noted a burning rubber smell, prompting him to make an immediate precautionary landing and shut down the helicopter.

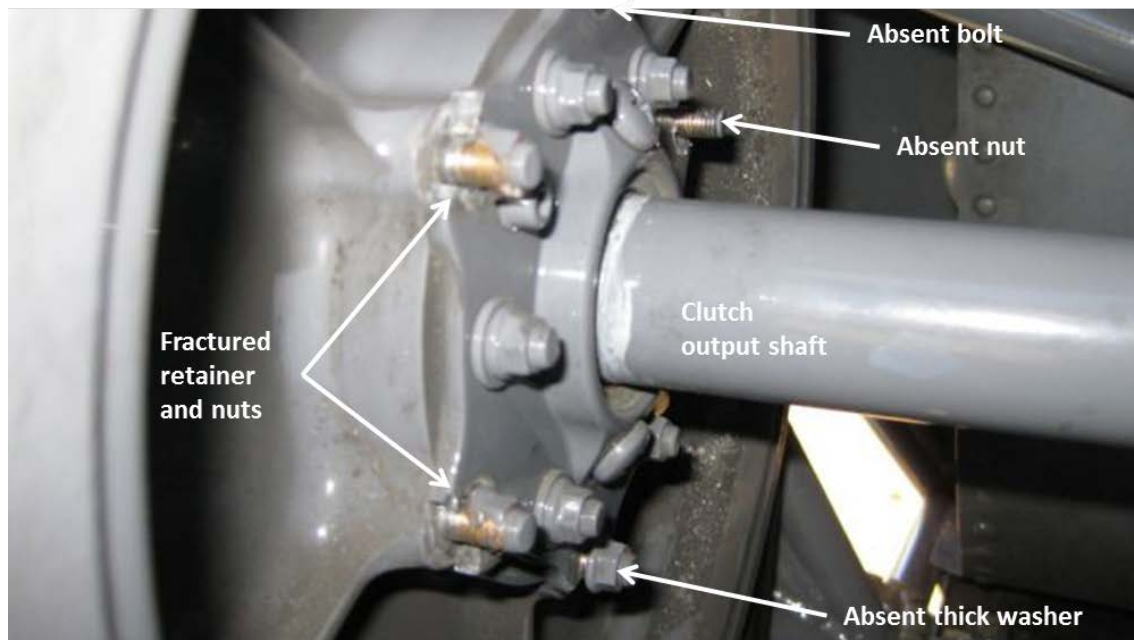
An inspection by the operator later that day identified damage to the helicopter's main rotor drive clutch assembly. Several retention nuts from the upper drive pulley (sheave) had failed (Figure 1), with corresponding lobes of the retainer having broken away beneath the nuts. The clutch actuator drive motor had also sustained some visible damage.

**Figure 1: In-situ photograph of the damaged clutch assembly**

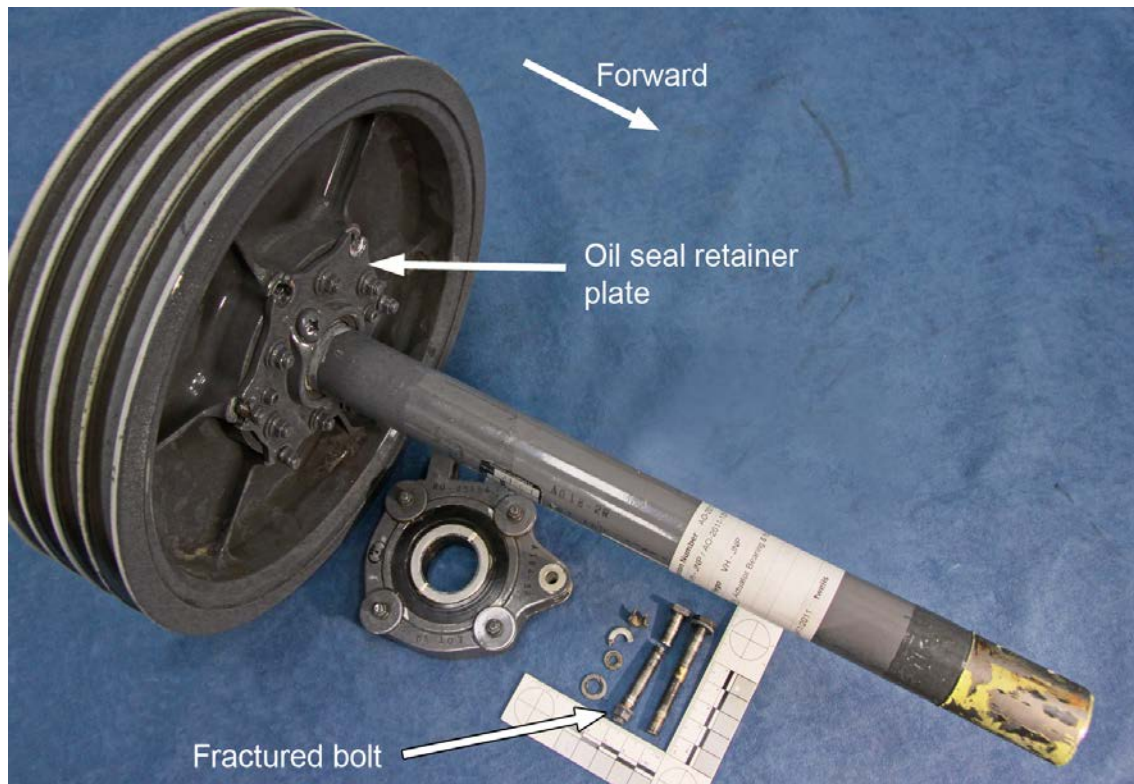
Following commencement of the ATSB investigation, the operator submitted the helicopter's clutch assembly for examination (Figure 3). Preliminary visual examination of the components noted the following:

**Figure 3: As-received clutch assembly when viewed from the forward end.**

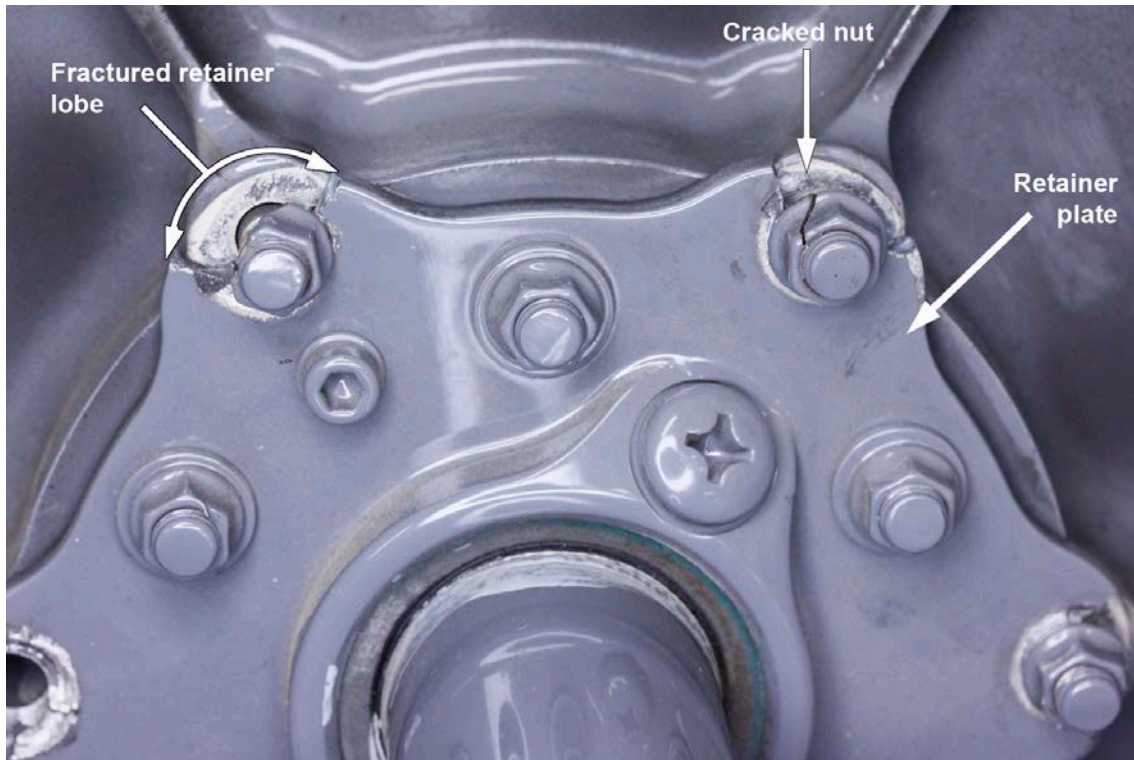
- The upper sheave did not reveal any uneven wear, damage or other indications of misalignment or abnormal operation.
- The outer lobe portions of both retainers had fractured (Figure 4).
- All six *inner* bolts/nuts/washers that secured the two retainers onto the sprag clutch housing were intact (Figure 4).
- The self-locking nuts and respective washers from five of the six retainer outer bolts had fractured (Figure 6).
- One of the outer, retainer bolts had fractured through the shank. Its self-locking nut remained whole and attached (Figure 5).

**Figure 4:** Close view of the clutch assembly damage. Five of the nuts had either cracked or had fractured.

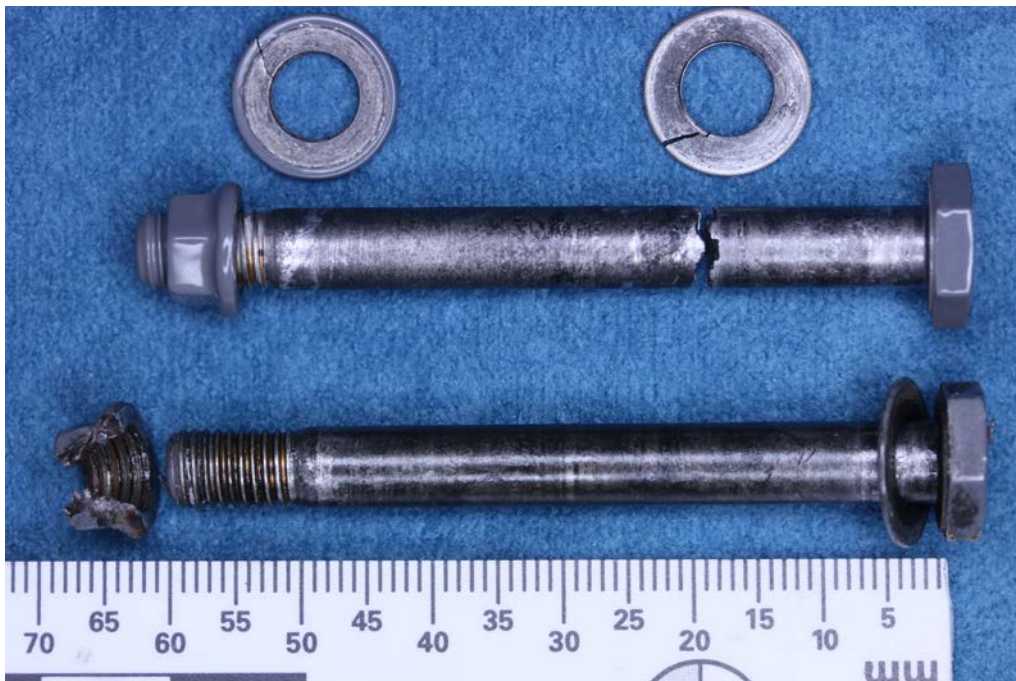
**Figure 5:** The as-received, loose outer, retainer fasteners.

As shown in Figure 5, one nut had fully fractured and separated from its mating bolt, allowing the bolt to migrate axially out of position to a point where the head came in contact with the clutch actuator bearing's fixed journal. This rotating contact during operation produced the gross angular wear observed on the bolt head surface (Figure 12).

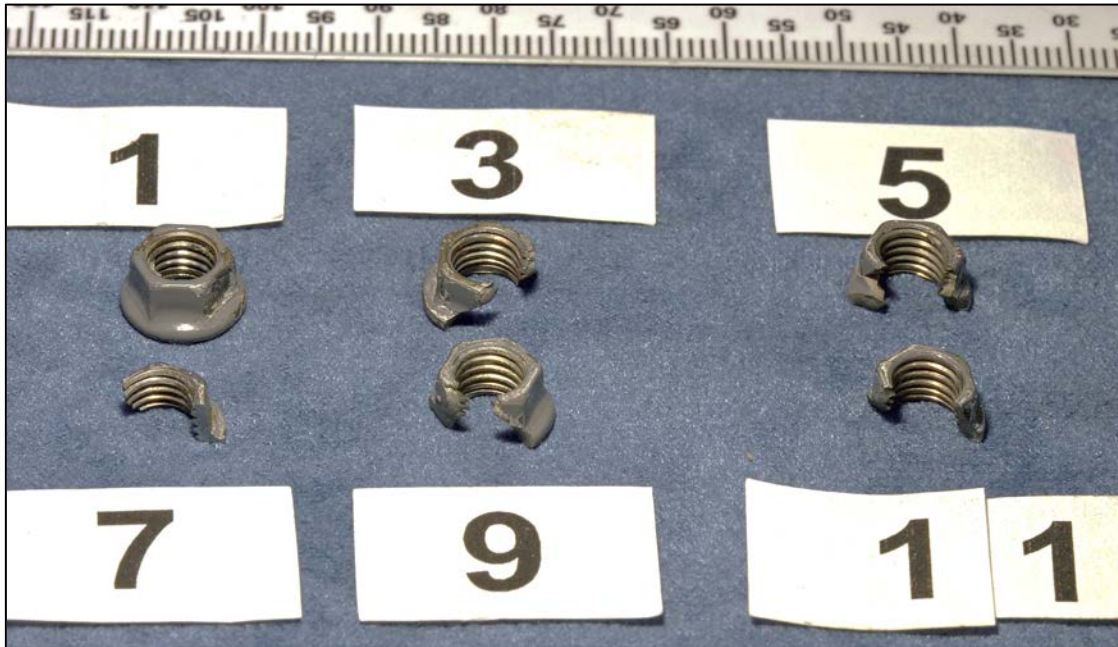
After controlled disassembly of the clutch, the fractured retainer outer locking nuts were examined visually and microscopically. All five fractured nuts presented two opposing cracks or fracture

surfaces (Figure 6). Characterisation of the fracture morphology under stereomicroscopic examination showed at least one fracture on each nut to have originated at the junction of the bearing surface and the start of the internal thread (Figure 7) – those origin regions typically presented macroscopic chevron patterning consistent with a brittle fracture mechanism.

**Figure 6: Nuts from the outer fasteners (labelled to relative positions on the ‘clock face’)**

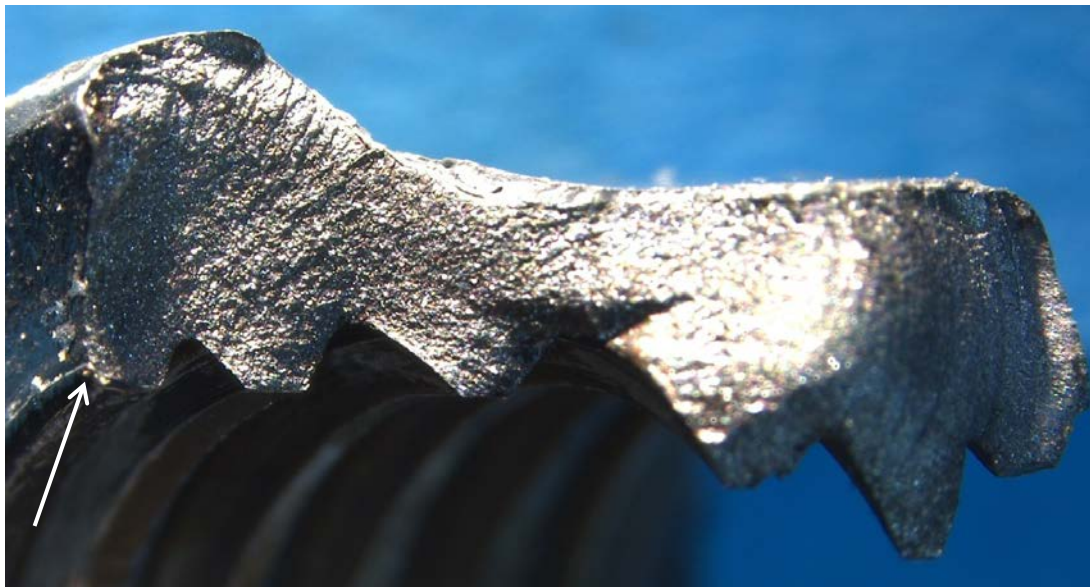
**Figure 7: Typical, axially-orientated nut fracture surface; note the reflective grain facets**

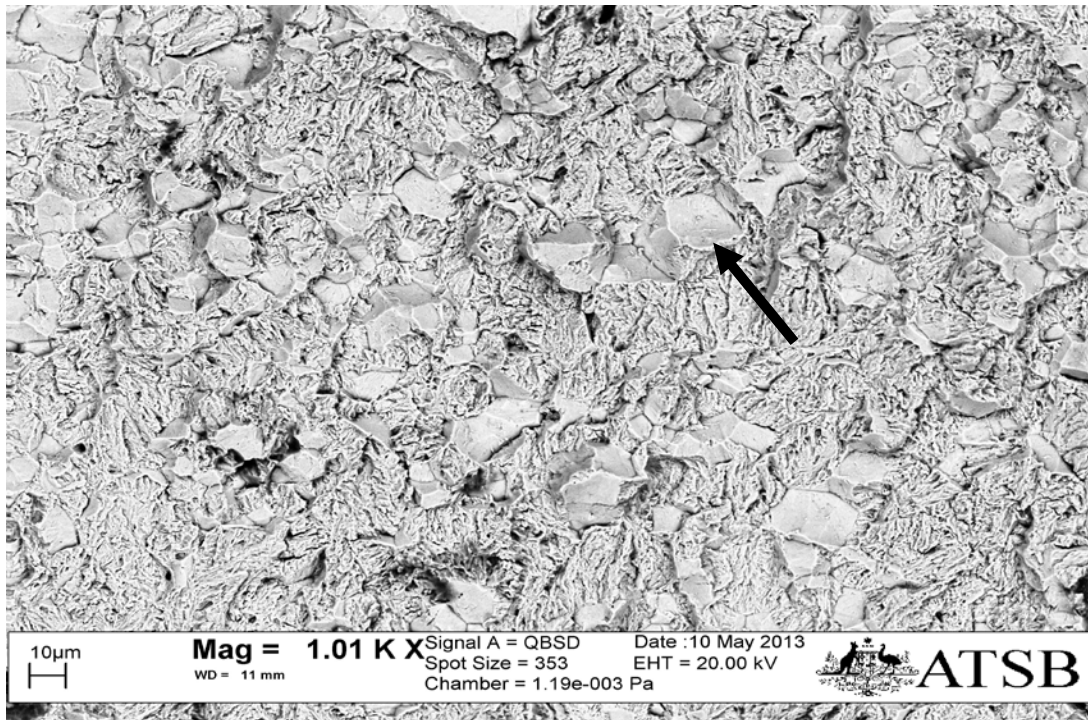
Across the fracture surfaces of four nuts were areas of bright, crystalline, reflective features – further indicative of a brittle fracture mechanism. Higher magnification examination of those areas under the scanning electron microscope found characteristic evidence of a mixed-mode failure, with areas of intergranular fracture (i.e. fracture following the grain boundaries) intermixed with regions presenting a more transgranular form. Figure 8 shows an area adjacent to one of the internal corners, while Figure 9 shows an area below a thread root; intergranular characteristics can be seen in both.

**Figure 8:** Fracture surface of a nut with initiation at an inner corner. The areas of smooth faceted appearance (example arrowed) are indicative of intergranular fracture.

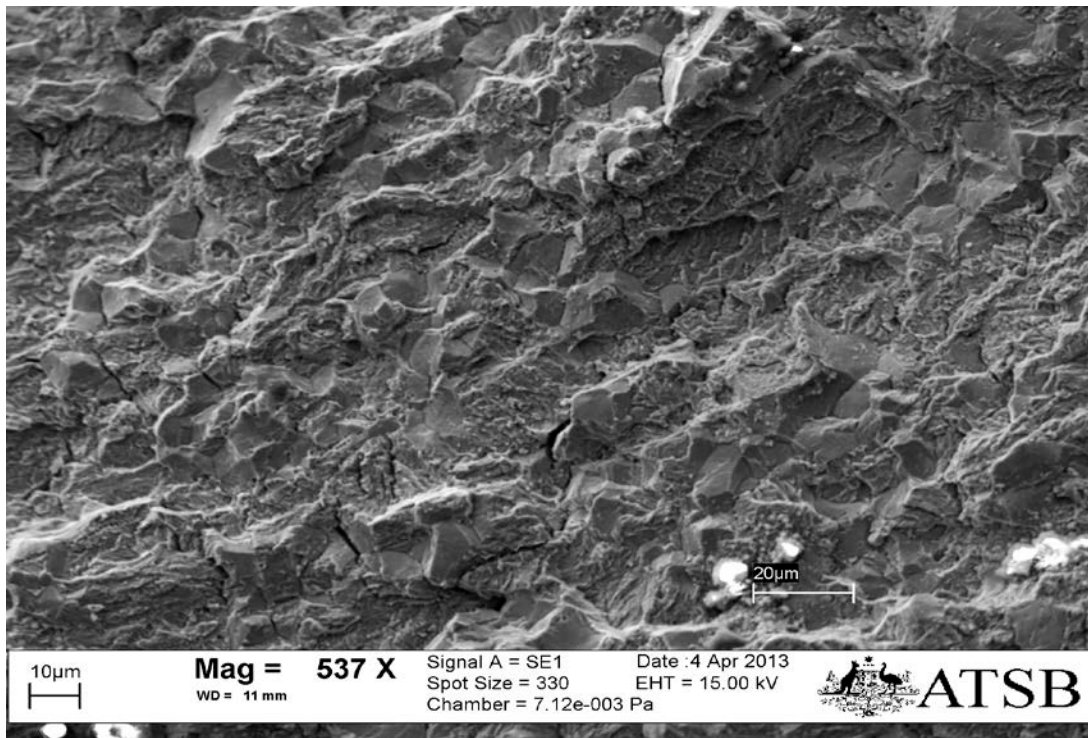
**Figure 9:** Intergranular cracking below the threads adjacent to the nut flanged surface.

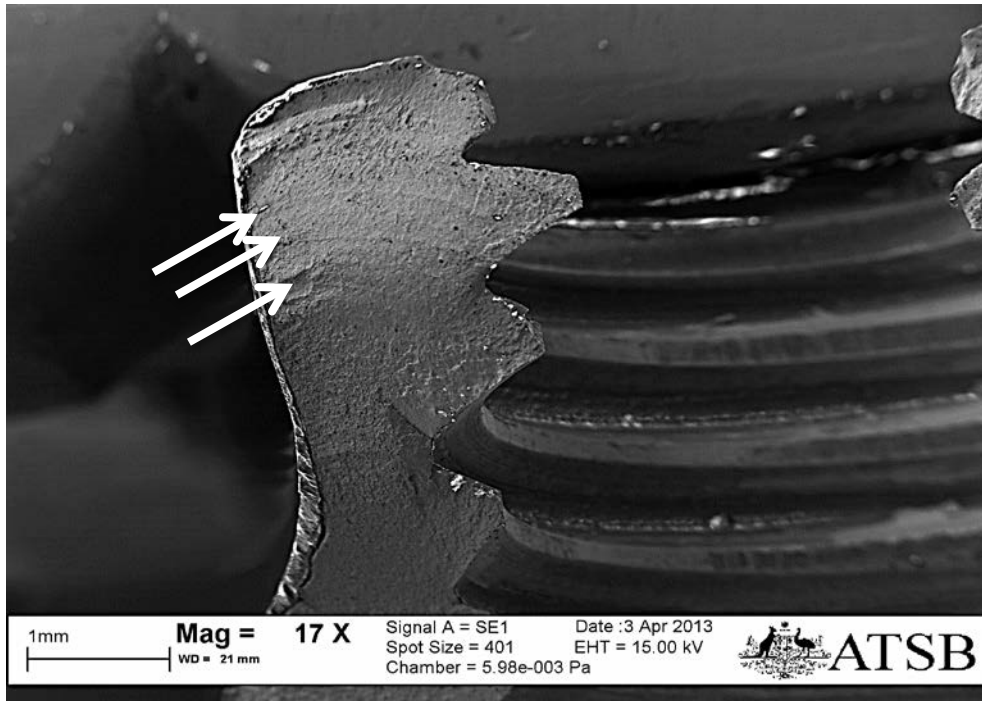
Away from the regions of intergranular/transgranular failure, the fracture surfaces presented areas of repeating crack progression markings; a characteristic of fatigue failures (Figure 10). In these regions, crack growth was almost completely transgranular, which is also typical of fatigue in ferrous materials.

**Figure 10: Beach marks (indicative of fatigue) extending away from the nut bearing face.**

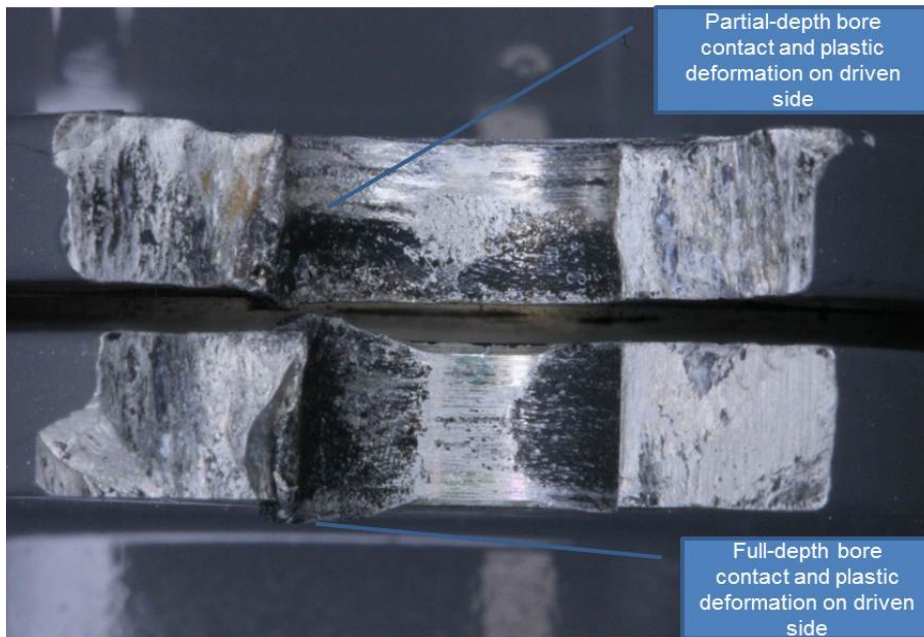
Examination of the nut mating components (washers and retainer lobes) identified features typical of overstress fracture. Many of the retainer lobe fractures showed areas of adjacent plastic deformation around the bolt hole bores, with the location and orientation of these areas being typical of sideways shear loading by the respective sheave-driven mating bolt (Figure 11). Wear and compressive deformation of up to 2.5mm was present on the retainer faces beneath the nut and washer stack, suggesting a period of significant axial movement between the components before the complete breakdown of the assembly.

**Figure 11: Lobe fractures of retainers; the forward retainer is uppermost.**

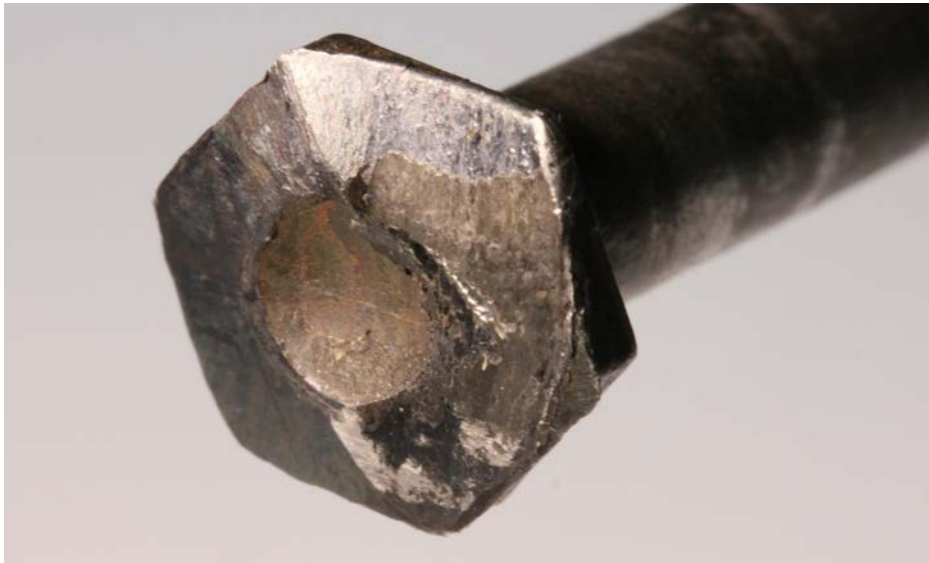
**Figure 12: Worn head of a retention plate outer bolt from contact with the clutch actuator fixed bearing journal.**

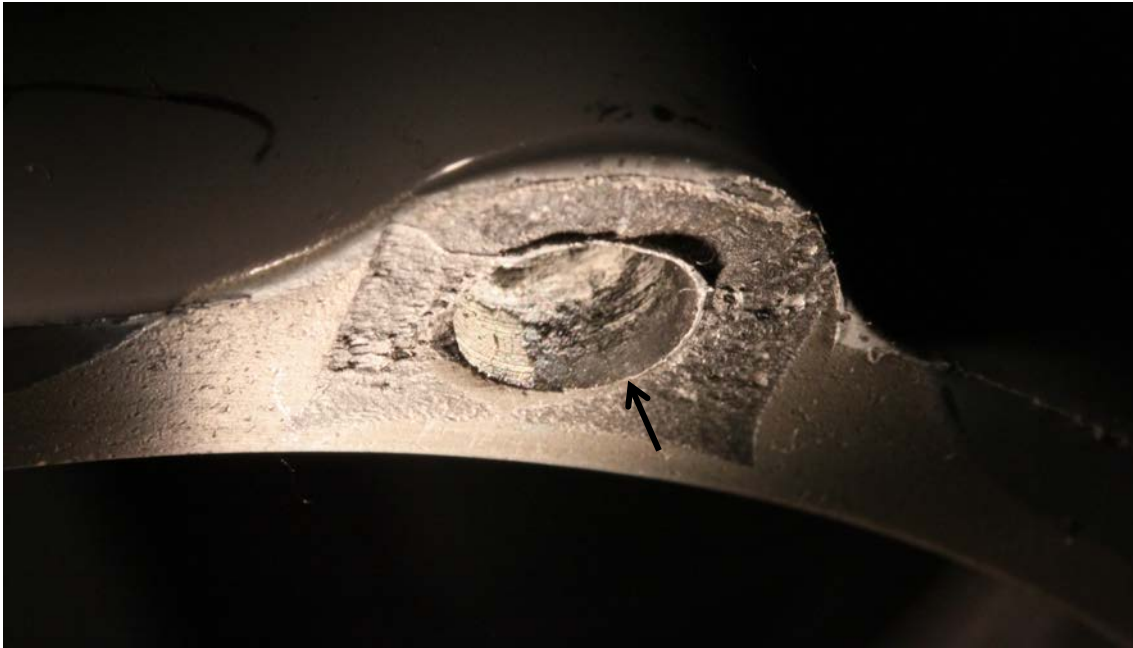
The bolt shank surfaces showed varying levels of surface fretting and light wear, consistent with repetitive rotational movement against the bore of the sheave through-holes. The bore surfaces also presented corresponding levels of wear, fretting and deformation – with a bias in the level of damage shown to one side that was consistent with the transmission of bearing loads in the direction of sheave rotation (Figure 13).

**Figure 13:** Sheave/retainer bolt hole bore showing associated driving-side wear and deformation (arrowed) from contact with the bolt shank.

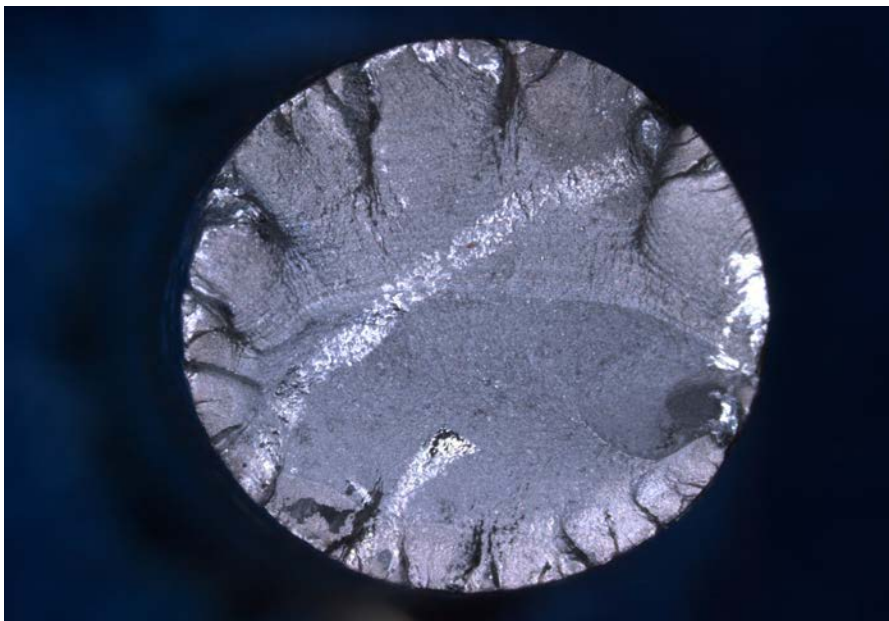
The bolt fracture surfaces showed multiple, radially-orientated ratchet marks extending around the circumference, with clear, bending fatigue crack progression marks between the ratchet marks, extending part-way across the bolt diameter (Figure 14). A small, offset zone of final ductile overstress failure was evident to one side of the central section.

**Figure 14:** Bolt fracture surface with fatigue steps around the perimeter and linked beach marks progressing from top to middle. Final overload is the dark grey remainder.

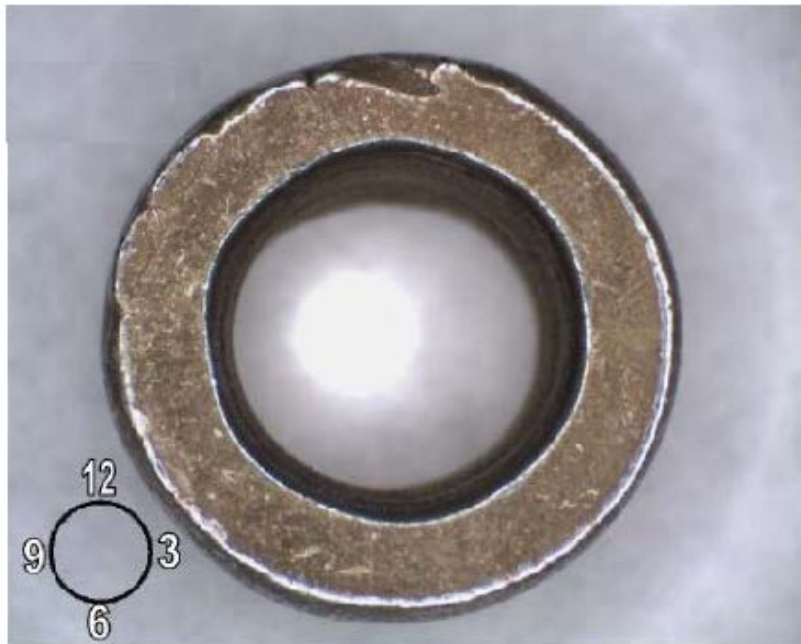
Figure 1: Example of surface irregularities observed on a nut. Overall view.

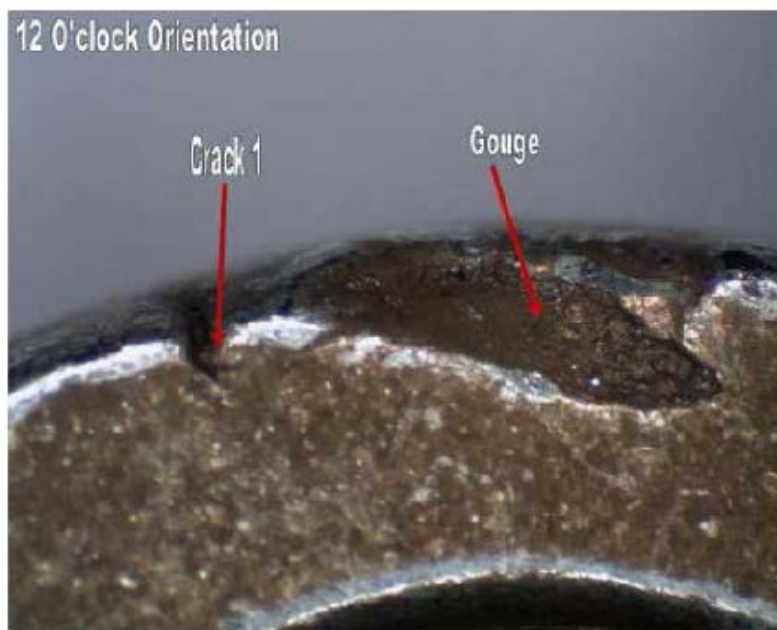
Figure 2: Example of surface irregularities observed on a nut. Detail

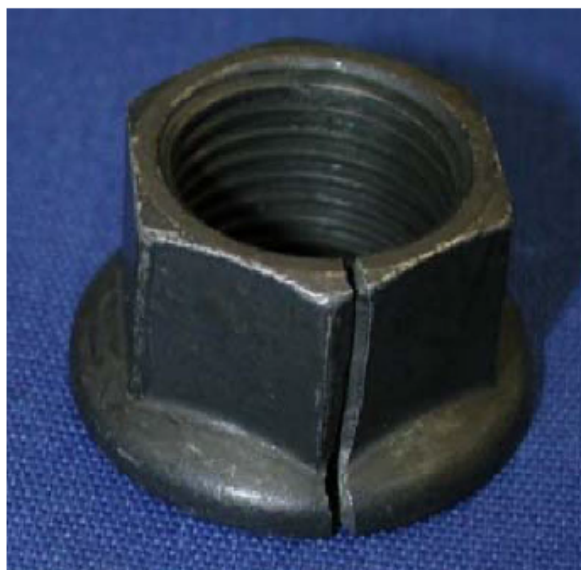
Figure 3: Example of longitudinal crack.
