Loss of control involving scale-replica Spitfire, VH-VSF

near Parafield Airport, SA | 17 March 2013

ATSB Transport Safety Report
Aviation Occurrence Investigation
AO-2013-051
Final – 28 January 2014

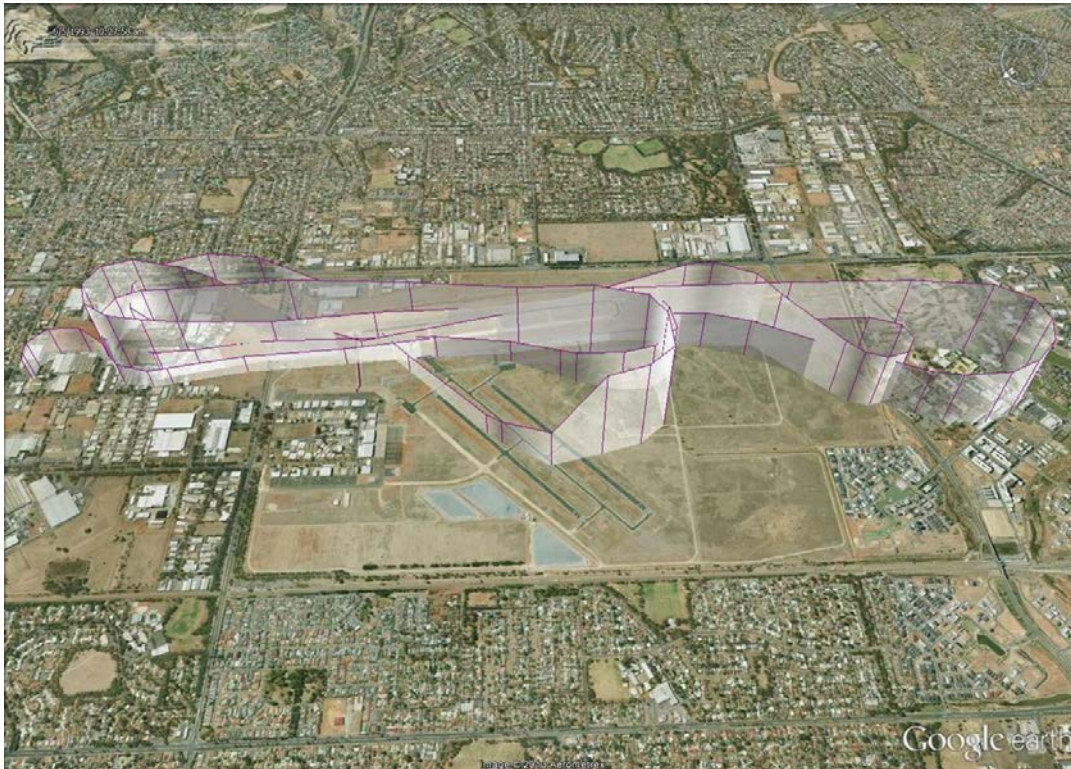
Figure 1: Spitfire GPS data of air display flight transposed onto satellite image

Passing abeam the main viewing area the pilot veered to the right and climbed then turned left to reverse direction for another fly-past along the runway. During this reversal the Spitfire reached 1,240 ft at a ground speed of 129 kt and on the pass descended to 778 ft at 149 kt. The pilot followed this general pattern (with one pass along runway 08 Left) to conduct a total of seven fly-pasts (Figure 1) with no aerobatics.

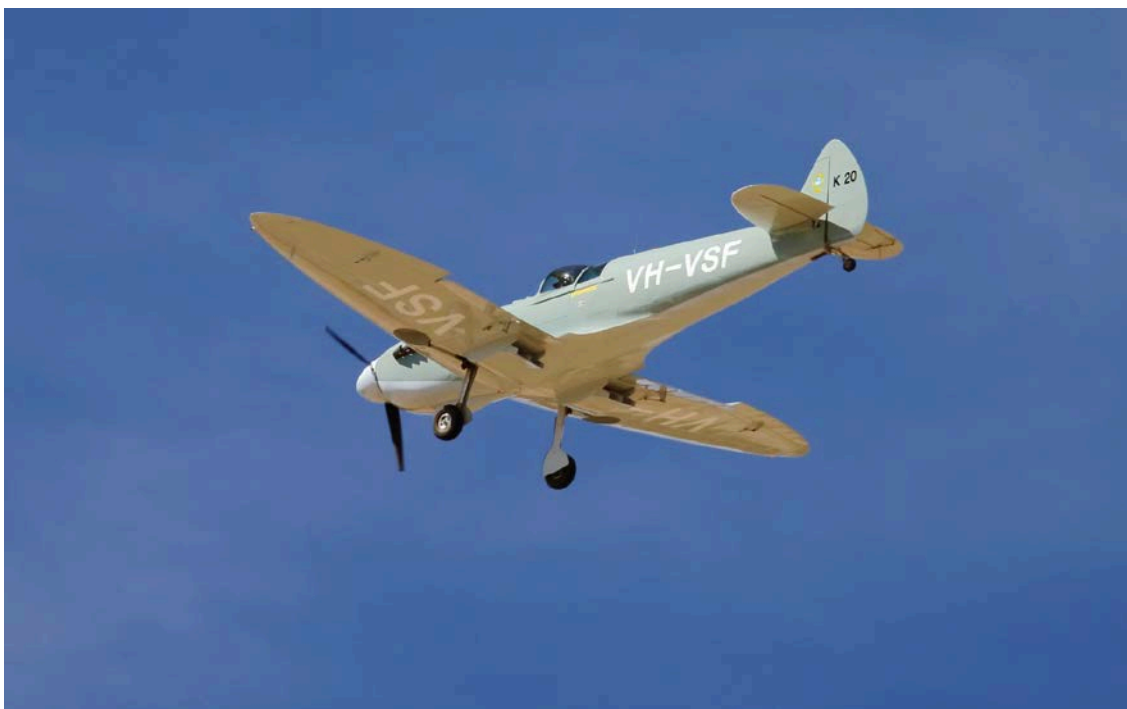
Figure 2: Spitfire on seventh and last flypast

On the seventh fly-past the pilot was heading northward along runway 03 and descended to as low as 320 ft at 90 kt ground speed. For this pass the landing gear was down and some wing flap between 10° and 15° was extended (Figure 2). Witnesses did not notice anything unusual about the aircraft during this sequence.

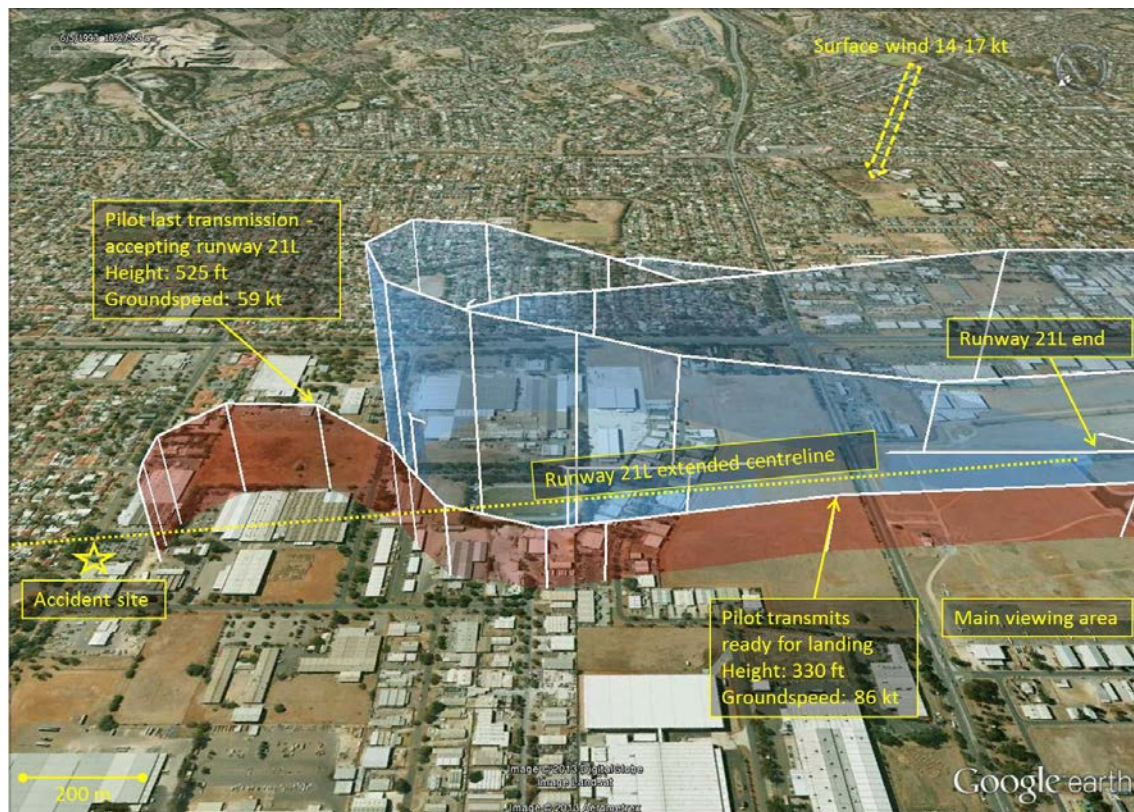
Figure 3: Spitfire GPS data re air display flight transposed onto satellite image (last fly-past and accident sequence highlighted red and prior display highlighted blue) with key events annotated

During this radio exchange the pilot veered slight left then turned to the right while climbing slightly. The turn progressed through about 60° so that the Spitfire was now on an easterly heading at 480 ft and 56 kt ground speed, near the extended centreline of runway 21L, and about 1,000 m from the runway threshold (Figure 3).

By the time the pilot had made his last transmission at 1356:51 to accept the assigned runway, the direction of turn had changed to the left and the height peaked at 550 ft. As the turn progressed, groundspeed reduced to about 55 kt and a slight descent was noted. (The last recorded data points were of uncertain validity due to the limitations of some GPS devices in unusual flight conditions)

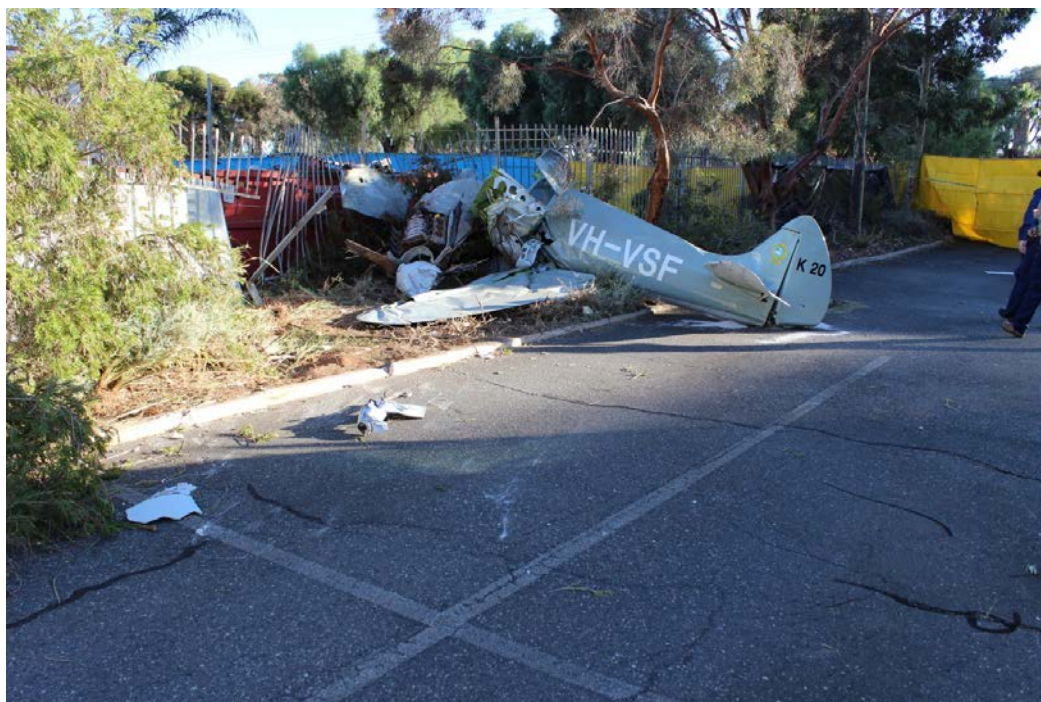
Figure 4: Aircraft wreckage

Damage to the aircraft was consistent with it descending steeply into terrain at a high rate of descent in a wings-level, nose-down attitude (Figure 4). There was no evidence of in-flight structural failure. All of the aircraft's components were accounted for at the accident site, with no evidence of pre-impact damage. Continuity of the aircraft's flight and engine control systems was established and on-site evidence indicated that the engine was producing power at ground impact. The fuel tank ruptured on impact with the result that no fuel was available for testing. The engine and a number of instruments and electronic units were recovered from the accident site for technical examination.
