# In-flight break-up involving de Havilland DH82A Tiger Moth, VH-TSG

300m east of South Stradbroke Island, Queensland, 16 December 2013

**ATSB Transport Safety Report**

AO-2013-226

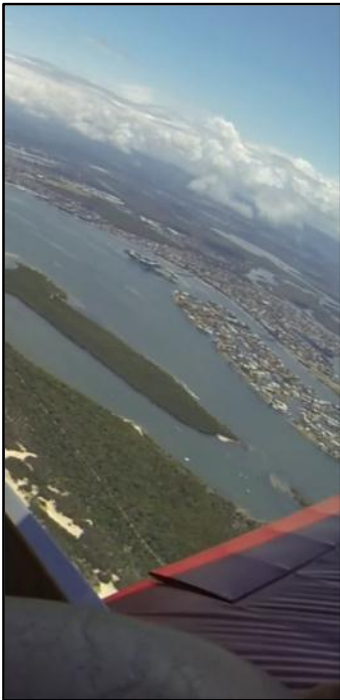
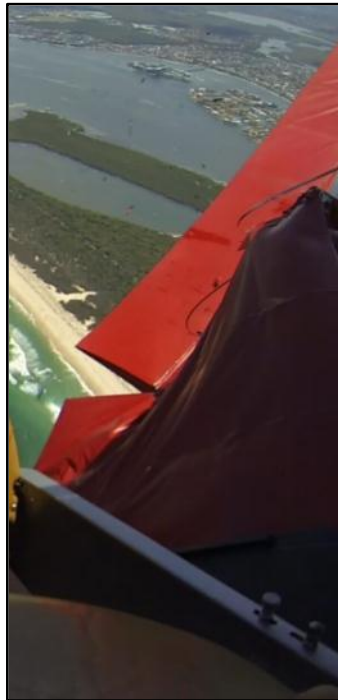
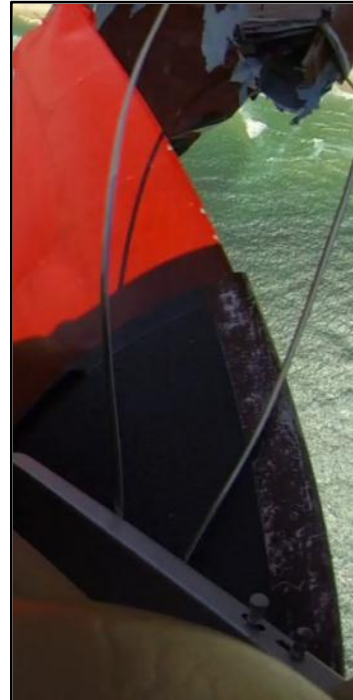
**Figure 9: Cropped view of 3 separate frames of video showing wing failure progression**

The video indicated that, after 1 minute of aerobatic manoeuvres and while pulling out at the bottom of a loop, the left lower wing appeared to fail in an area forward and outside of the camera's view. The initiation point of the failure was in an area that was either part of the wing's forward spar structure or at its attachment point to the fuselage. A very short time later, the upper left wing failed and both left wings folded backwards towards the fuselage. The time between normal operations to complete failure of the lower and upper left wings was less than 1 second.

Figure 9 is a cropped selection of video frames displaying the progression of the left lower wing failure, from a slight ripple on the left lower wing fabric covering to complete failure.

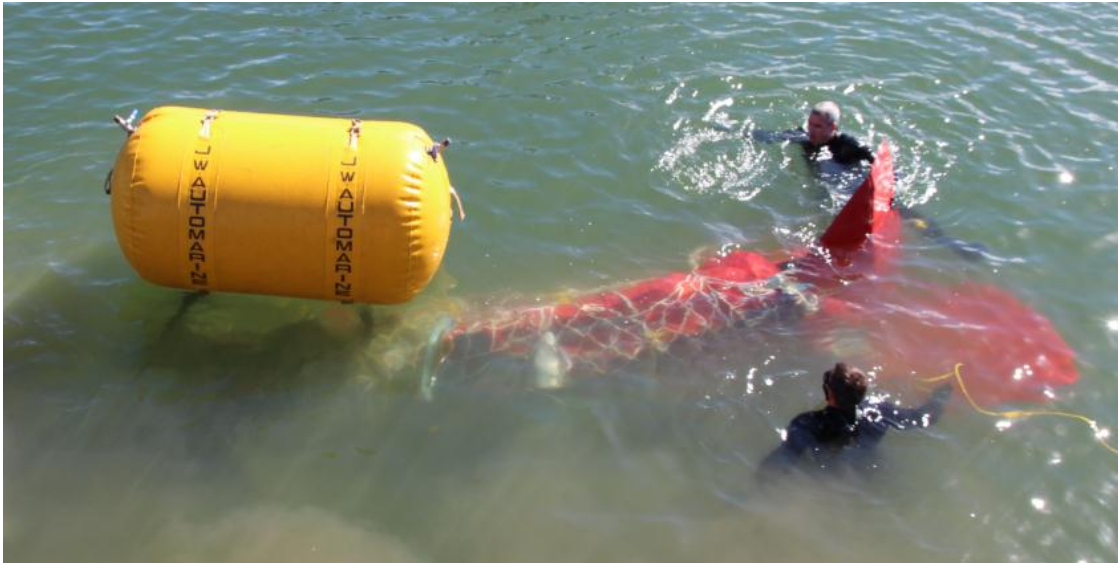
**Figure 10: Aircraft recovery**

The aircraft was located in about 15 m of water on the ocean side of South Stradbroke Island. The Queensland Police Service floated and recovered the main wreckage 2 days after the accident (Figure 10), in conditions including rough seas, high winds and reduced underwater visibility. One of the two video cameras fitted to the aircraft was located on the ocean floor, having separated from the aircraft during the accident sequence. The other video camera was not on its mounting point and was not located after an extensive search. Other items of wreckage were collected floating on the ocean surface or washed up on South Stradbroke Island.

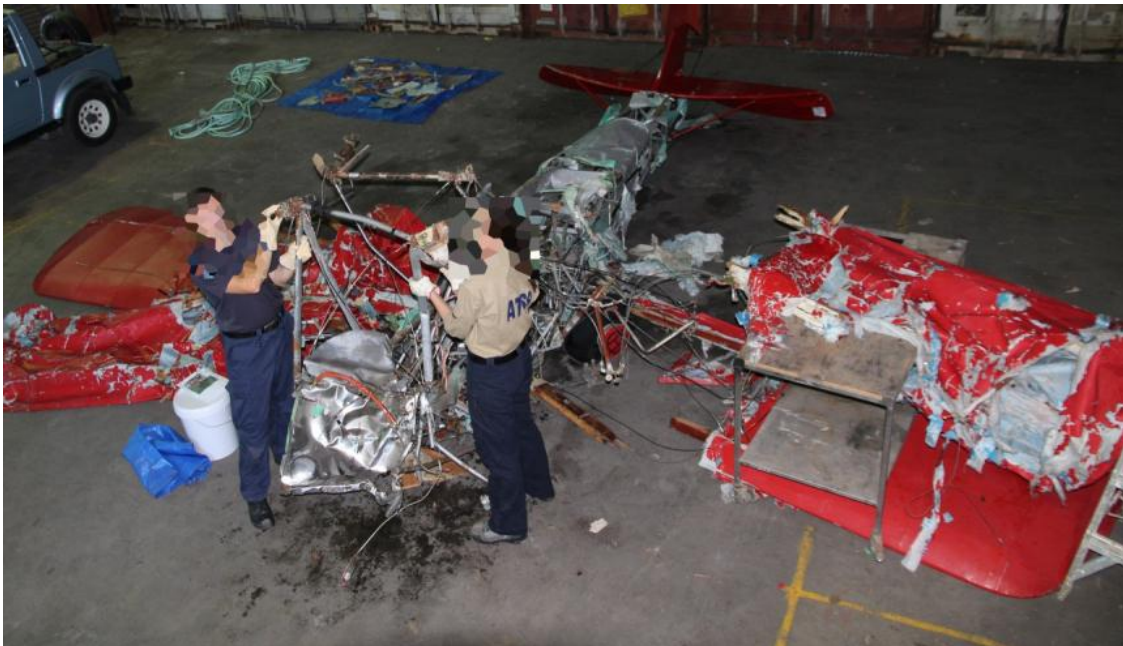
**Figure 11: Wreckage reconstruction**

The aircraft was significantly damaged, consistent with the impact with the water. Though the fuselage was relatively intact, the wing structures were severely disrupted, having broken into numerous pieces, some of which were recovered as flotsam. The engine had separated from the fuselage during the impact sequence and the propeller had fragmented. However, the majority of the propeller hub remained attached to the engine's attachment flange.

The fuselage structure and flight control systems were inspected with no pre-impact defects identified. The fuselage and wings were reconstructed to assist with determining the aircraft break-up sequence (Figure 11).

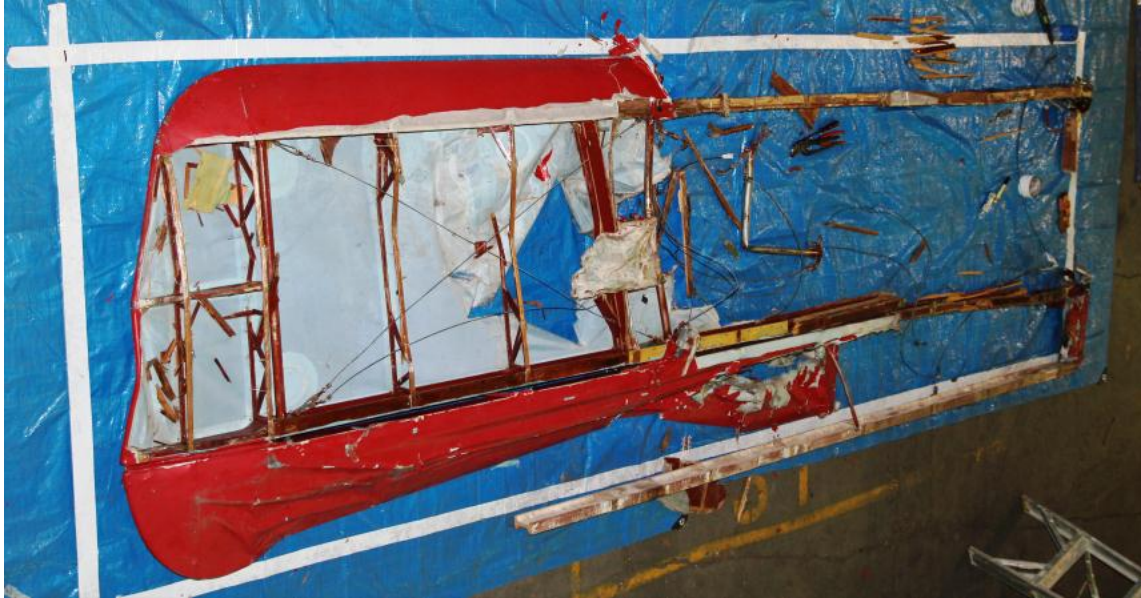
**Figure 12: Left lower wing looking at the upper surface**

The wings were reconstructed with about 95 per cent of the main spar structures accounted for. The left wing flying wires and landing wires were still attached to their corresponding attachment points. The internal wing bracing wires were also intact. Figure 12 shows the partially reconstructed left lower wing.

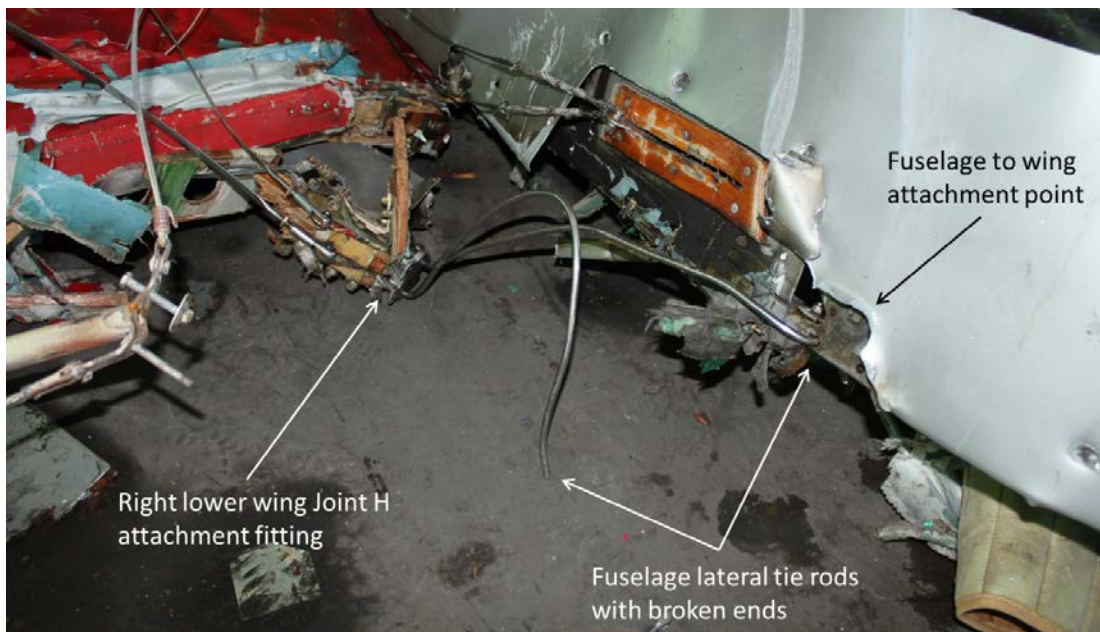
**Figure 13: Right wing-to-fuselage attachment point**

The lower wing attachment point Joint H fittings were still attached to the wings, but had separated from the fuselage (Figure 13). Both lateral tie rod ends were fractured through the threaded section at the left wing attachment point. The remaining part of the threaded section and nut for each tie rod were not recovered.

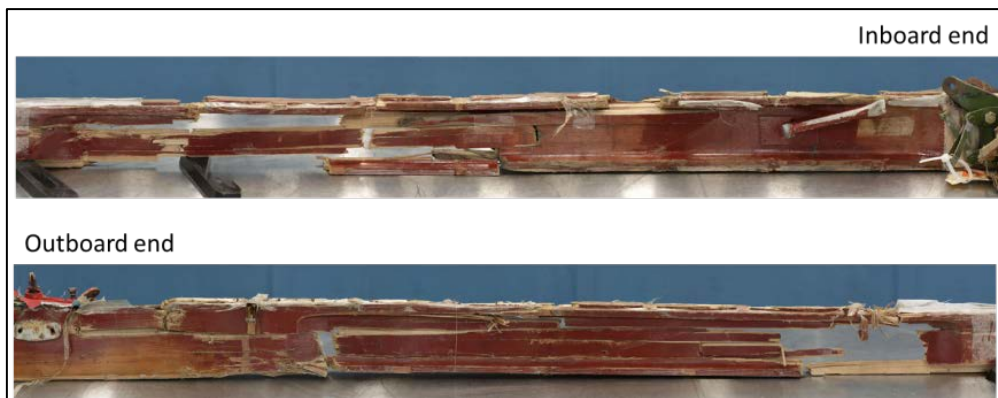
**Figure 14: Inboard two thirds of the left lower wing main spar viewed from the rear**

Examination of the inboard end of the left lower wing main spar identified an inscription indicating that it was manufactured in 1943. The spar was constructed from one piece of timber (not of laminated construction) and was severely fragmented with numerous fracture surfaces requiring inspection (Figure 14). The inspection of the main spar is ongoing.

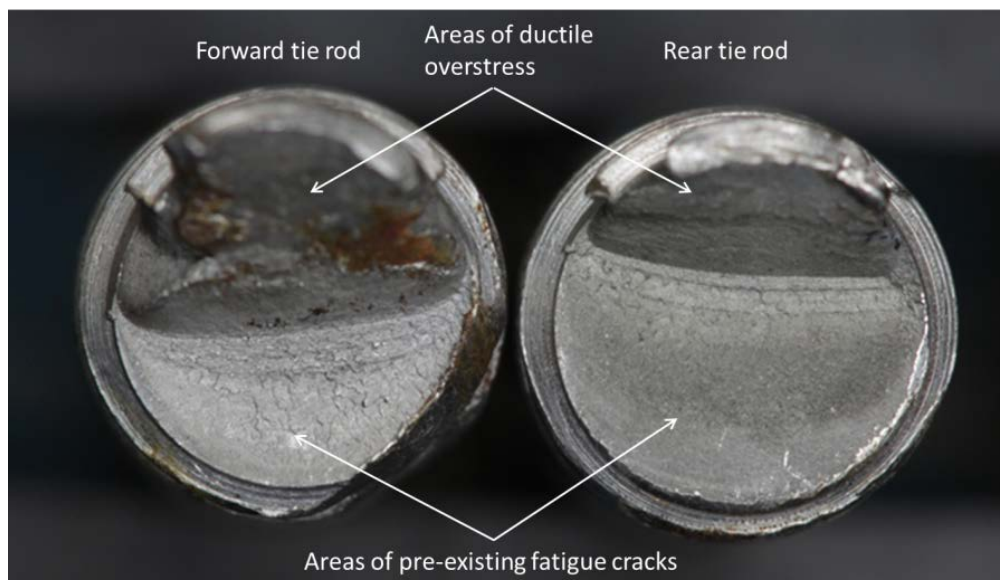
**Figure 15: Fuselage lateral tie rod fracture surfaces showing the left side thread ends**

Both lateral tie rods fractured at an area of pre-existing fatigue cracking within the threaded section (Figure 15). The rear tie rod cracking extended across approximately 70 per cent of the total rod cross-sectional area and the forward rod cracking extended across approximately 50 per cent. The remainder of the fractures on both rods was consistent with ductile overstress. No significant corrosion was evident at or surrounding the points of fracture.

The fuselage lateral tie rods on a Tiger Moth are a safety-critical component. It is likely that the in-flight failure of both tie rods would lead to a loss of control and in-flight structural break-up of the airframe. At this preliminary stage of the investigation, the ATSB cannot determine whether the failure of the tie rods, or another mode of wing structural failure was the initiator of the left wing separations. However, the extent of the pre-existing fatigue cracking meant that such a wing failure was likely to occur at some stage.

- The two JRA-776-1 fuselage lateral tie rods fitted to de Havilland DH82A Tiger Moth, registered VH-TSG, had significant, pre-existing fatigue cracks in the threaded sections. The parts' service life was significantly less than the published retirement life for DH82A tie rods of 2,000 flight hours or 18 years. [Safety Issue]

The Australian Transport Safety Bureau advises all owners and operators of de Havilland DH82 and DH82A (Tiger Moth) aircraft to consider the safety implications of the initial findings of this investigation regarding the fatigue cracking on both lateral tie rods and take action where considered appropriate. The safety issue has particular relevance to aircraft fitted with JRA-776-1 tie rods, aircraft that have been used for aerobatics, aircraft that have experienced heavy landings, and/or aircraft with lateral tie rods that have accrued longer periods in service.

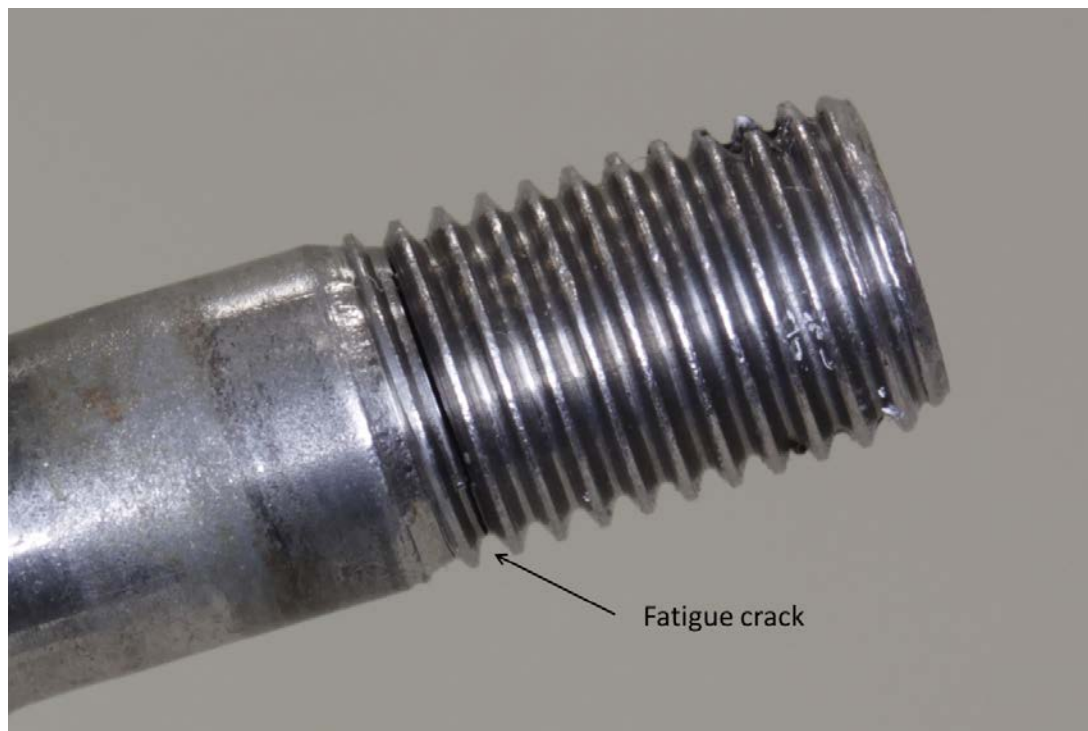
**Figure 16: Forward fuselage lateral tie rod showing right side thread**

Pre-existing fatigue cracking was also evident in the threaded section of the right end of the forward lateral tie rod. The crack had propagated in the same thread-root area as the left side, although the rod had not completely fractured in that area (Figure 16). The crack extended across about 40 per cent of the cross-sectional area.
