# Loss of separation assurance between an Airbus A320, VH-VNQ and a Boeing 737, VH-VZB

50 km SSE of Hay Airport, New South Wales, 30 August 2013

**ATSB Transport Safety Report**  
Aviation Occurrence Investigation  
AO-2013-138  
Final – 25 February 2014

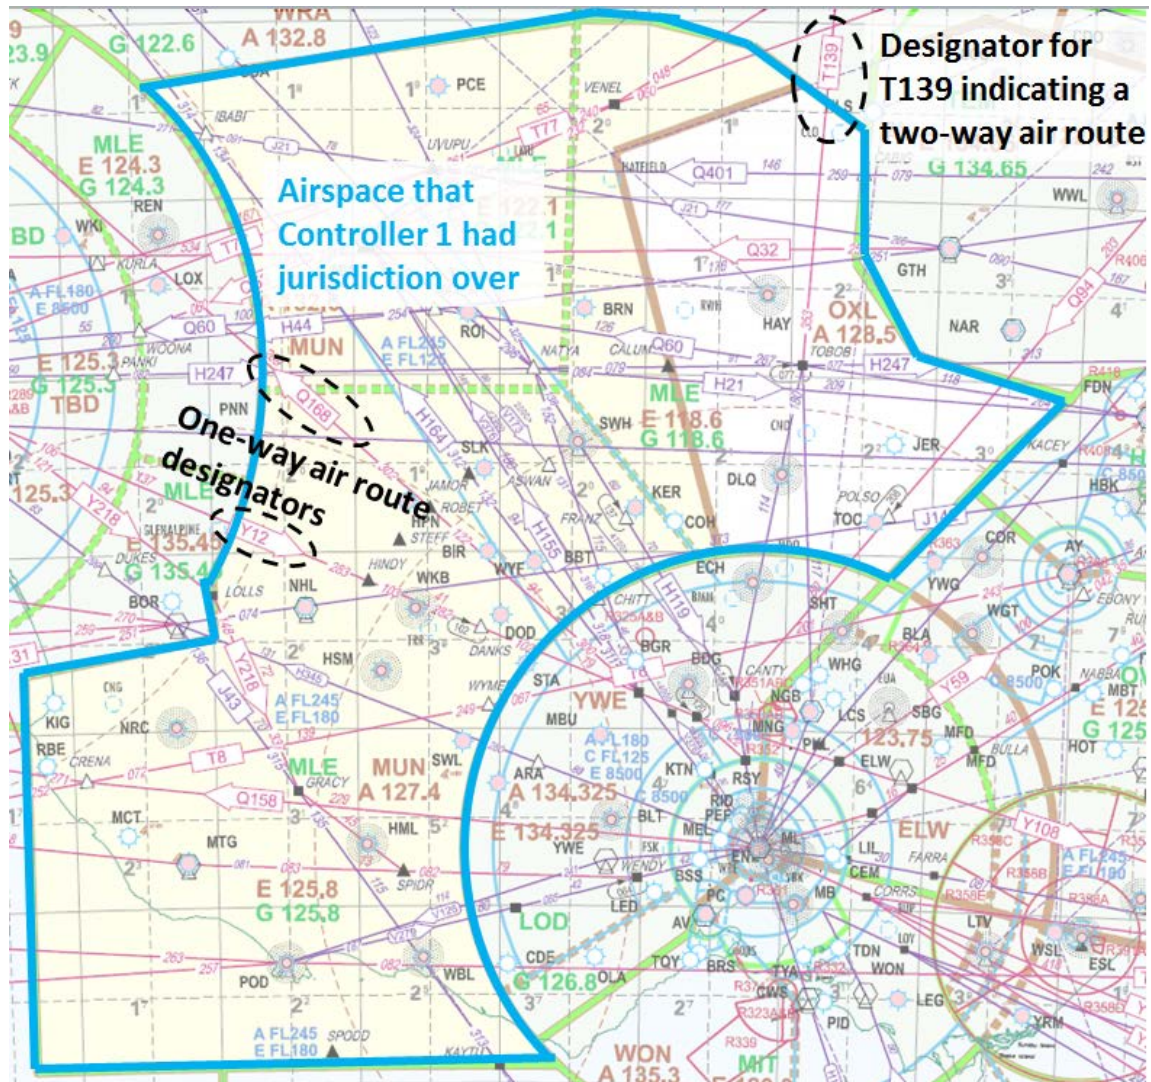
**Figure 1: Airspace that Controller 1 had jurisdiction over**

Both aircraft were operating in Class A airspace,<sup>3</sup> under the control of an Airservices Australia (Airservices) air traffic controller (Controller 1). The required separation standard in the portion of Class A airspace covered by radar surveillance was 5 NM laterally or 1,000 ft vertically. The majority of air routes in the airspace over which Controller 1 had jurisdiction were one-way routes – aircraft could only operate in the direction marked on the aeronautical charts (Figure 1). The Melbourne to Cairns route was a two-way route designated T139 (Figure 2). The airspace also contained a number of east/west routes that crossed T139, as well as a number of north-west/south-east routes. As well as separating aircraft under their jurisdiction, Controller 1 was also responsible for sequencing aircraft arriving through their airspace for arrival into Melbourne.

aware of the aircraft converging at the same level when, at 1624, the Short Term Conflict Alert (STCA) activated and radar separation was about 18 NM (33 Km). Controller 1 immediately issued a safety alert,<sup>6</sup> and issued instructions to the crew of VNQ to turn right and provided traffic information<sup>7</sup> on VZB, which was now 14 NM (25 Km) away in their 12 o'clock position.<sup>8</sup> Controller 1 then issued a safety alert and issued instructions to the crew of VZB to also turn right. Controller 1 subsequently issued instructions to the crew of VZB to descend to FL350 and provided traffic information on VNQ which was now at 6.3 NM in their 9 o'clock position. Radar separation reduced to 5.9 NM and 900 ft at 1625 as the aircraft passed abeam each other. While there was a loss of separation assurance, radar separation was not infringed.

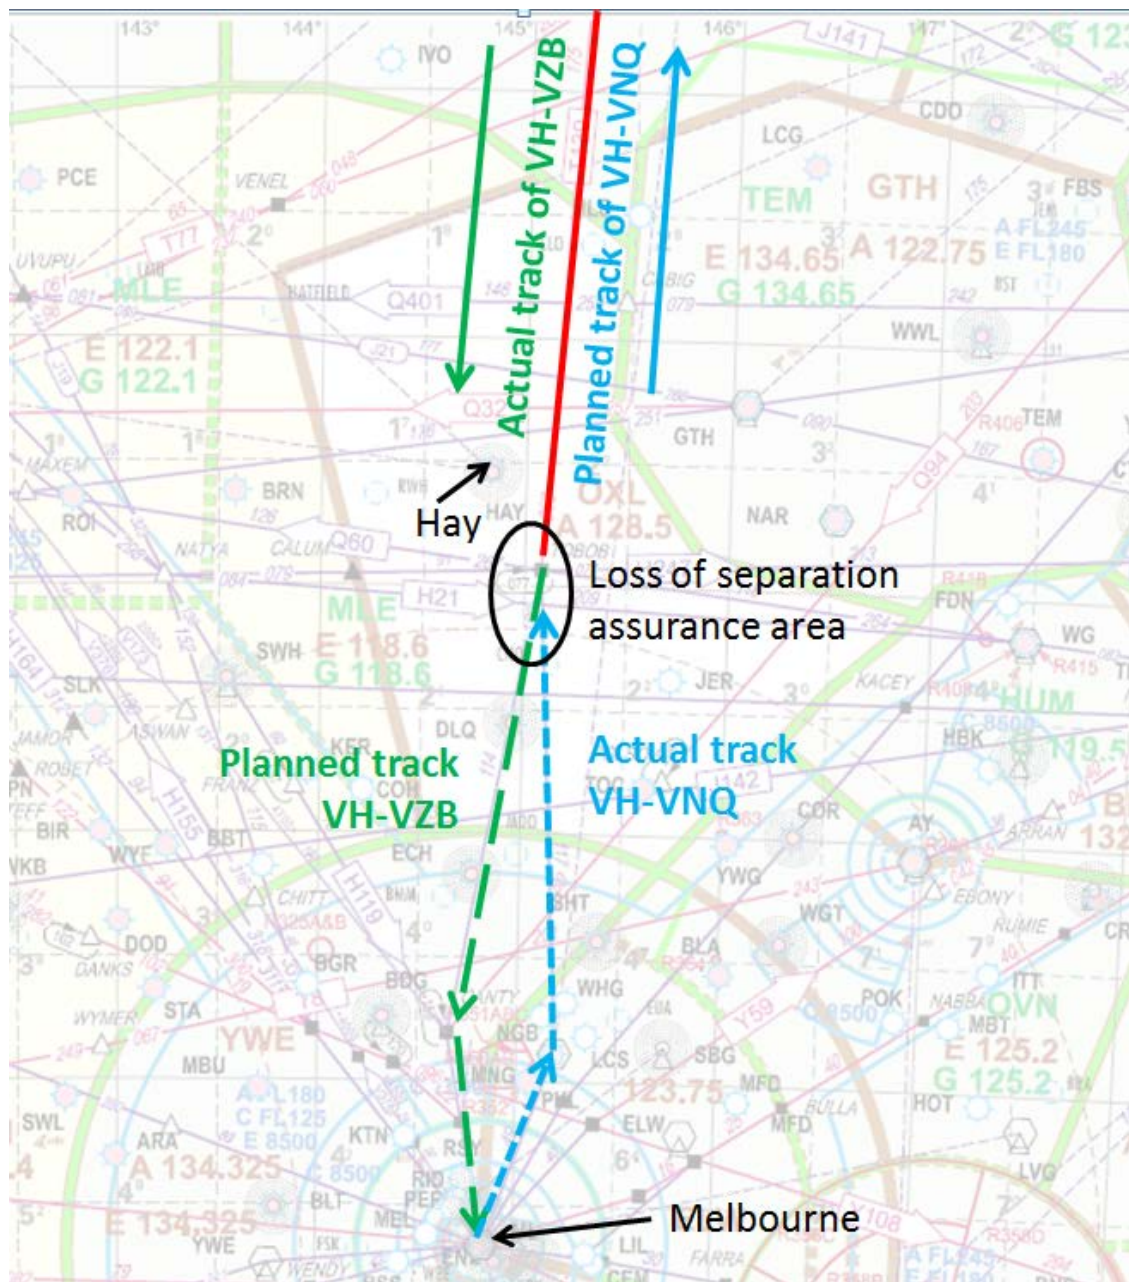
**Figure 2: Airspace map overlaid with aircraft tracks and the LOSA area**

The Airservices investigation into the LOSA found that Controller 1 correctly utilised compromised separation techniques by issuing safety alerts, turning the aircraft away from each other, descending VZB and passing traffic information. The report also found that an adjustment to the STCA warning distance parameter eight months prior to the incident provided an additional five seconds alert time. The additional time may have assisted Controller 1 to initiate recovery action prior to the separation standard being infringed.

The report noted that the Melbourne to Cairns route structure had not undergone a review following an increase in traffic. Further, the report noted that the Manual of Air Traffic Services (MATS) stated that ATC may assign non-conforming cruising levels only when traffic or other operational circumstances require and to return aircraft to conforming levels when traffic and workload allows.

As a result of this occurrence, Airservices has advised the ATSB that they will review the Melbourne to Cairns air route with regard to creating one-way routes, and more generally review similar routes and risk review mechanisms in place nationally. In addition, Airservices has issued a Standardisation Directive reminding air traffic controllers of their responsibilities regarding the application of non-standard levels and subsequent return to standard levels.
