Aircraft proximity event between a Piper PA-44, VH-CZH and a Mooney M20, VH-DJU

Near Rottnest Island aerodrome, Western Australia, 5 October 2013

ATSB Transport Safety Report

AO-2013-176

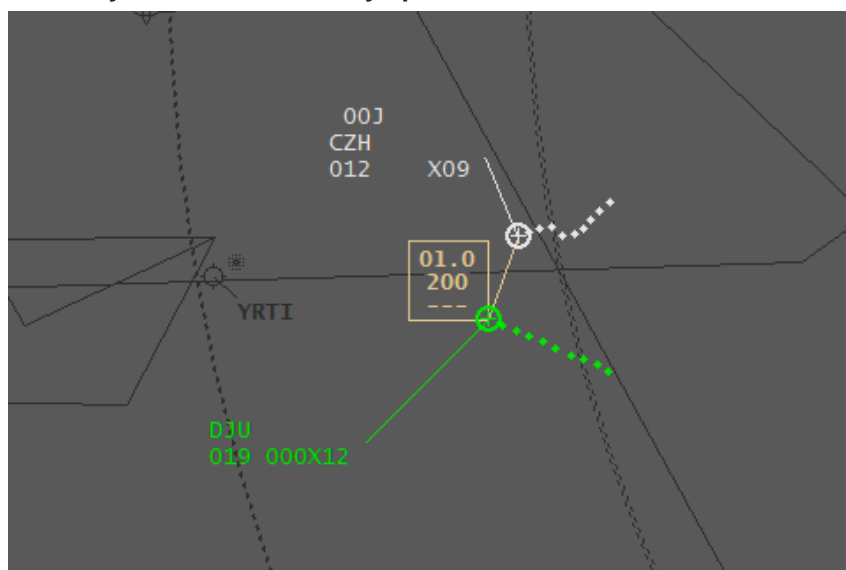
Figure 2: Radar data at 1516:16 showing both aircraft on converging tracks and 700 ft vertically and 1.0 NM laterally apart

At about 1516, Perth Centre ATC alerted CZH that DJU was in their 10 o'clock⁶ position on converging tracks and descending through 1,900 ft (Figure 2). As CZH was about to turn inbound to the NDB, and would soon be conducting the published missed approach climbing southward to 2,000 ft (Figure 3), the instructor in CZH broadcast on the Perth Centre frequency and suggested to the crew of DJU that they climb to 3,000 ft. The crew in DJU responded, advising they were currently at 2,000 ft. The pilot of CZH advised that they were at 1,200 ft. DJU then commenced a climb to 3,000 ft.
