# Incorrect configuration involving Beechcraft A36, VH-YEN

Camden Airport, New South Wales, 12 November 2013

**ATSB Transport Safety Report**

AO-2013-207

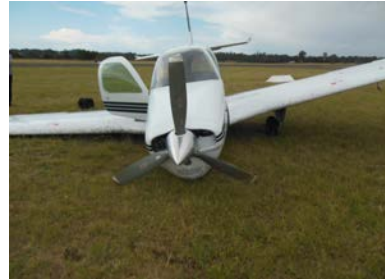
**VH-YEN damage**

The instructor and student were not injured, but the aircraft sustained substantial damage.

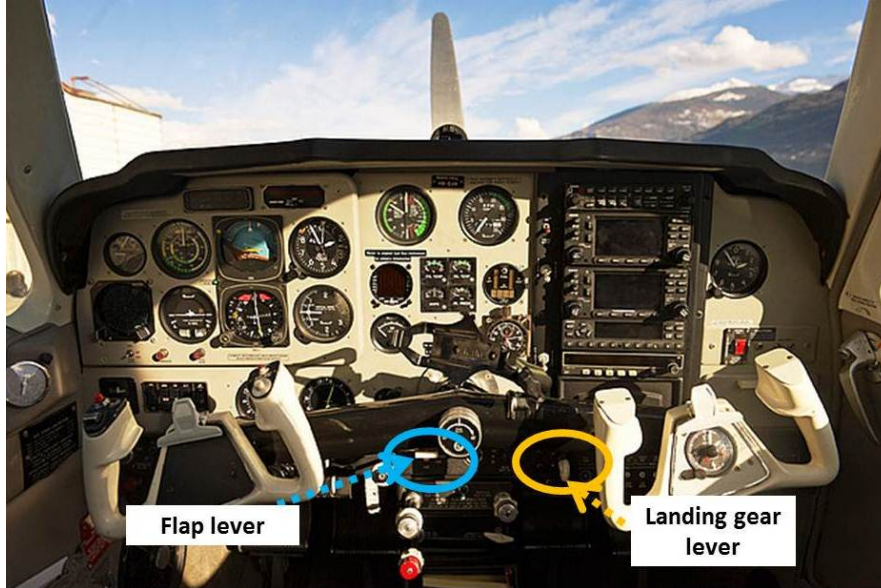
**Figure 1: Cockpit of a Beech Bonanza similar to VH-YEN**

Soon after, the flight departed for the training area to complete the upper air training section of the endorsement. For about 40-45 minutes, the instructor worked with the student to complete a range of flight activities. This included conducting stalls<sup>1</sup> in various configurations; operating at different engine power settings with varying combinations of landing gear and flap selections, steep turns, the manual landing gear extension procedure and practice forced landings. Throughout the exercise, the student operated both the flap and landing gear levers (Figure 1), including a go-around from a practice forced landing.

The student had completed his recent training in a Cessna 182 aircraft, which had the flap lever located in a position similar to that of the landing gear lever in the Bonanza (Figure 1 and Figure 2).
