Wirestrike involving a Robinson R44, VH-HJT

28 km S of Cootamundra aerodrome, New South Wales, 17 December 2013

ATSB Transport Safety Report
Aviation Occurrence Investigation
AO-2013-227
Final - 19 March 2014

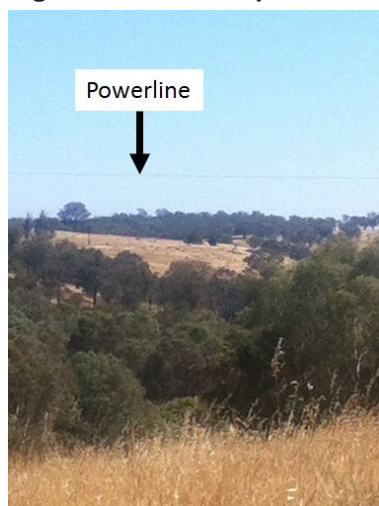
The pilot then commenced spraying the gully, which required looking out of the helicopter window and door towards the ground. He then sighted power lines (Figure 1) just as the helicopter main rotor disc struck the wires. The pilot immediately conducted a precautionary landing. The helicopter sustained substantial damage to the main rotor blades (Figure 2). The pilot was uninjured. The strike also resulted in insulators being detached from the 22,000 volt power lines.

Figure 1: Unknown powerline

- purchasing a computer and printer to be used for planning operations to ensure all maps and overlays are available for the briefing and can be printed for the pilots
- obtaining maps and global positioning system (GPS) data from the power company regarding the location of power lines
- GPS units are being upgraded to enable power wires and obstacles to be depicted on the GPS screen used by company pilots. Training will also be provided in the use of the technology.
- ensuring sufficient and accurate information is provided to pilots prior to commencing spraying operations
- the operator will emphasise to pilots the importance of conducting a thorough inspection prior to application of chemical and at any time during the application as required.

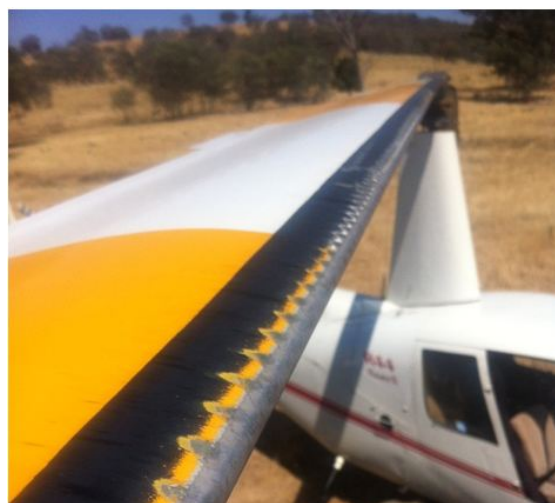
Figure 2: Damage to VH-HJT
