Hard landing involving a Cessna U206G, VH-UFT

Hicks Island (ALA), Queensland, 21 December 2013

ATSB Transport Safety Report
Aviation Occurrence Investigation
AO-2013-228
Final – 19 March 2014

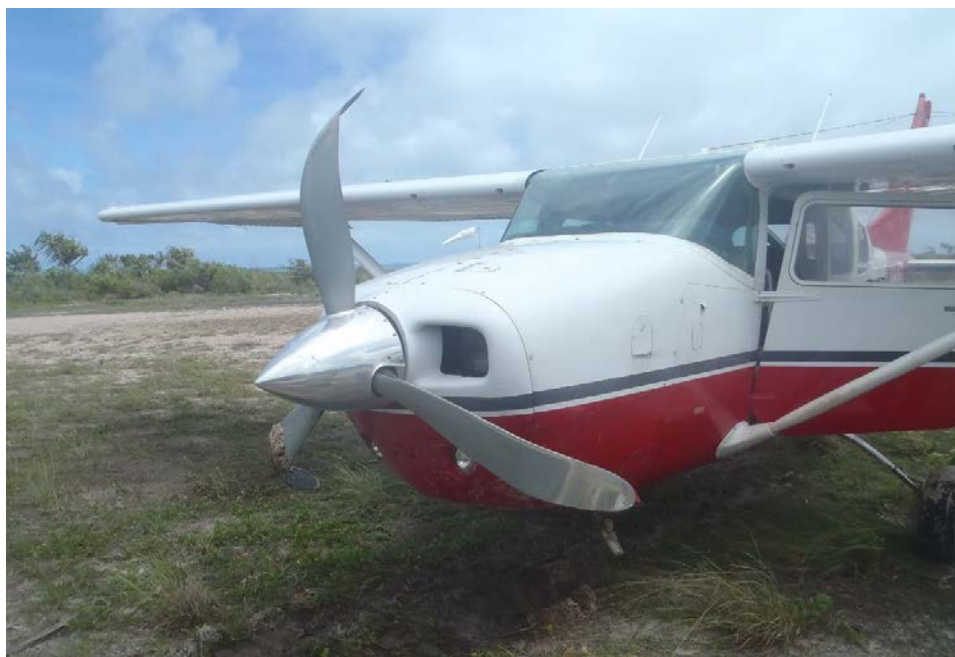
Figure 1: Damage to VH-UFT

The pilot continued the approach and after the initial touchdown, the aircraft remained on the ground for about 3-4 m then became airborne and subsequently bounced. The nose landing gear then contacted the ground and detached from the aircraft (Figure 1). The aircraft came to a stop on the runway.

- The pilot had 6.7 hours of flying experience in the Cessna 206 with the most recent flight 3 months earlier.
- Runway 09 at Hicks Island slopes up and then levels off and then slopes up again. The pilot had previously experienced that aircraft becoming momentarily airborne after the initial touchdown on the runway and another company pilot reported having the same experience.
- The pilot elected not to conduct a go-around after the aircraft became airborne because the bounce on landing was perceived to be normal for that runway.
- The landing did not seem hard enough to cause the nose landing gear to shear off.
- During the flight, when the aircraft encountered showers of rain, the water on the windscreen made it difficult to distinguish the cloud from the sea.
- The upslope of the runway gave the illusion that the aircraft was high on the approach.

A go-around is the procedure for discontinuing an approach to land. It is a standard manoeuvre that is performed when the pilot is not completely satisfied that the requirements for a safe landing have been met.

This incident is a reminder to pilots to be go-around ready.
