Ground proximity event involving a Cessna 208, VH-LNI and a vehicle

Jurien Bay (ALA), Western Australia, 31 December 2013

ATSB Transport Safety Report
Aviation Occurrence Investigation
AO-2014-002
Final – 19 March 2014

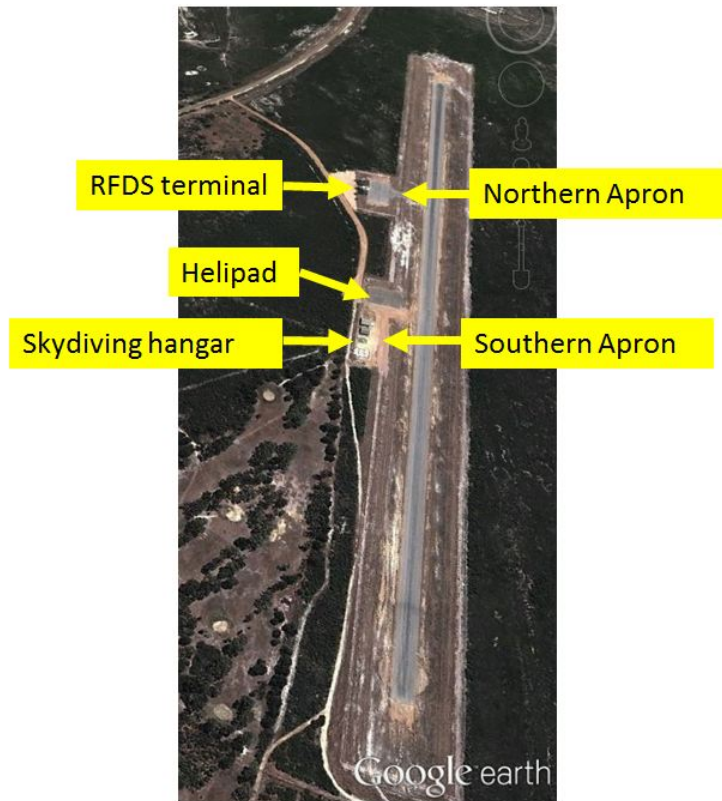
Figure 1: Jurien Bay (ALA)

LNI then parked at the northern apron (Figure 1), with the engine running, in preparation for the arrival of the parachutists. The northern apron was in front of the Royal Flying Doctor Service (RFDS) terminal and the southern area of that apron was restricted to patient transfer operations. According to an agreement with the Dandaragan Shire Council, the skydiving aircraft were permitted to use the northern apron for parachute loading, but not to be parked to the east or north of the RFDS building on that apron at any time, or to impede access of emergency services vehicles.

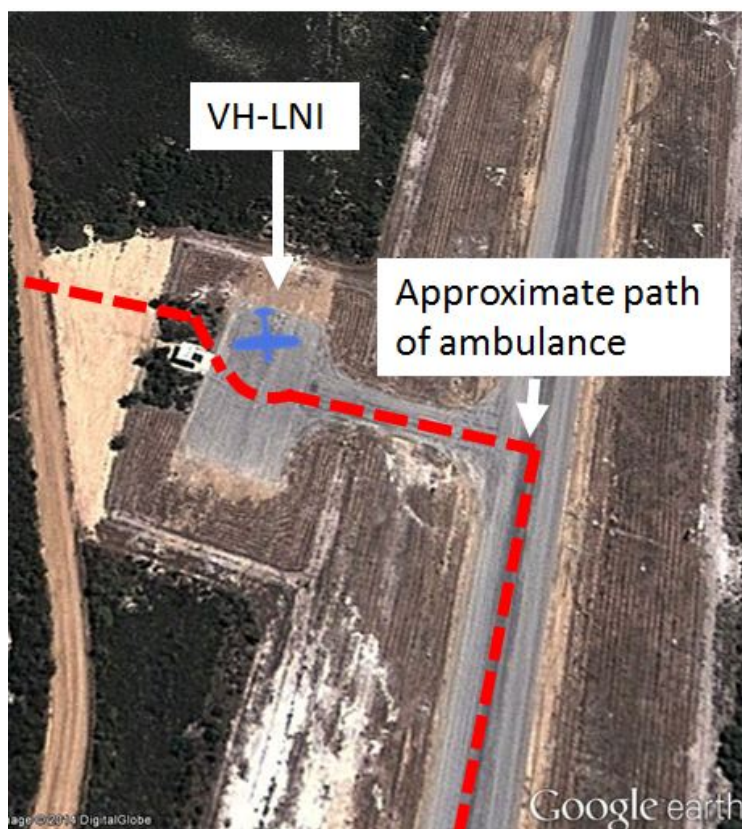
Figure 2: Jurien Bay (ALA)

The ambulance driver then proceeded to the runway and stopped prior to entering the runway. The driver reported that he and his ambulance partner conducted a thorough visual inspection for aircraft approaching and on the runway. The ambulance then entered the runway and drove towards the helipad, about 300 m south of the RFDS apron (Figure 2).
