Australian Government
Australian Transport Safety Bureau

Aviation Short Investigation Bulletin

Issue 27

AB-2014-024

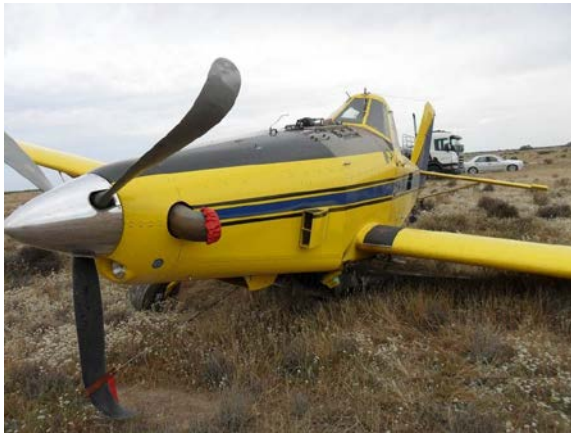
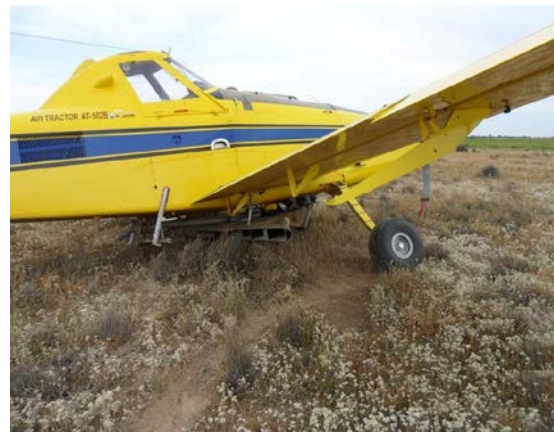
Figure 2: Damage to VH-FLH

During the landing, the main wheels touched down first, followed by the tail, which was locked into place. Shortly after, the aircraft suddenly veered right about 45°. The pilot considered a go-around, but was concerned that the aircraft would not clear the boundary fence (Figure 1). Consequently, he elected to continue the landing and selected reverse thrust, applied left brake, left rudder and left aileron in an attempt to re-align the aircraft with the runway. The aircraft did not slow down as the pilot expected. The wheels began to 'grab' and the left undercarriage leg became detached which caused the aircraft to rotate facing about 90° away from the runway. The left wingtip and propeller subsequently contacted the ground. The pilot shut down the aircraft and exited. The pilot was not injured, but the aircraft was substantially damaged (Figure 2).

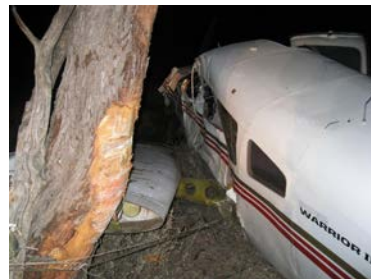
Damage to VH-CCQ

The aircraft was substantially damaged (Figure 1), the pilot sustained serious injuries and the passenger sustained minor injuries.

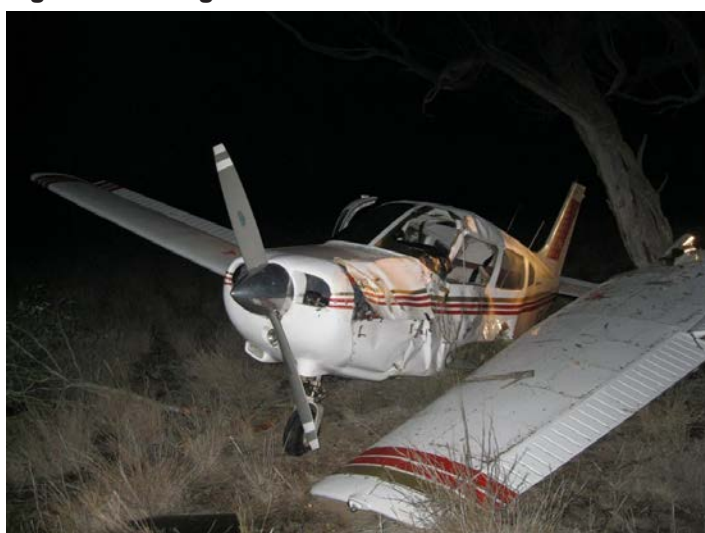
Figure 1: Damage to VH-CCQ

An engineering report provided to the ATSB stated that during an inspection of the engine conducted after the accident, the carburettor float bowl was found to be empty.

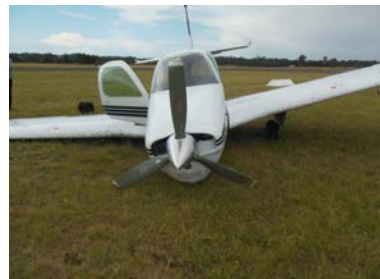
VH-YEN damage

With the left main gear almost extended, the aircraft began to veer to the right. The instructor noted that there were buildings in the path of the aircraft and elected to reject the take-off. When the aircraft had slowed to about 30-40 kt, the nose dug into the grass alongside the runway.

The instructor and student were not injured, but the aircraft sustained substantial damage.

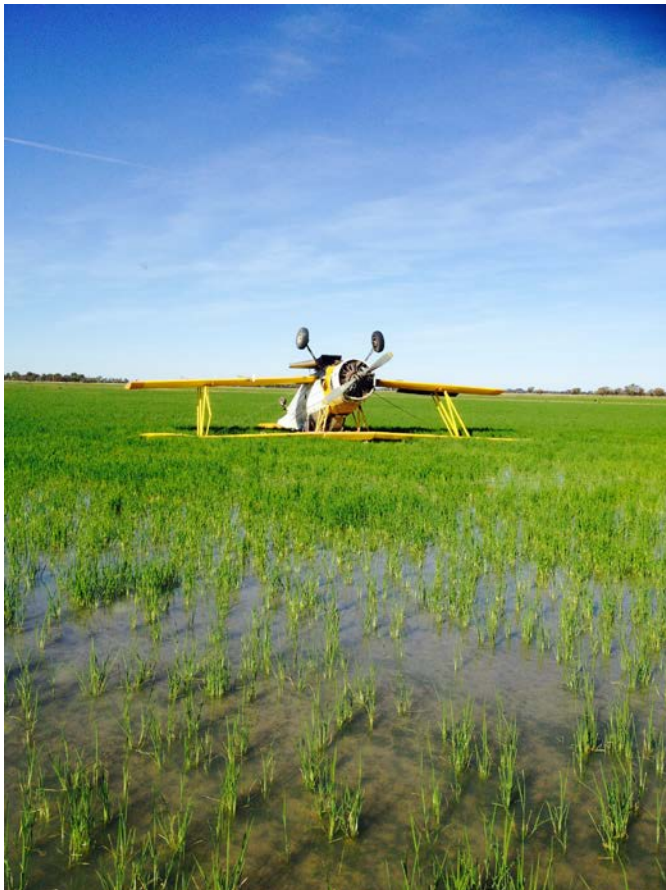
Figure 1: Damage to VH-CCF

When at about 20-30 ft AGL, with a nose high attitude, the pilot felt the aircraft's wings shaking, indicating an imminent stall.¹ The pilot increased engine power in an attempt to avert the stall, but the aircraft continued to descend. Shortly after, the wheels touched down in a rice paddy in about 20 cm of water and the aircraft flipped over (Figure 1). The aircraft was substantially damaged. The pilot was uninjured.
