Fall from the pilot ladder on board the chemical tanker *Golden Concord*

Goods Island, Torres Strait | 4 July 2013

Marine Occurrence Investigation

301-MO-2013-008

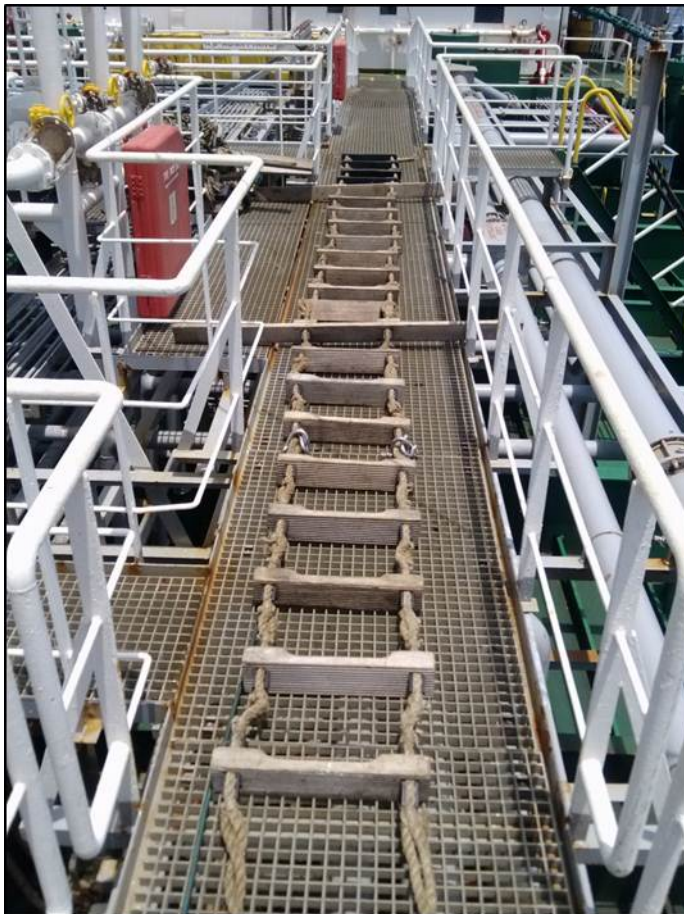
Figure 4. The pilot ladder laid out for inspection after the fall

At about 0700 on 4 July, *Golden Concord's* master inspected the condition and rigging of the pilot ladder and manropes. The ladder, shackles, ropes and securing arrangements were found to be in good order (Figure 4).

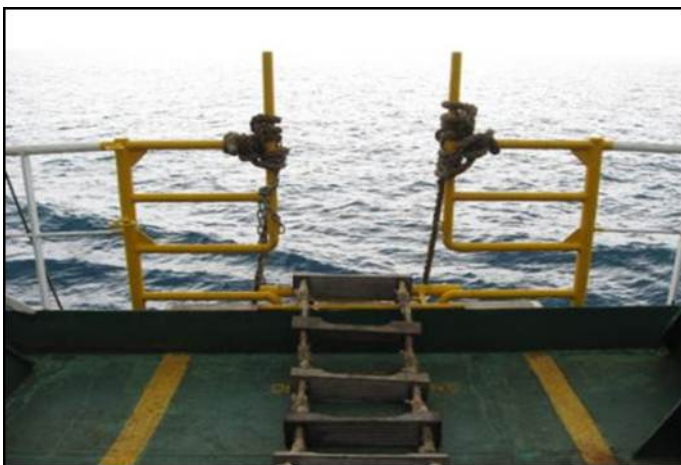
Figure 6. Manrope securing arrangements

The pilot ladder and manropes were prepared in accordance with the requirements of the ship's safety management system (SMS) procedures on the afternoon of 3 July. This included fastening the manropes directly to the ship's railing (Figure 6).

During the course of the investigation, the ATSB identified that it was routine for *Golden Concord*'s pilot ladder manropes to be secured directly to the ship's hand railing (Figure 6). This arrangement was in accordance with the requirements of the ship's SMS.

Dorval Ship Management has advised that it has revised its navigation manual procedures for pilot transfer to ensure that the securing of manropes is in accordance with SOLAS recommendations, as follows:
