# Loss of control involving SOCATA TB 20, VH-HBB

3 km south of Lismore Airport, NSW | 9 November 2012

**ATSB Transport Safety Report**  
Aviation Occurrence Investigation  
AO-2012-149  
Final – 11 March 2014

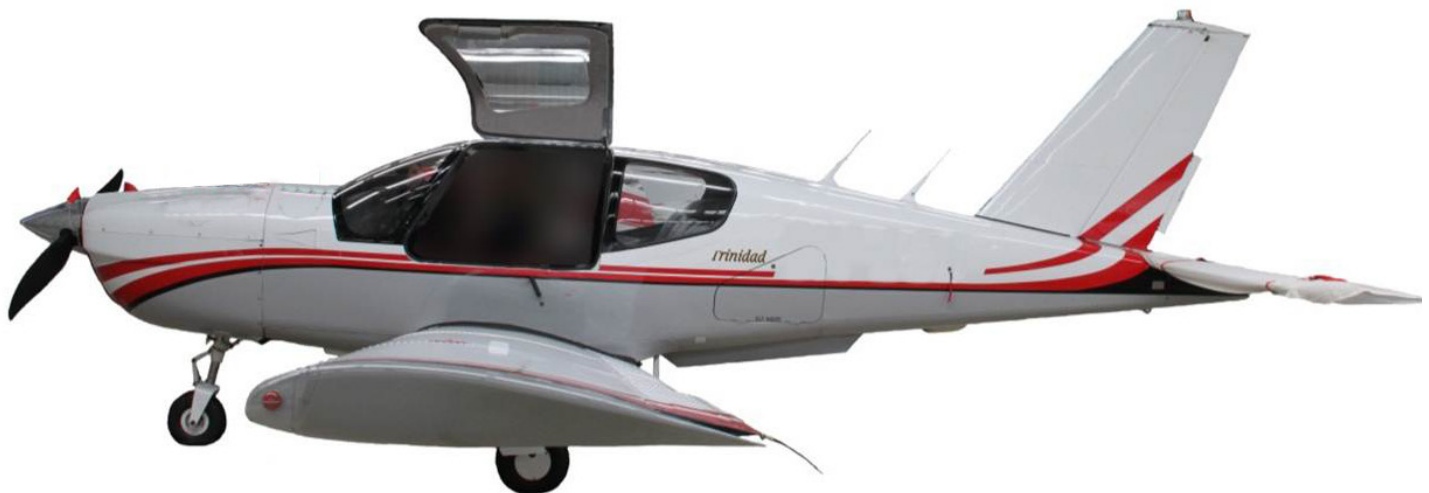
**Main wreckage site**

On 9 November 2012, a student and instructor departed Gold Coast Airport, Queensland for a training flight in a SOCATA TB 20, registered VH-HBB, to Lismore Airport, New South Wales. This included circuit training as part of the student's conversion to the aircraft type. On their fifth circuit, and while making a left turn from downwind to base, the aircraft aerodynamically stalled and the left wing dropped steeply. A recovery was commenced, but the aircraft collided with terrain in a paddock to the east of the Bruxner Highway, about 3 km south of Lismore Airport. Both occupants received fatal injuries and the aircraft was destroyed by the impact and an intense fuel-fed, post-impact fire.

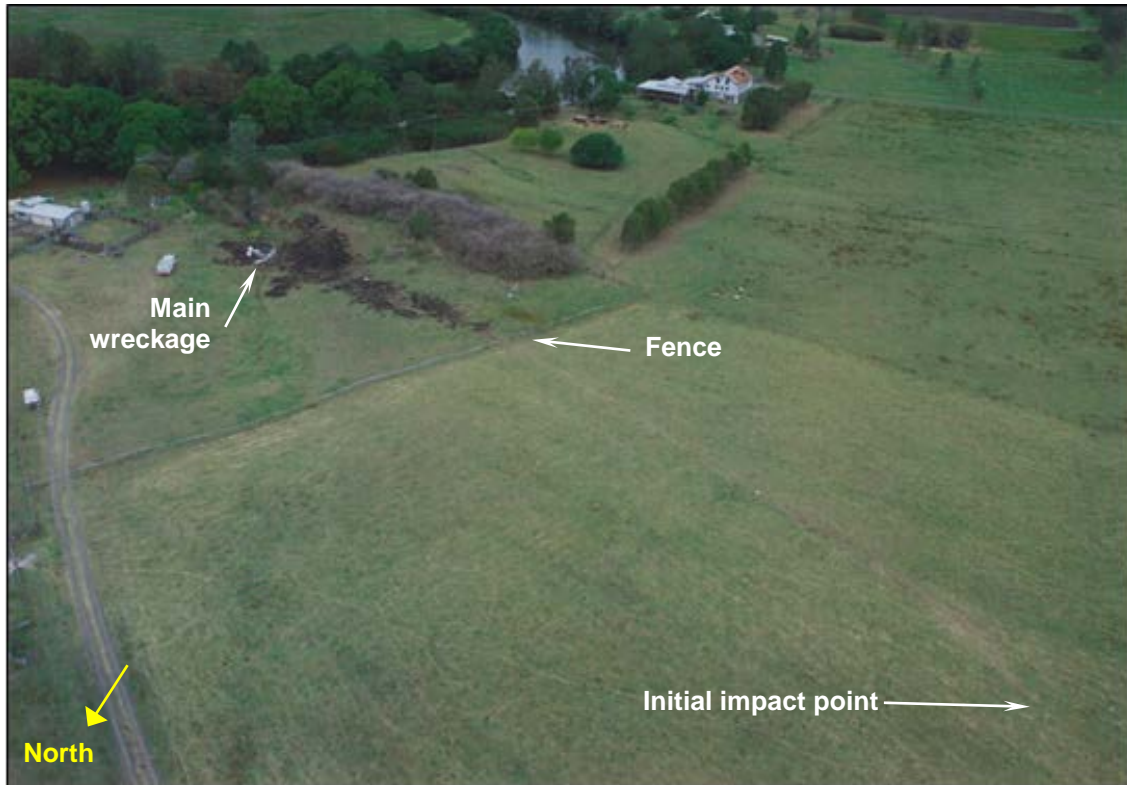
**Figure 3: Aerial view of the accident site**

The impact broke the left main and nose landing gear from the aircraft and it continued to skid along the ground, yawing<sup>4</sup> to the left as it decelerated. About 100 m from the initial impact point, the aircraft passed through a wire fence that breached a wing fuel tank, releasing fuel that then ignited (Figure 3). About 1 m past the fence, the aircraft impacted a small mound of earth that separated the engine from the aircraft. That impact also resulted in the aircraft yawing further and the right wingtip impacted the ground, rolling the aircraft onto its roof. The aircraft travelled about

20 m further before coming to rest inverted in a gully about 170 m from the initial impact. Both occupants were fatally injured and the aircraft was destroyed by the impact and an intense fuel-fed fire.

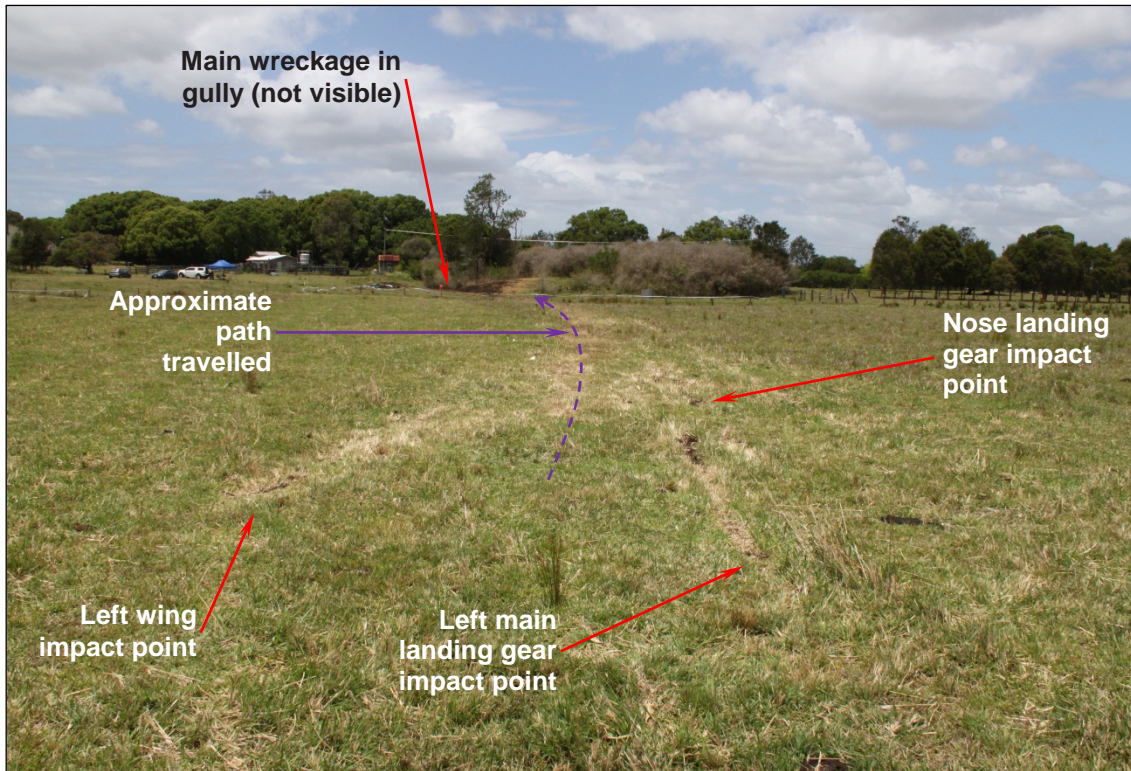
**Figure 7: View looking in a south-easterly direction along the wreckage trail from initial impact towards the main wreckage**

The wreckage trail consisted of two distinct areas that were divided by a fence. The initial part of the wreckage trail was characterised by scoring and gouging of the grass with a sparse distribution of aircraft wreckage (Figure 7). That wreckage was primarily associated with the left wingtip, left main landing gear and nose landing gear.

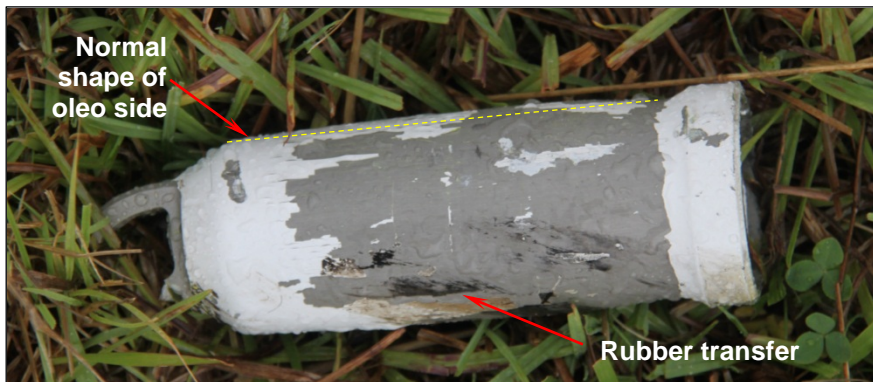
**Figure 8: Left main landing gear oleo showing bulging**

The ground impact marks and the damage to the landing gear indicated that it was extended at impact. There was no indication of pre-existing damage to the left main and nose landing gear. The left main landing gear oleo was bulged out from its normal straight sides and had rubber transfer marks from contact with the tyre, both indicating that it had been subjected to a large vertical load (Figure 8).

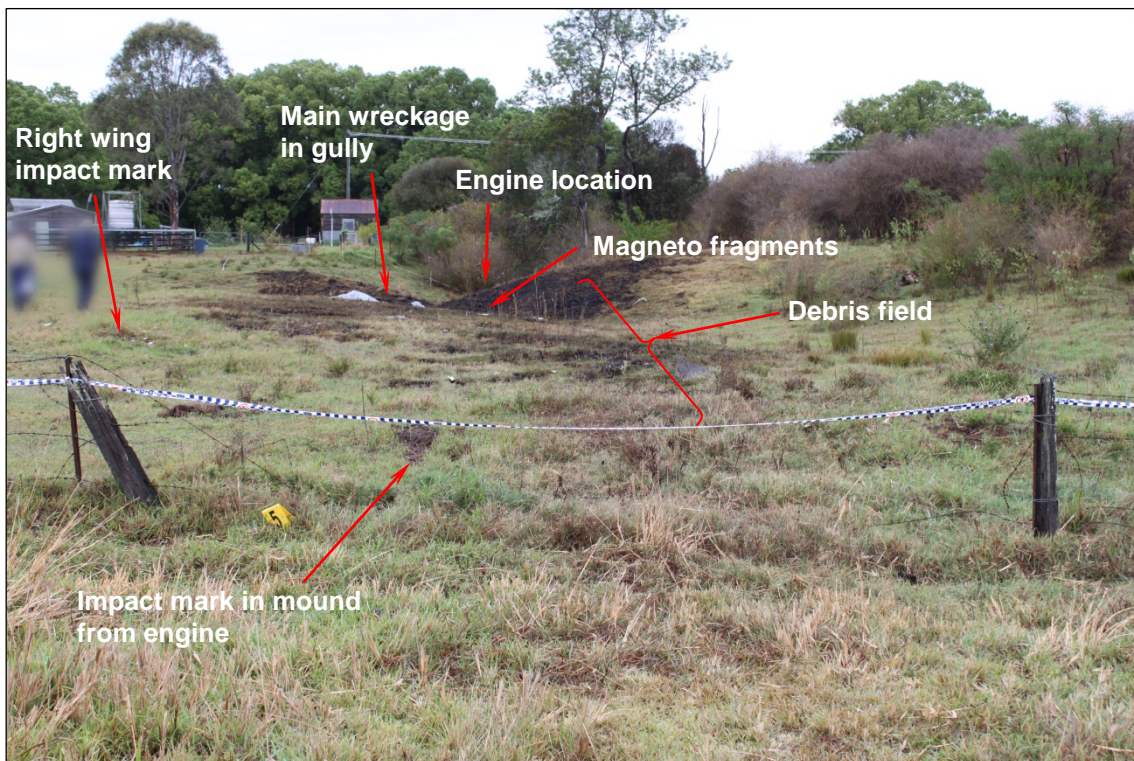
**Figure 9: Wreckage trail through the fence**

The aircraft passed through a three-strand barbed wire fence that was strung between timber and steel posts spaced about 5 m apart (Figure 9). All three strands of barbed wire were fractured; however, there was no indication of aircraft contact with the fence posts.

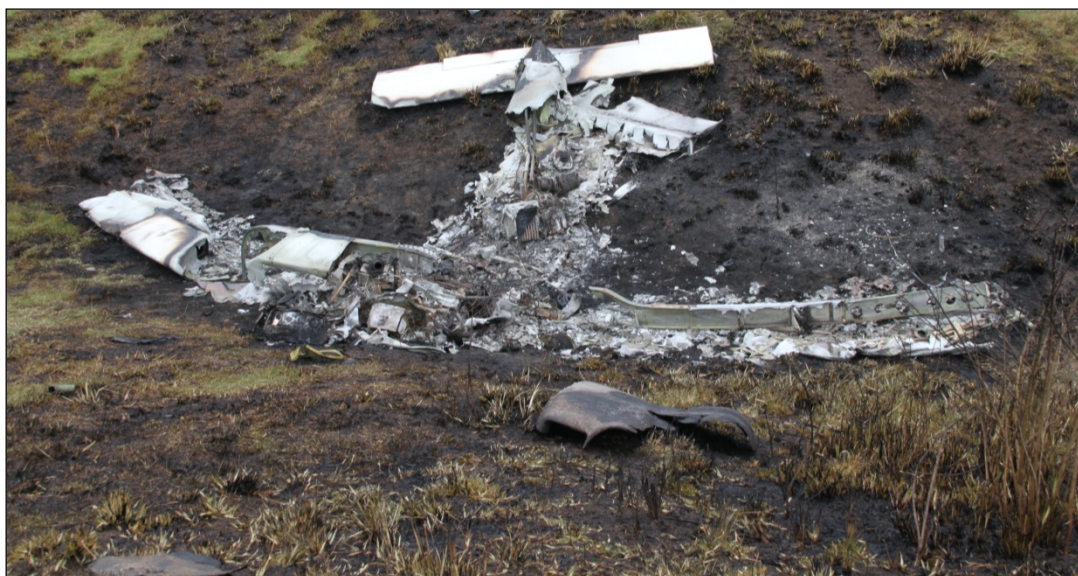
**Figure 10: Main wreckage**

The main wreckage was located in a shallow gully. The aircraft came to rest inverted and facing in a westerly direction (Figure 10). The fire was most intense in the gully and resulted in significant post-impact damage to the structure. Despite that damage, all the aircraft's major components were accounted for at the site.

Fire damage to the aircraft wreckage and surrounds indicated that an intense fuel-fed fire started after the aircraft passed through the barbed wire fence. There was no indication of a fire prior to the impact with the fence. The fire resulted in significant post-impact damage to the aircraft.

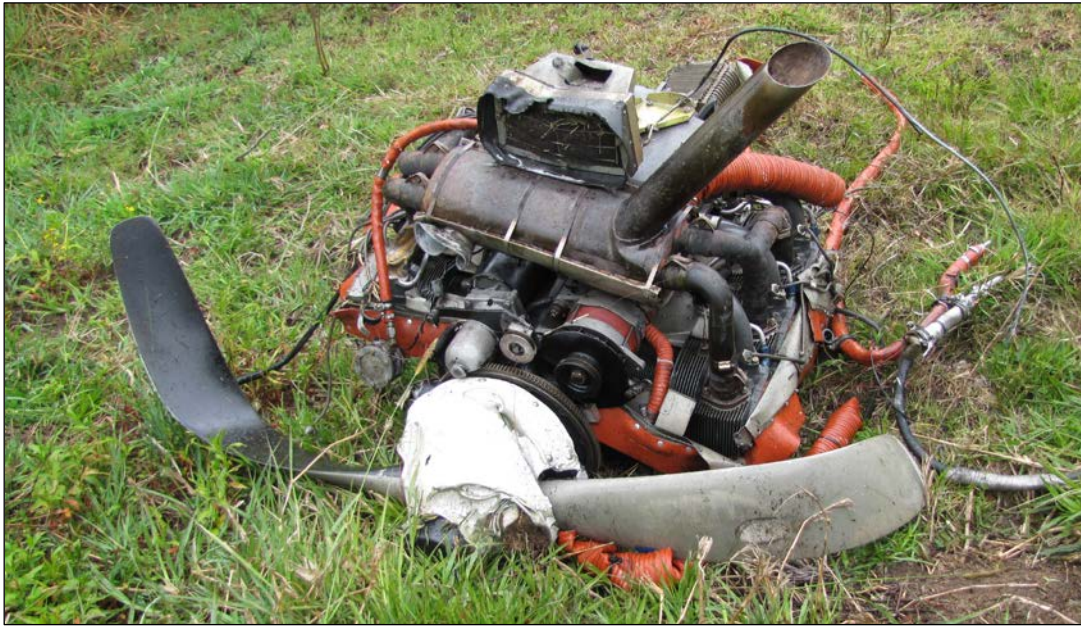
**Figure 11: Engine - on-site**

After the engine separated from the aircraft it impacted the wall of the gully before coming to rest about 13 m beyond the main wreckage. The engine was primarily intact, except for the magnetos<sup>20</sup> on the rear of the engine, and was unaffected by the fire (Figure 11). Remnants of the magnetos were found at the point the engine impacted the gully wall. The engine was retained by the ATSB for further examination. With the exception of the magnetos, which were severely damaged by the impact and unable to be tested, that examination did not identify any issues that would have precluded normal engine operation.

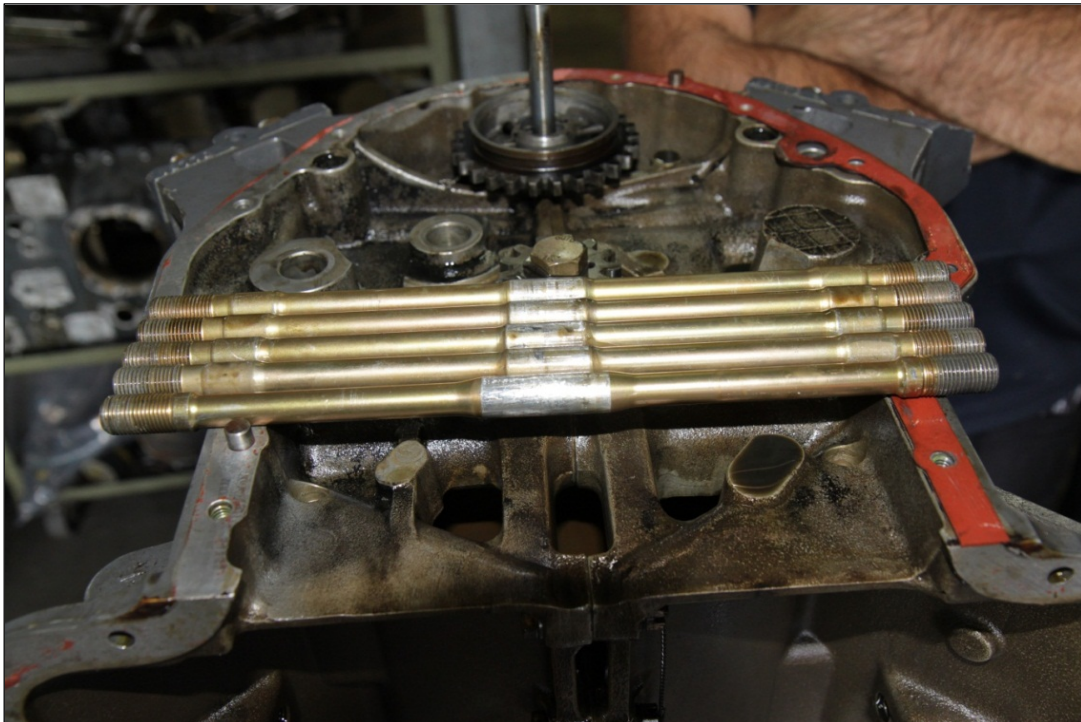
**Figure 12: One Lycoming (foreground) and four Continental Motors through bolts from the engine**

Although they did not affect engine performance or have an effect on the accident, the engine examination determined that four of the eight through bolts that hold the engine crankcase halves together were from a Continental Motors engine (Figure 12). There was no associated paperwork indicating that those parts were approved for use in a Lycoming engine and they could not be identified without disassembling the engine.

The history of the Continental Motors through bolts was unknown; however, some contained score marks that were made before the bolts were cadmium plated, suggesting that they were

second-hand (Figure 13). Continental Motors Service Bulletin SB97-6B, Mandatory Replacement Parts (overhaul), stated:

The ATSB found that half of the engine crankcase through bolts were from a different engine manufacturer. While it is possible to use parts that differ to the original manufacturer, such use must be approved. No approval to use Continental Motors bolts in this Lycoming engine was identified in the aircraft documentation and, as such, they were probably unapproved parts.

Of additional concern, some of the Continental bolts showed damage indicating that they were second-hand parts. Although, if they were in an acceptable condition, the original Lycoming through bolts could be re-used, Continental Motors required their through bolts to be replaced at overhaul. Thus, the use of second-hand Continental through bolts was not authorised in any engine and their ongoing integrity could not be assured. To compound this, the damage had the potential to further reduce the life of the bolts by adding points of increased stress, reducing their fatigue life.

In addition, aircraft owners and maintainers should ensure that all parts fitted to their aircraft are appropriately approved for the application. The use of unapproved parts means that aircraft safety cannot be assured.
