Loss of control involving a Piper PA-28R-201, VH-HVX

Orange Airport, New South Wales, 15 January 2014

ATSB Transport Safety Report
Aviation Occurrence Investigation
AO-2014-008
Final – 27 March 2014

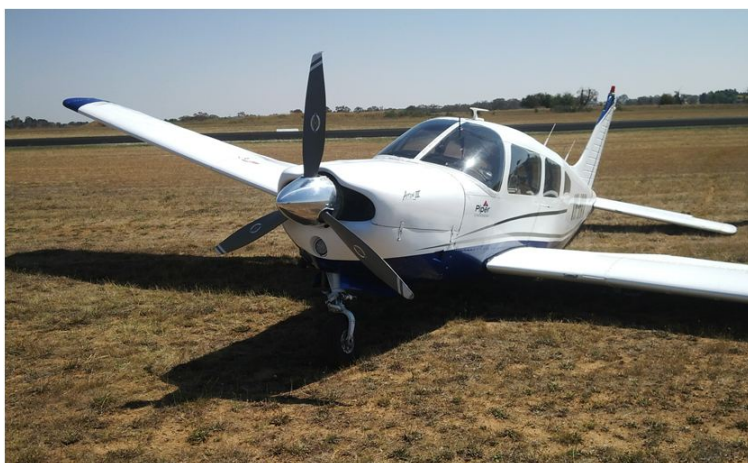
Figure 1: Damage to VH-HVX

When at about 50 ft above ground level (AGL) and about 65-70 kt IAS, the testing officer reduced the engine power to idle and stated “simulated engine failure”. The pilot immediately lowered the nose of the aircraft in an attempt to increase the airspeed and selected the third stage of flaps. At about 10 ft AGL, the pilot reported the aircraft was sinking and flared³ the aircraft for landing. However, the aircraft continued to sink and landed heavily. The left main undercarriage collapsed and the aircraft slid along the runway and then veered off to the left, coming to rest outside the airstrip gable markers. The aircraft was substantially damaged and both pilots were uninjured.

The pilots reported that the stall warning did not sound during the descent and that a shift in the wind direction was the most likely cause of the accident.

This incident highlights the critical importance of considering local conditions such as wind, elevation and temperature, as well as the inherent risks of conducting simulated engine failure at low altitude.
