Runway excursion involving a Fairchild SA226, VH-OGX

Archerfield Airport, Queensland, 23 January 2014

ATSB Transport Safety Report
Aviation Occurrence Investigation
AO-2014-016
Final – 27 March 2014

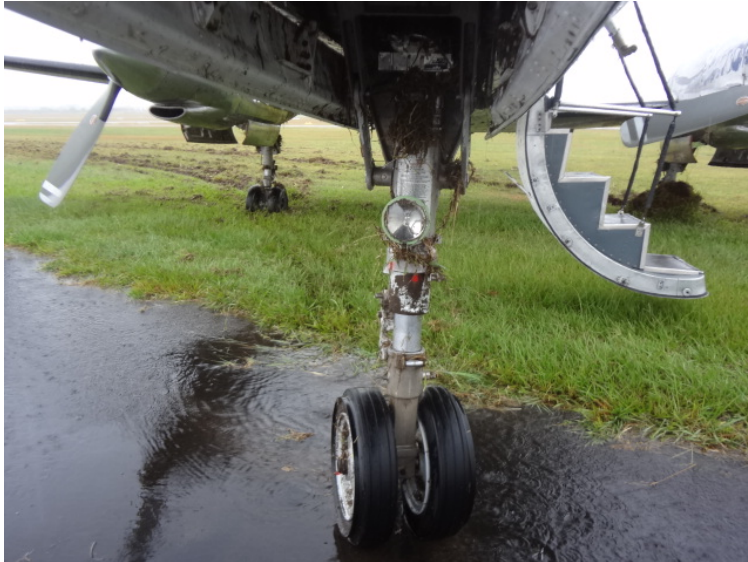
Figure 1: VH-OGX nose landing gear

The aircraft then slid along the runway and veered off to the left side. As the left main landing gear entered the grass, the aircraft slowed, coming to rest at an angle of about 30 degrees to the runway and with the main landing gear on the grass.

A runway inspection revealed standing water up to 50 mm deep on the right side of the runway near the threshold. After the incident, aquaplaning marks were visible on the runway.

The operator of OGX will introduce procedures for flight crew regarding runway contamination events.
