Aircraft proximity event between a Cessna 172S, VH-FPV, and a Piper PA-28-161, VH-OWO

Moorabbin Airport, Victoria, 25 January 2014

ATSB Transport Safety Report
Aviation Occurrence Investigation
AO-2014-014
Final – 27 March 2014

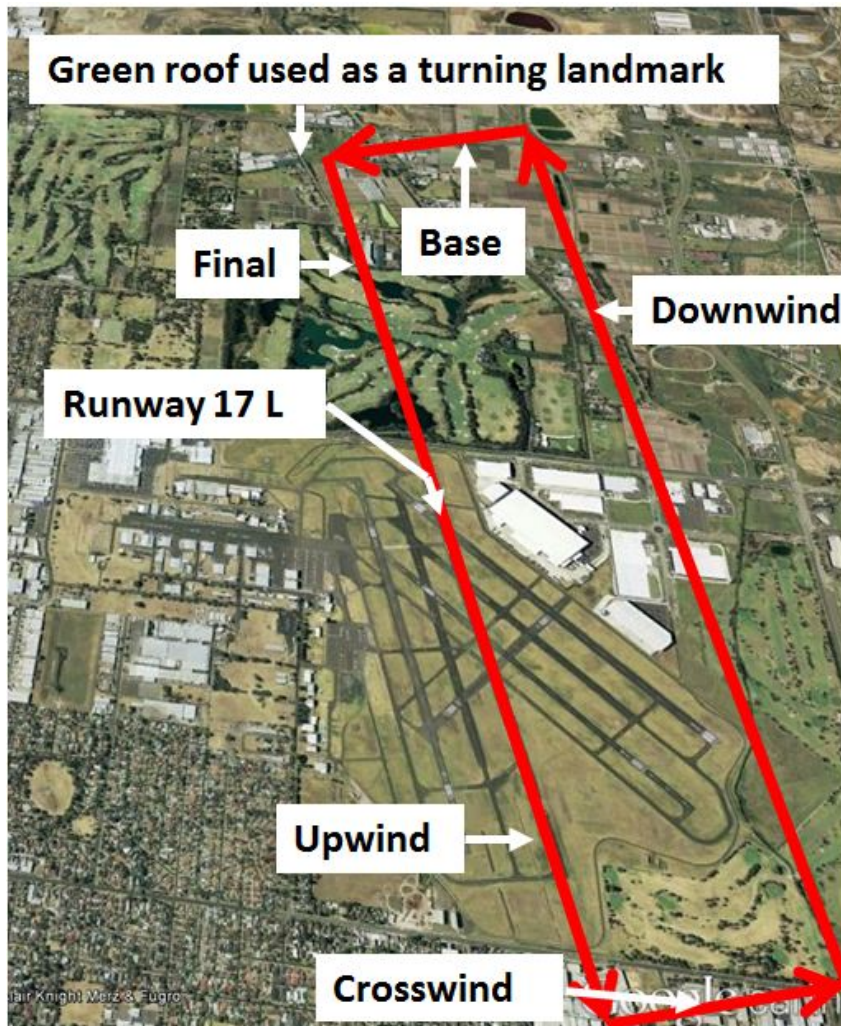
Figure 1: Circuit flown by VH-OWO including circuit 'legs'

The pilot of OWO conducted two more uneventful touch-and-go circuits and reported that he was concentrating on flying 'perfect' circuits with regard to spacing, altitude and turning landmarks such as the green roof used for turning onto final (Figure 1). At about 1121, when on his fifth and planned final circuit, the pilot of OWO reported downwind for a full stop landing. He was instructed to follow a Cessna (FPV) and sighted the aircraft.

When on about mid-downwind, the pilot moved his attention inside the cockpit to switch the fuel selector to the other fuel tank. When he had completed the fuel tank selection and the downwind checks, he looked up and sighted an aircraft on final, assumed it was FPV and continued to follow that aircraft.

At about 1123, the pilot of FPV reported that FPV was established on early final, at about 400 ft AGL, when he sighted OWO in a turn about 100 ft above and just in front of FPV. He immediately took control of the aircraft from the student and descended to increase the vertical separation between the two aircraft.

As the pilot of OWO commenced the turn onto final, at about 500 ft AGL, he sighted FPV to his right about 200 ft below OWO. He reported that at the time he was unsure whether that aircraft was landing on the parallel runway, 17 Right (17 R), however he levelled OWO off to maintain separation between the two aircraft.

The operator conducted a briefing of staff and student pilots, addressing the need for situational awareness, visual scanning and prioritising tasks. An emphasis was placed on developing an effective scan and maintaining a listening watch to assist in building an awareness of the other aircraft operating in the airspace. Pilots were advised to maintain traffic separation and not fly circuits solely by reference to ground features.
