Runway excursion involving a Beech A36, VH-EUB

Lilydale (ALA), Victoria, 19 February 2014

ATSB Transport Safety Report
Aviation Occurrence Investigation
AO-2014-026
Final – 8 April 2014

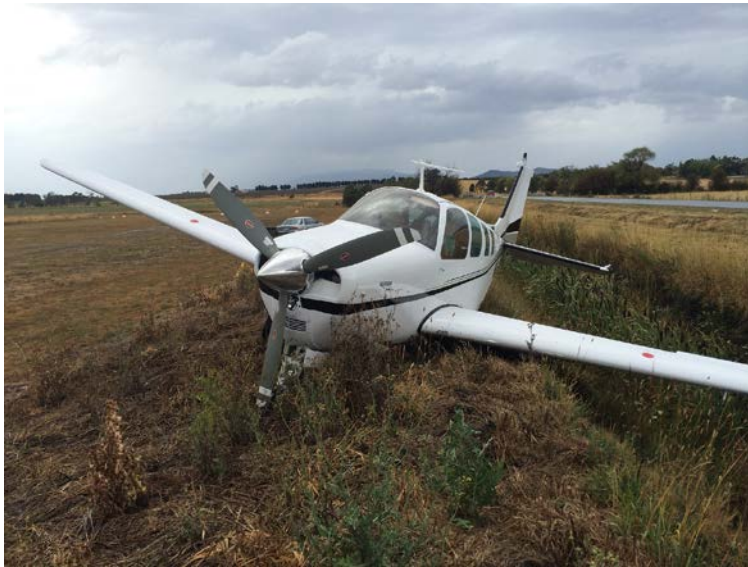
Figure 1: VH-EUB

With less than 100 m of runway remaining, the pilot and instructor both applied right rudder in an attempt to steer the aircraft away from an embankment located about 20 m beyond the end of the runway. The aircraft rotated 90° to the right and continued to slide in the direction of the runway. The aircraft came to rest on top of the embankment and the left main landing gear collapsed (Figure 1).

After exiting the aircraft, the instructor observed that the wind had veered and was then about 10 kt from 340° and assessed that a tailwind may have contributed to the incident.

- The shower of rain had left a film of water on the runway. Although the aircraft had skidded for some distance along the runway, both aligned with and at right angles to it, no skid marks were visible on the grass.
- The landing distance required, calculated from the aircraft manual, at 20 °C, sea level, nil wind at 1,350 kg aircraft weight, was 480 m including a 15% safety factor. The runway length was 850 m.
- His decision to continue with the landing (rather than go-around), was based on previous experience in the aircraft type on a wet runway at Lilydale.
- Lilydale had two parallel runways, runway 18 L was shorter and wider than runway 18 Right, which was 1400 m in length. One runway was nominated as the runway in use each day, and the other marked with white crosses to indicate that the runway was closed. This was to allow the grass to recover.

This incident highlights the importance of conducting a go-around as soon as landing conditions appear unfavourable.
