Inflight fire involving a Beech 58, VH-SBS

111 km W Gove aerodrome, Northern Territory, 26 February 2014

ATSB Transport Safety Report Aviation Occurrence Investigation AO-2014-040 Final – 8 April 2014 Released in accordance with section 25 of the Transport Safety Investigation Act 2003

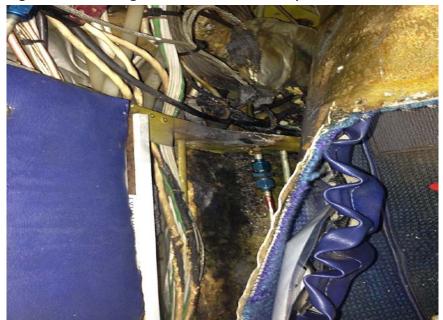
At about 1815, the pilot detected fumes and smoke emanating from within the cockpit. The pilot flying ICUS saw smoke and flames by his left leg adjacent to the circuit breaker panel. He immediately switched off the electrical master switch. The supervising pilot seated in the right seat took control of the aircraft and commenced an immediate descent. The pilot ICUS retrieved the BCF extinguisher from underneath his seat and extinguished the fire (Figure 1).

An engineering inspection found that exhaust gas temperature (EGT) wiring had penetrated through the heater supply fuel line causing it to arc out and burn a hole in the fuel line. With an ignition source and fuel, the fire in the cabin was started. Engineers disconnected and capped the heater fuel line and reconnected the vacuum line.

The engineer also reported that the wires had been bundled together and were rubbing on the fuel line. Inspection of the wires prior to the flight would have required the internal panel to be removed, and was not a routine inspection item.

Figure 1: Fire damage behind the left internal panel of VH-SBS
