# Collision with terrain involving a Robinson R44, VH-UGR

near Yass, New South Wales, 22 February 2014

**ATSB Transport Safety Report**  
Aviation Occurrence Investigation  
AO-2014-031  
Final – 8 April 2014

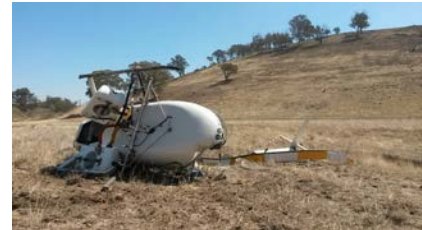
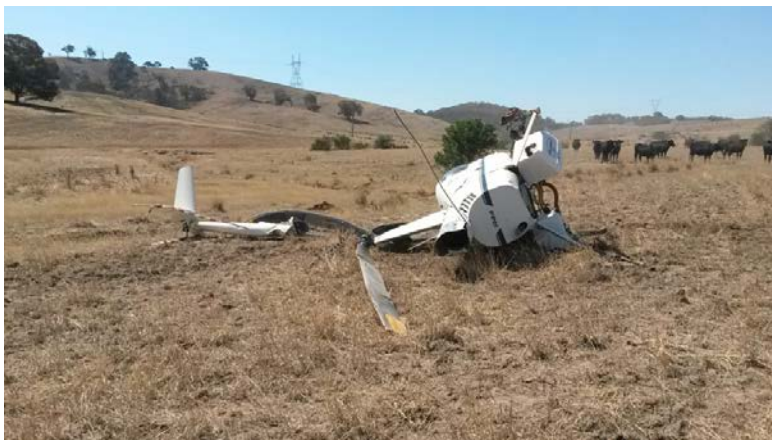
Figure 1: Damage to VH-UGR

The helicopter was about 40-50 m beyond where the load had been jettisoned, and the pilot was focused on gaining lift, when the left skid contacted the ground, and the helicopter rolled over (Figure 1).

| Damage: | Substantial | |

The pilot reported that if he had dumped the load earlier, and performed a run-on landing, rather than attempted to gain lift, the accident may have been avoided. This incident highlights the importance of assessing options in case of reduced aircraft performance on take-off. A pre-take-off safety brief can keep alternative options front-of-mind for pilots, particularly during operations with multiple take-offs and landings.
