# Hard landing involving a Bell 206B, VH-XJA

Sunshine Coast Airport, Queensland, 21 February 2014

**ATSB Transport Safety Report**  
Aviation Occurrence Investigation  
AO-2014-033  
Final – 8 April 2014

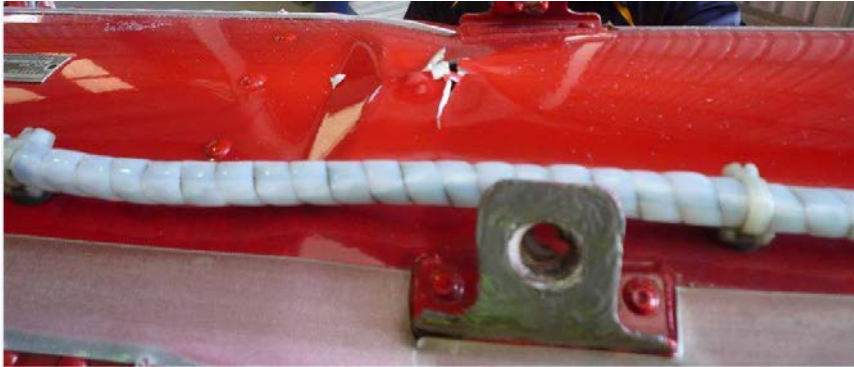
**Figure 1: Damage to VH-XJA**

When at about 20 ft AGL, the instructor directed the student to commence levelling the helicopter. At the same time the low rotor revolutions per minute (RRPM) warning horn sounded. The instructor realised that the throttle was still at idle and took control of the helicopter from the student. He controlled the yaw, levelled the helicopter, allowed the helicopter to sink, and completed the autorotation to the ground, however the helicopter landed heavily, resulting in substantial damage (Figure 1).

For a power terminated autorotation, the standard procedure was to verbally state “decision – power terminate” prior to 400 ft AGL, and to confirm full throttle prior to passing 200 ft AGL, however these were inadvertently omitted due to the high workload of the instructor.

The instructor reported that the hard landing may have been avoided if he had realised earlier that the throttle was at idle and he had taken control of the helicopter from the student, prior to terminating the flare.

In future, the sequence is to be commenced from at least 1,500 ft AGL, to provide more time and reduce the task workload for both the instructor and the student.

The company is reviewing the conduct of practice autorotations in conjunction with other organisations.

Company flight instructors have been reminded to be familiar with current company policies and procedures. Team discussions will be held prior to conducting autorotations.
