# Loss of control involving a Robinson R22, VH-HW

70 km SW of Lake Nash Station, Northern Territory, 1 September 2013

**ATSB Transport Safety Report**  
Aviation Occurrence Investigation  
AO-2013-137  
Final – 8 April 2014

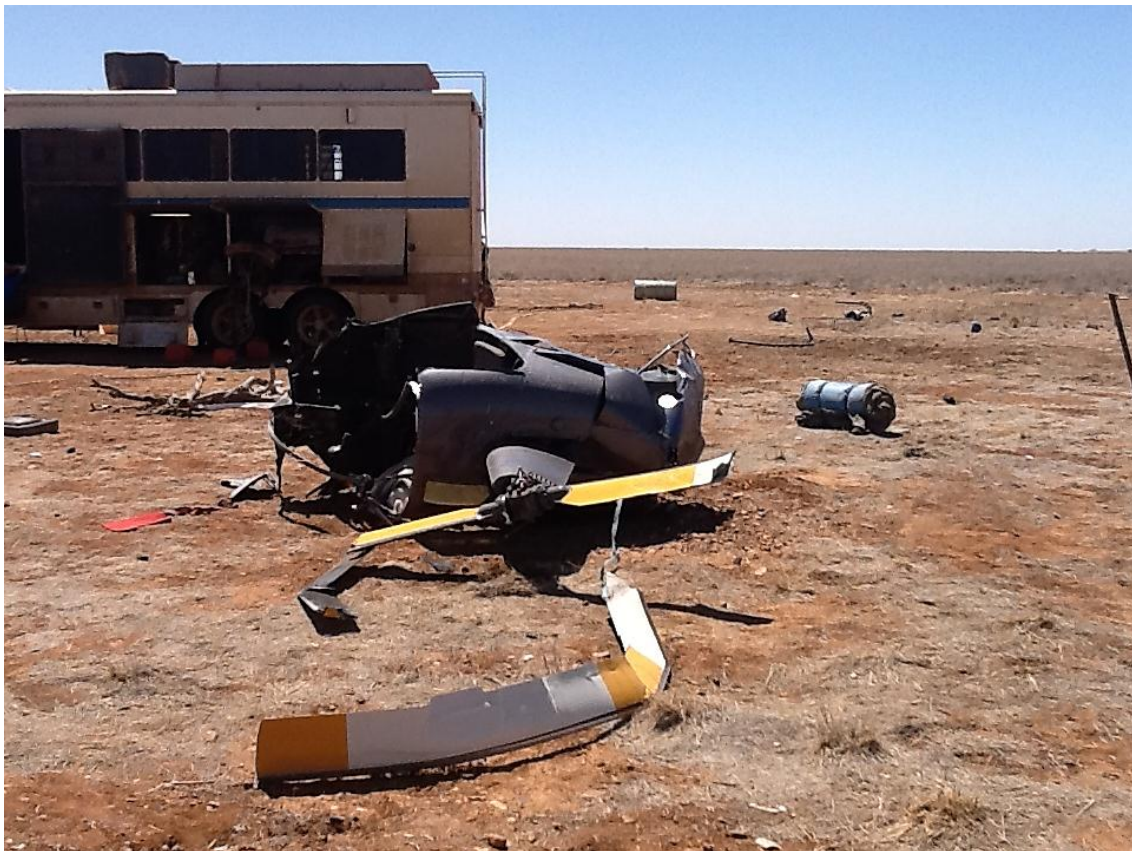
Shortly after take-off, the helicopter was observed by witnesses at the stock camp to commence a steep climbing left turn. As the helicopter turned into a downwind position, a number of the witnesses reported that the wind appeared to affect the controllability of the aircraft. It appeared that the pilot attempted to respond to the situation, however, there was insufficient altitude to recover. The helicopter skids contacted the ground and became separated. The helicopter slid along the ground and then flipped over a number of times before coming to rest near the stock camp. During the accident sequence, the pilot was ejected from the helicopter and sustained serious injuries; the helicopter was destroyed (Figure 1).

**Figure 1: Damage to VH-HVW**

The aircraft owner attended the accident site, and based on his observations and that of the witnesses, believed that when the helicopter was in a downwind position, a negative G<sup>1</sup> situation may have occurred. During the subsequent attempted recovery, the pilot appeared to have pushed the nose of the helicopter forward in an attempt to regain airspeed; however, the helicopter contacted the ground.

Wind direction and velocity are important considerations for helicopter pilots. It is crucial that pilots maintain an awareness of the wind and be aware of the consequential effects on helicopter performance. This will assist pilots with responding promptly and appropriately to a situation and preventing a loss of control.
