Loss of control during landing, involving Cessna 182, VH-LMA

Tyabb Aerodrome, Victoria, 7 December 2013

ATSB Transport Safety Report

AO-2013-219

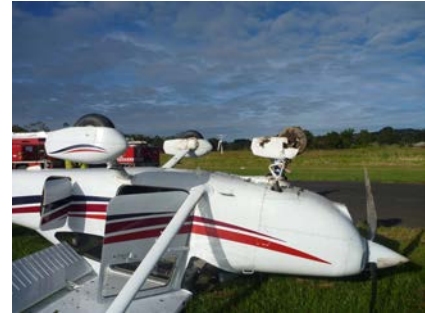
VH-LMA damage

When the aircraft had slowed to about 50 knots, he began to apply the brakes. At about the same time, a gust of wind pushed the aircraft to the left. The pilot applied right rudder in an attempt to steer the aircraft back to the centreline, but stated the aircraft pulled to the left and felt like the left brake had locked. The grass verge next the runway was wet due to recent heavy rain. The aircraft rapidly decelerated, and continued along a path through the wet grass a few metres to the left of the sealed runway. As it stopped, the aircraft nosed forward, and then tipped over onto its back (Figure 2).

The pilot and his passenger were hanging upside down, and due to their weight on the straps, were unable to release the seatbelts. Fortunately, a person had been waiting for the aircraft to arrive, and quickly rendered assistance. The young passenger was able to slip through the harness and was carried a safe distance from the aircraft by the assistant. The pilot then instructed the assistant to find the pocketknife which he kept in a bin between the two front seats, while he reached to shut off the fuel and master switch. The pocketknife was located on the now upside down aircraft ceiling and was used to cut the seatbelt and free the pilot. Both the pilot and his passenger received minor injuries and the aircraft was substantially damaged.

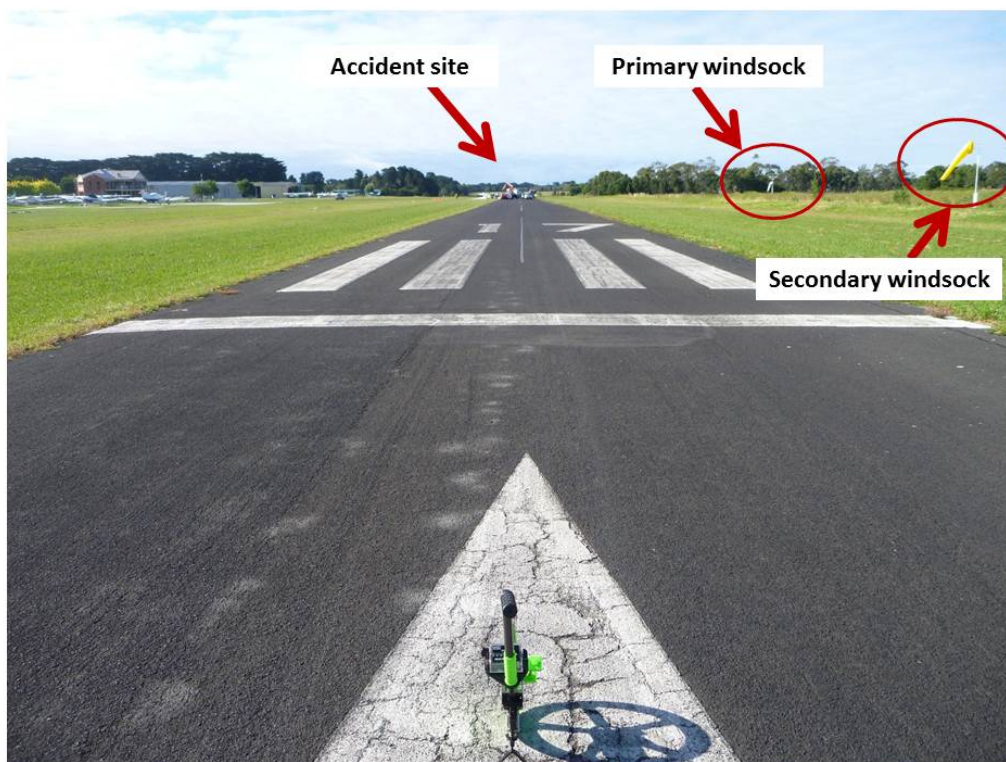
Figure 1: Approach to runway 17 at Tyabb ALA

During the base leg, he again broadcast on the CTAF, then completed the pre-landing checks, except for selecting the final stage of flap. When on final approach, he checked the secondary windsock (Figure 1) and noted the wind was predominantly crosswind from the right, gusting around 5-10 knots. With the final stage of flap selected, the aircraft touched down on the main wheels about 20-30 metres past the runway threshold, close to the centreline. The pilot estimated that the aircraft touchdown speed was about 65 knots. During the landing roll, he applied a small amount of right aileron to counter the crosswind.

The pilot's normal procedure was to overfly non-controlled aerodromes at the recommended 1500 ft above ground level (AGL). This allowed time to assess the wind, check the runway status, check for traffic and prepare to join the circuit. On this occasion, wanting to comply with the ERSA noise abatement procedure notes for Tyabb, which include an instruction to avoid overflying the aerodrome and the Tyabb township unless operationally required, coupled with the lack of other traffic he elected to join base leg at circuit altitude.

It is important in the pre-flight planning to obtain all possible information for the flight, and where a full NOTAM or TAF service is not available, to contact the airfield operator and check the airport status. By not flying over the primary windsock where warning signals to the pilot are placed, the pilot also missed the opportunity to notice any unserviceability markers and to assess the wind near ground level.

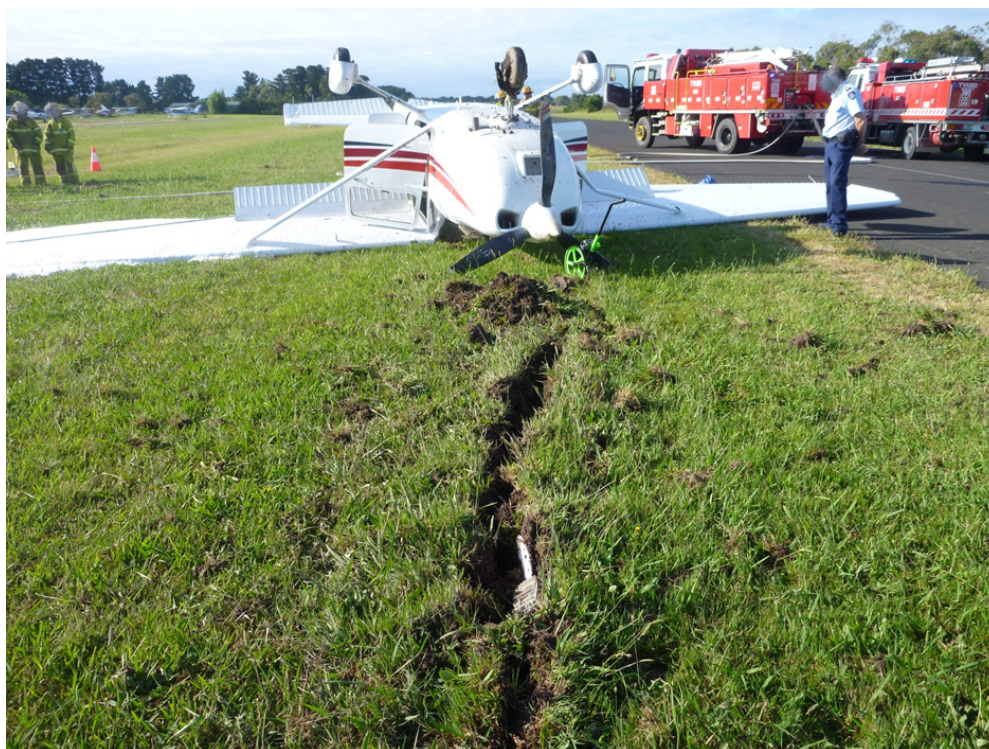
Figure 2: VH-LMA showing path through the grass verge

Also, in hindsight, the pilot felt that if he had applied right rudder a little earlier during the landing roll, this may have prevented the aircraft leaving the sealed runway, and onto the sodden grass verge.
