Australian Government  
Australian Transport Safety Bureau

# Collision with ferris wheel involving Cheetah Sierra 200, 24-7634

near Old Bar, NSW | 1 October 2011

**ATSB Transport Safety Report**  
Aviation Occurrence Investigation  
AO-2011-126  
Final – 17 April 2014

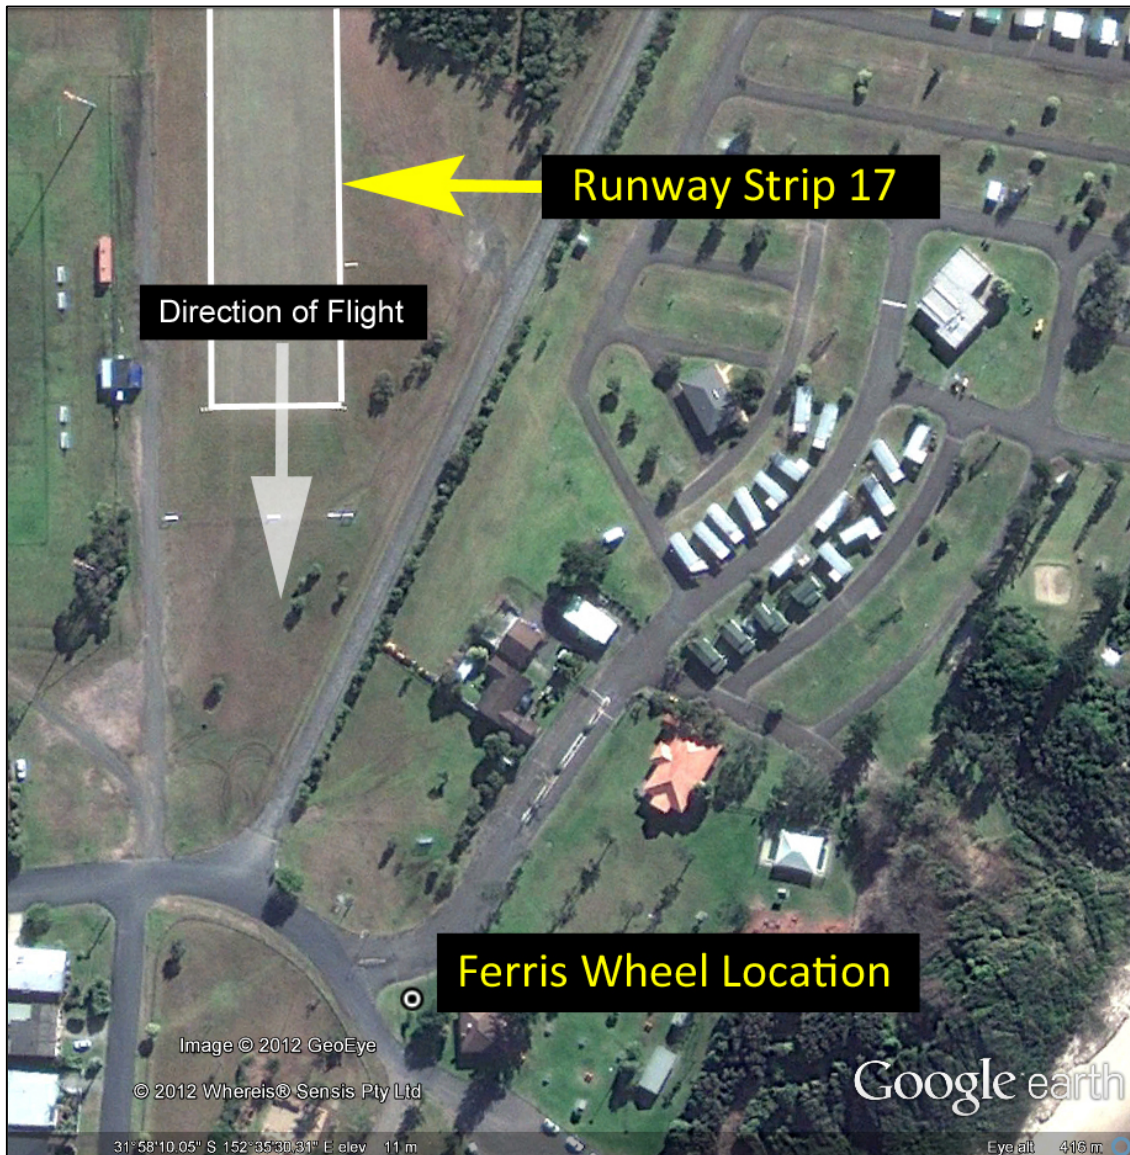
**Figure 1: Location of the ferris wheel in relation to the runway strip**

The passenger in the Sierra reported receiving a minor injury as a result of the impact. There were no reported injuries from either the pilot or the occupants of the ferris wheel. The NSW Police received one report of a minor injury from a member of the public as a result of debris that was liberated during the Sierra's impact with the ferris wheel. The aircraft was substantially damaged.

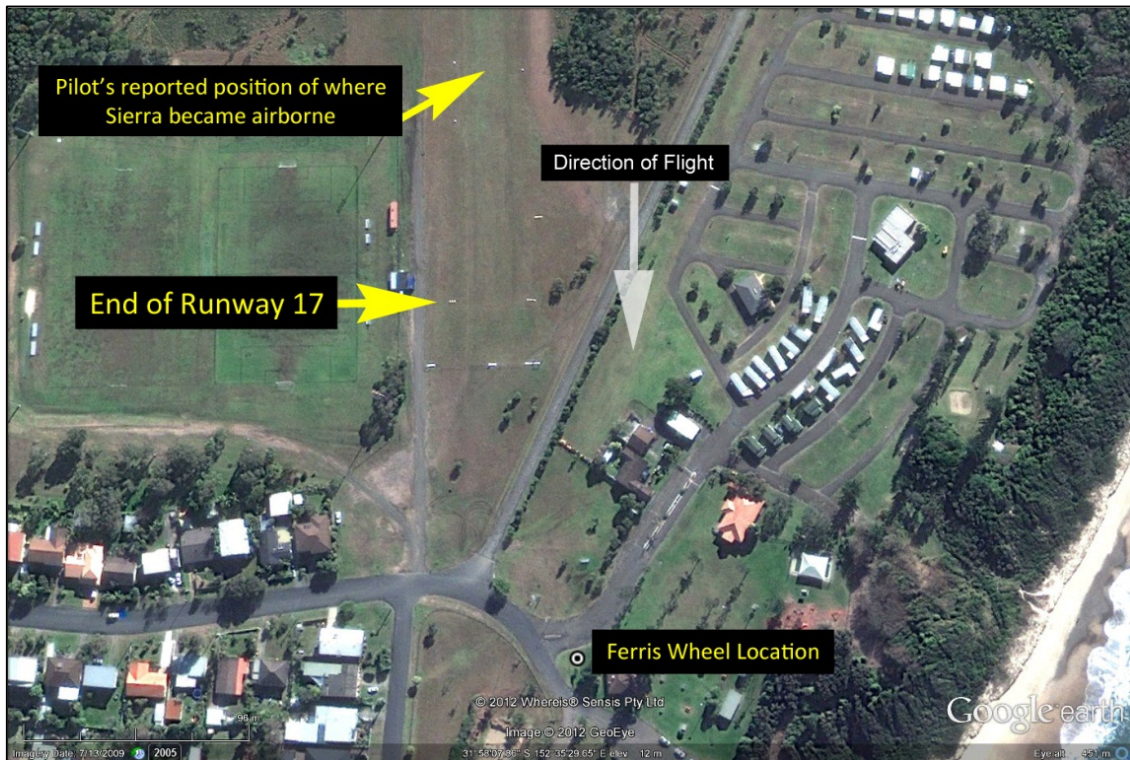
**Figure 2: Pilot's reported lift-off position**

The Sierra pilot reported flying a normal circuit and touching down about 6 m from the threshold markers on runway 17. He raised the flaps and applied full power for a touch-and-go in order to check the condition of the strip and to make sure that there were no obstructions on or around the strip. The pilot reported that the second circuit was similar to the first, with the turn onto base and aircraft configuration being consistent: namely, flaps lowered to three quarter down and airspeed between 50 and 60 kt. He indicated that he touched down in nearly the same spot as previously, and described both circuits as being virtually the same. The pilot reported that at no time during the overfly or the first or second circuits did he see the ferris wheel to the south of the airstrip.

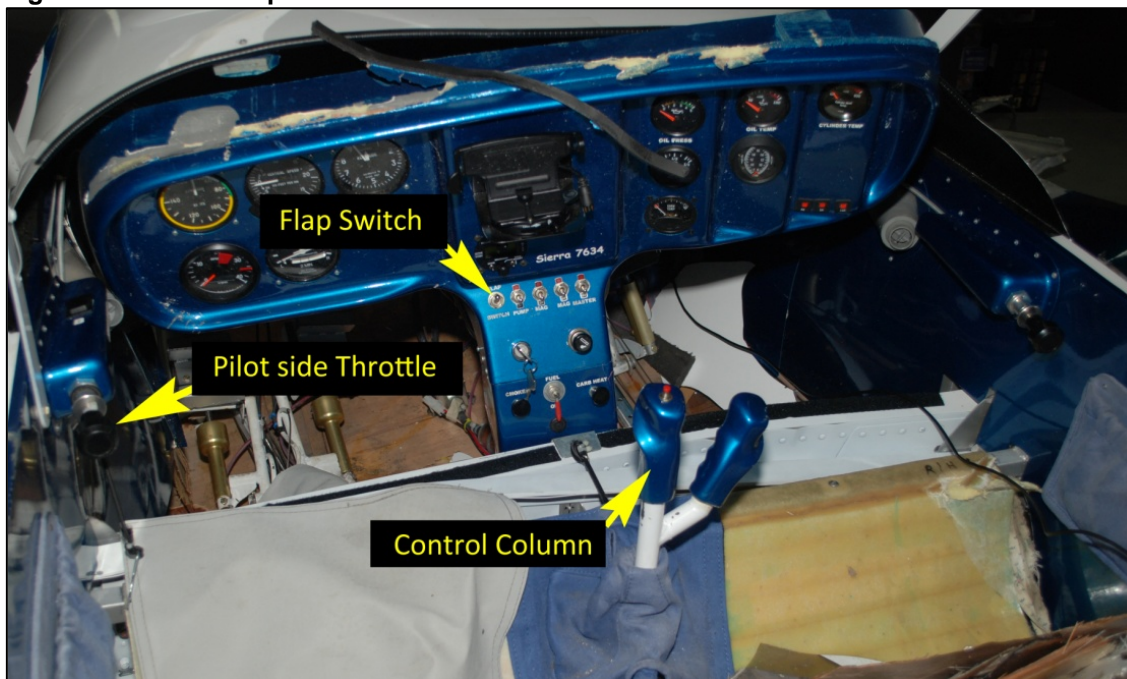
**Figure 3: Sierra cockpit and control locations**

The cockpit of the Sierra was configured for two persons, a pilot and passenger. The pilot occupied the left seat. There was one control column that was located between the two seats and duplicated throttles. The flap control switch was located on the centre control panel of the aircraft (Figure 3).

A pilot flying the Sierra from the left seat would place their right hand on the control column, and operate the throttle with their left hand. When conducting a touch-and-go landing, a pilot would keep their right hand on the control column, and operate the flap switch with their left hand. Once the flaps had been raised, they would then open the throttle using their left hand. The pilot confirmed that this was the procedure that he used when conducting the go-around at Old Bar.

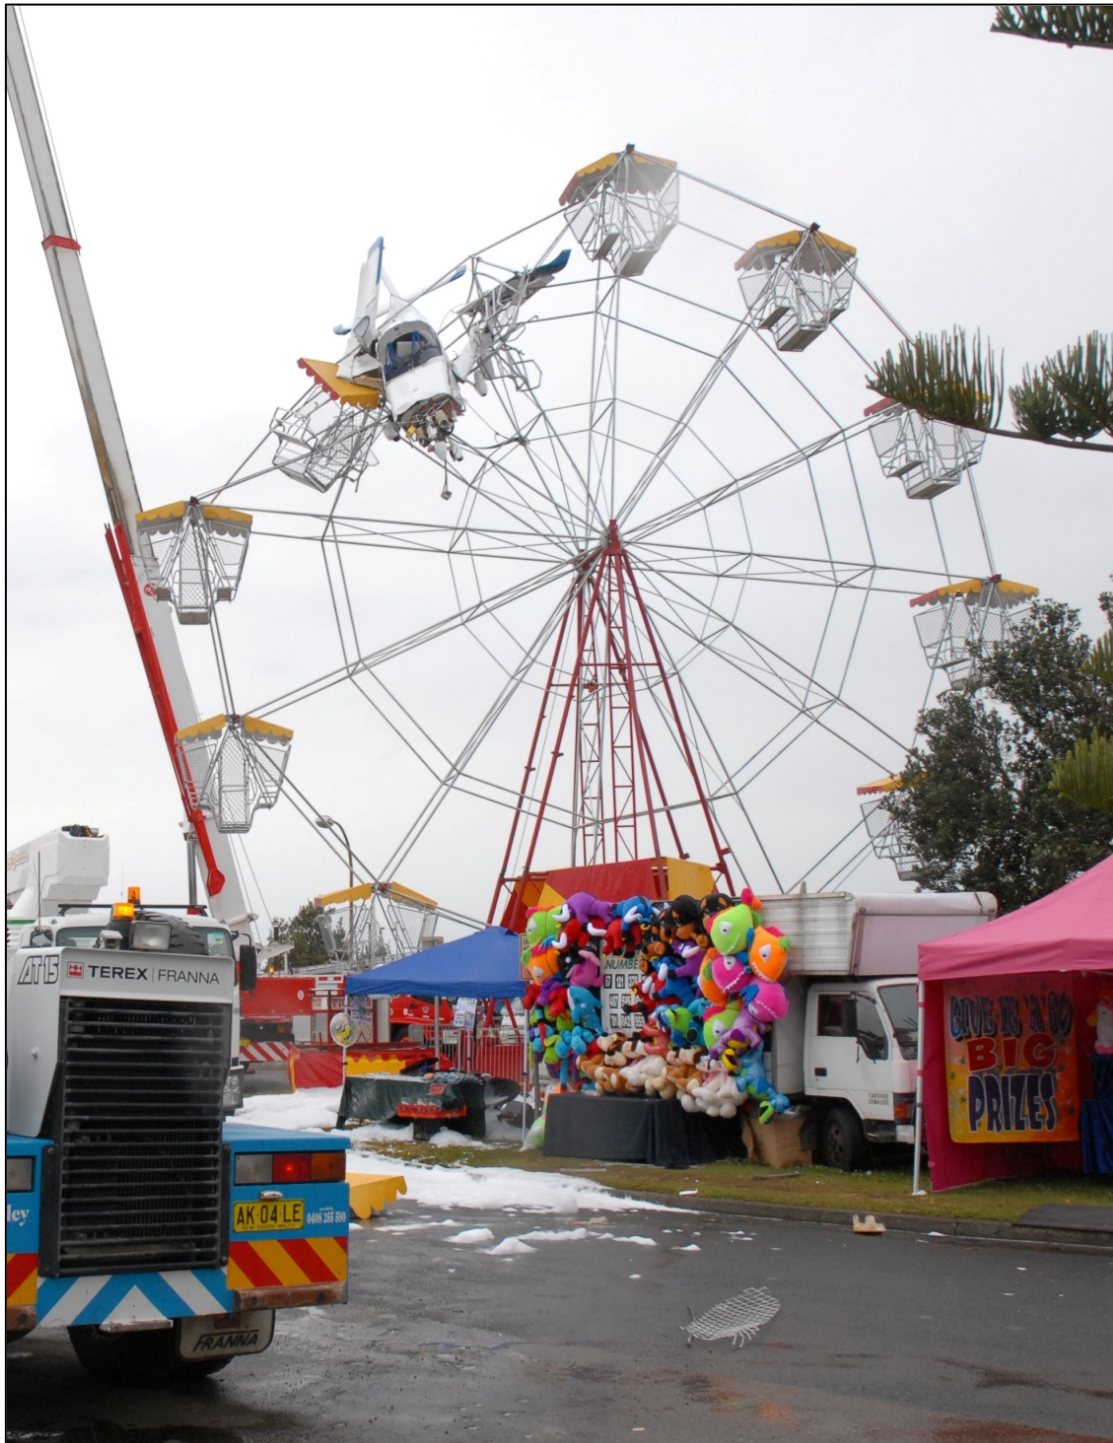
**Figure 4: Aircraft entangled in the ferris wheel**

The cabin area and fuselage sustained minimal damage from the impact. The majority of the damage was sustained by the wings of the aircraft (Figure 4).

The aircraft became entangled in the structure and took considerable effort to remove (Figure 4). The aircraft was reportedly leaking fuel following the impact and firefighting foam was deployed by emergency services to minimise the risk of fire.

The operator of the ferris wheel reported that when he inspected the wheel following the collision most of the structure appeared to have been damaged.

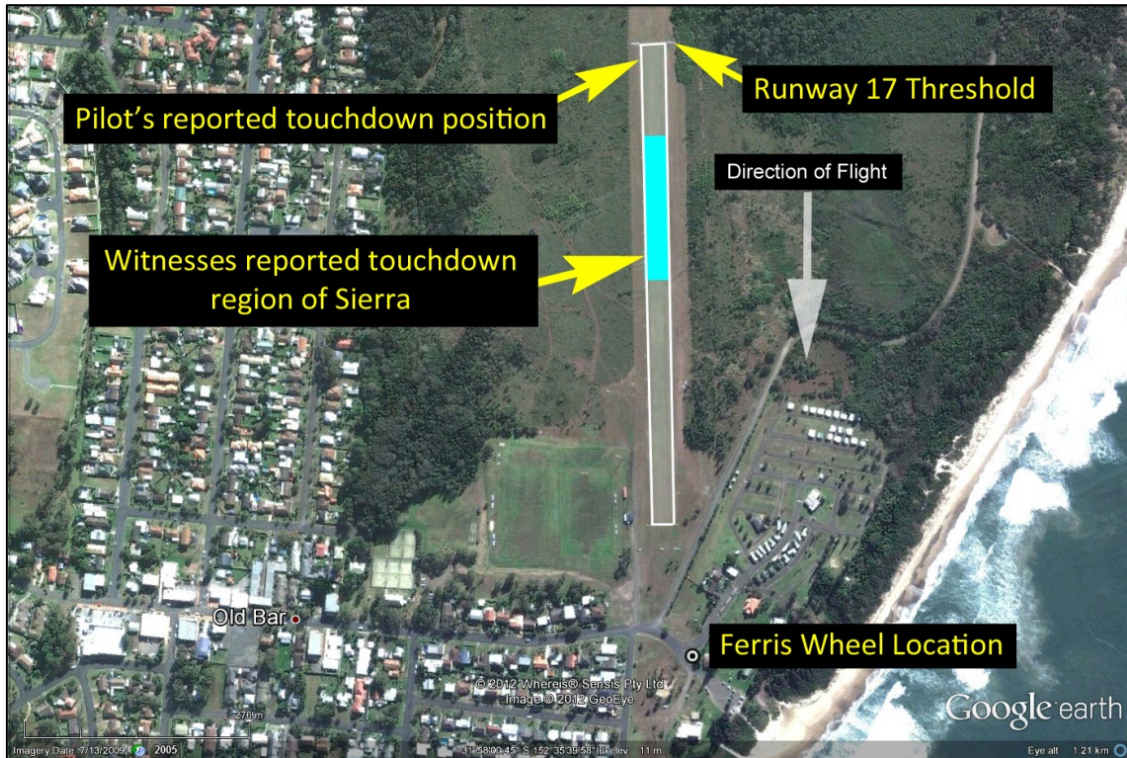
**Figure 5: Touchdown region as reported by witnesses**

Witnesses located in the vicinity of the airstrip were able to describe the final landing approach, ground roll and go-around of the Sierra. A number of the witnesses indicated that the Sierra appeared to touch down well into the airstrip, some distance from the landing threshold. Two witnesses reported that it touched down approximately halfway down the airstrip (Figure 5).

Two witnesses, who had considerable aviation experience, indicated that it appeared the pilot was late in applying the brakes on the aircraft after it touched down. One witness reported becoming 'alarmed' on hearing the pilot increase engine power to go around. Another witness reported having 'grave concerns' about the performance of the Sierra and the actions of the pilot and gave the aircraft his full attention.

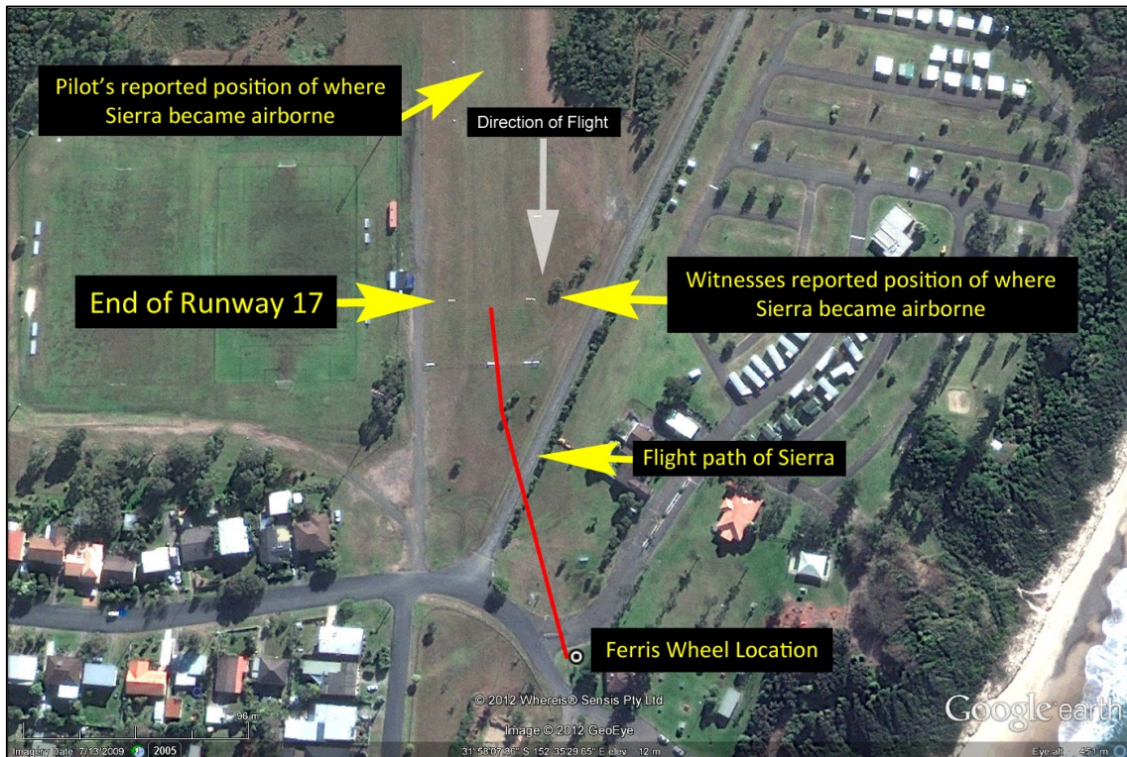
**Figure 6: Reported lift-off position and subsequent flight path**

A video recording taken by persons at the festival at the time of the impact confirmed the lift-off point of the Sierra and its subsequent flight path as reported by the witnesses.

An analysis of the video recording of the lift-off and subsequent flight was used to estimate the groundspeed of the aircraft during the time from when it passed the upwind end of runway 17 until it impacted the ferris wheel. That analysis revealed the aircraft was travelling at an estimated ground speed of 63 kt. Given the indicated airspeed at the time of 60 kt as reported by the pilot, this suggested that the aircraft was being subjected to a tailwind component of approximately 3 kt. If the aircraft was travelling slower than the speed reported by the pilot, then the tailwind component was greater than 3 kt.

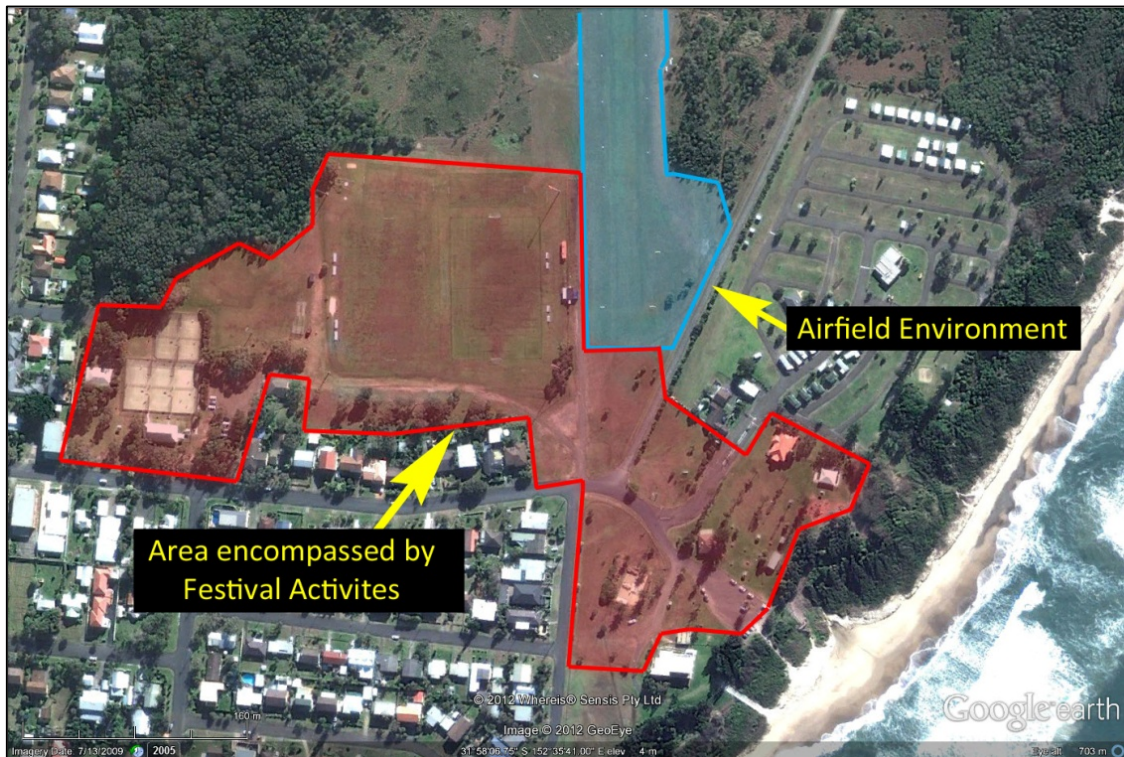
**Figure 7: Area of ground based festival activities**

The Old Bar Beach Festival committee president reported that in 2011, two members of the Old Bar Airstrip committee were invited to be members of the festival organising committee as the festival committee did not have any aviation expertise within its members. Examination of the meeting minutes of the festival committee for the period March to September 2011 revealed that only one of the airstrip committee members who were appointed to the festival committee attended any meetings in that period. The other member of the airstrip committee reported that they were not aware of being invited to be part of the festival committee.

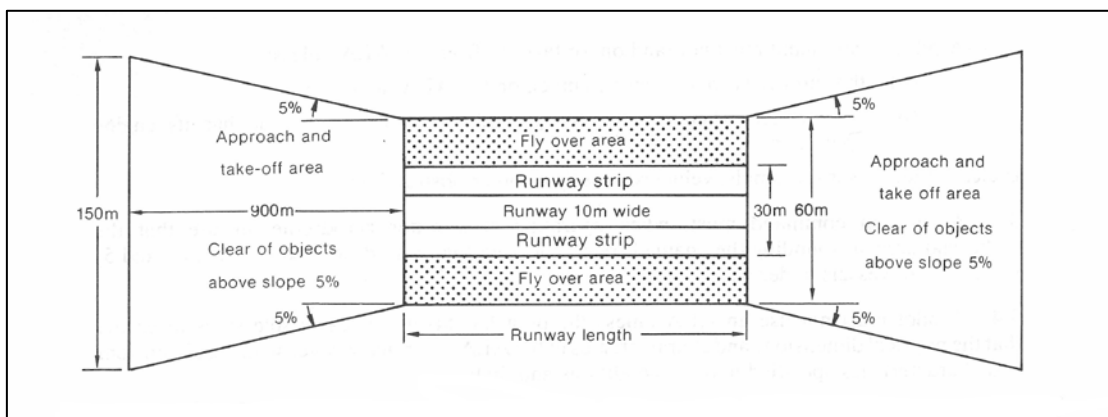
**Figure 8: Recommended physical characteristics of an aircraft landing area**

Figure 8 was taken from CAAP 92-1(1) and outlines the areas that have to be considered in relation to obstacle clearance areas. These guidelines are intended for use without the need to employ a surveyor. In the guidelines, the lateral splay moves outward from the edge of the strip at a gradient of 5 per cent and can be expressed as a ratio of 1:20. This means that for every 20 units of measurement<sup>36</sup> moved over the ground in a direction parallel to the runway centre-line and away from the end of the airstrip, the splay moves one corresponding unit outwards over the ground at right angles to the runway centre-line. The same ratio applies to the vertical surface; for every 20 units moved across the ground away from the end of the airstrip, the splay moves one unit vertically up from the ground. That process continued until 900 m from the end of the airstrip.

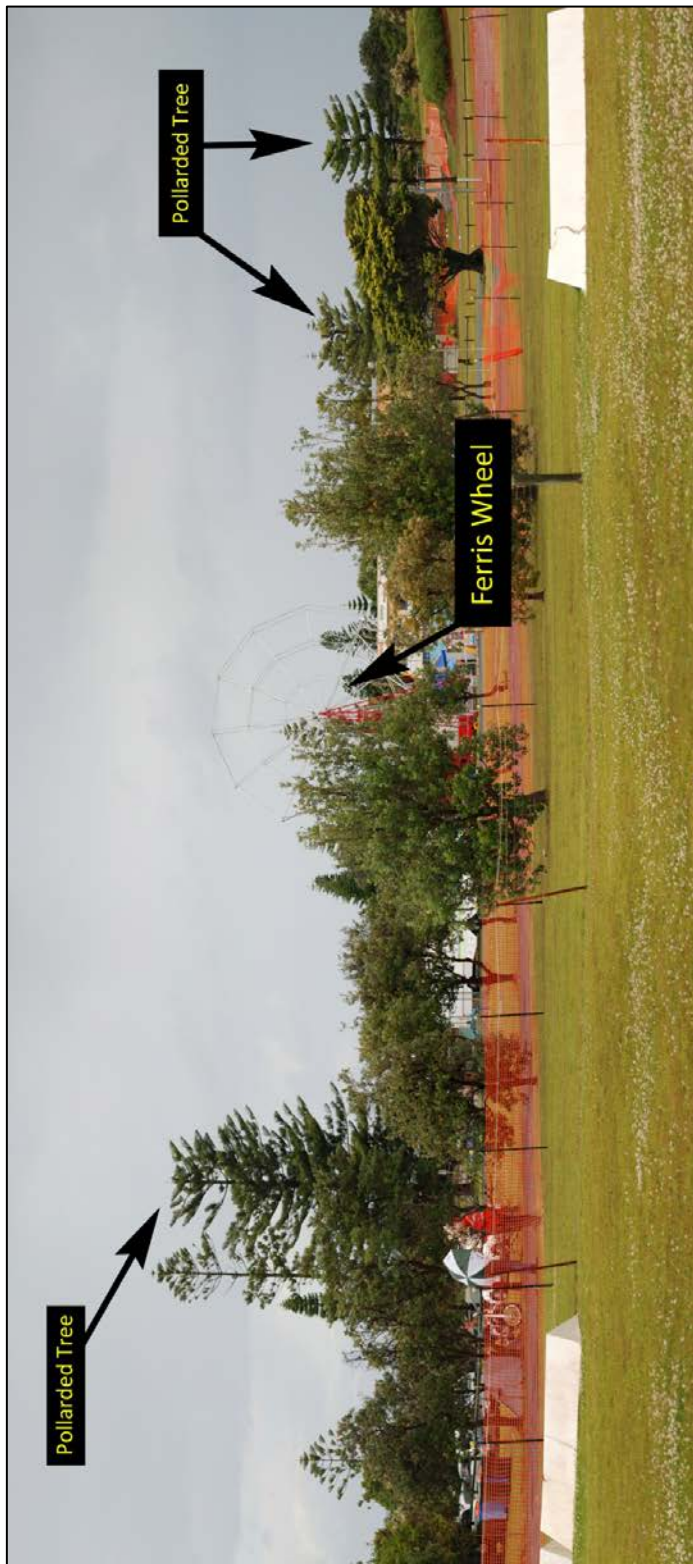
**Figure 9: Pollarded trees in the vicinity of the ferris wheel**

The local council reported that the airstrip had never been formally surveyed for obstructions. However, a number of trees to the south of the airstrip under the approach path and to the south-eastern side exhibited evidence of pollarding<sup>43</sup> to ensure that they did not pose a hazard to aircraft operations. The airstrip caretaker reported that when the trees started to encroach on the approach path, they were pollarded by a local tree surgeon.

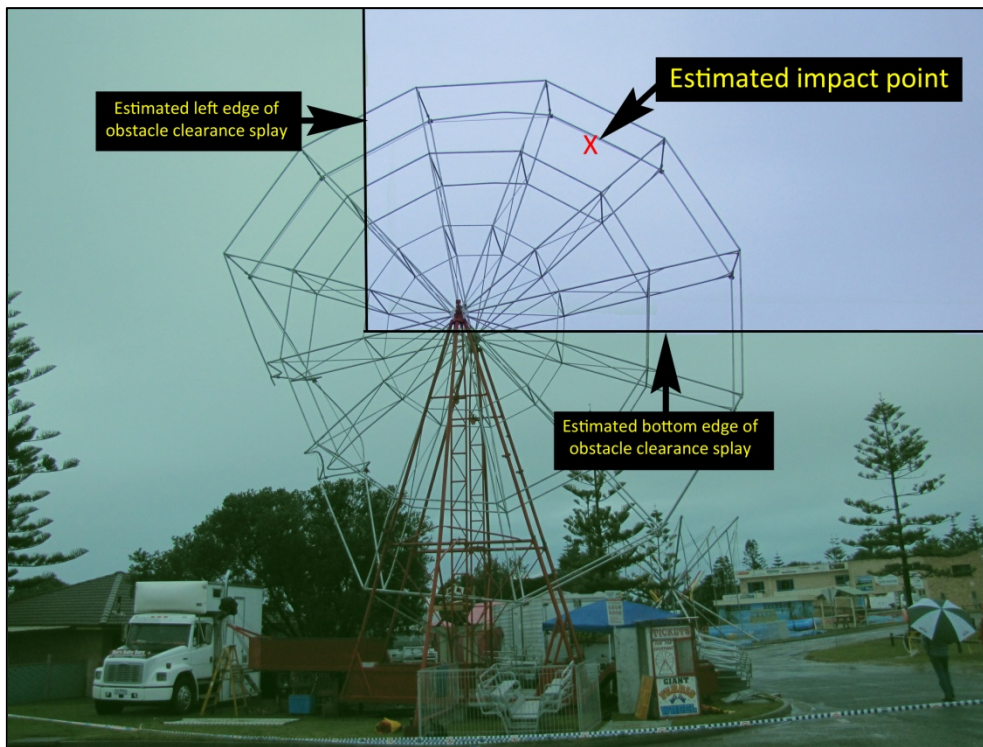
**Figure 10: Looking south along the direction of flight towards the ferris wheel with lateral and vertical obstacle clearance splays superimposed<sup>47</sup>**

By superimposing the estimated obstacle clearance splay boundaries on a picture of the ferris wheel, the ATSB found that part of the wheel was within the required runway 17 departure/35 approach obstacle clear area (Figure 10).

<sup>47</sup> The damaged section of the ferris wheel has been moved to the lower left (above the white truck) and the carriages have been removed.

The festival and airstrip committees reported that in future the airstrip will be closed and aviation operations suspended when the festival is taking place.
