# Engine power loss and departure from controlled flight involving Piper Seneca, VH-LCK

Near Broome Airport, Western Australia | 11 July 2012

**ATSB Transport Safety Report**  
Aviation Occurrence Investigation  
AO-2012-093  
Final – 3 June 2014

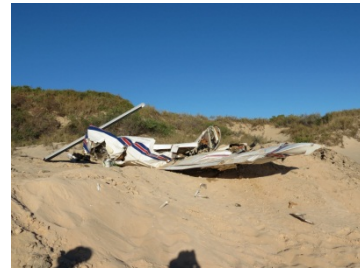
Aircraft wreckage

On 11 July 2012, the pilot of a Piper Seneca I, registered VH-LCK, was conducting a freight-carrying flight between Broome and Port Hedland, Western Australia. The flight was conducted at night under the instrument flight rules. Witnesses who heard or saw the aircraft take-off reported hearing unusual noises from the engines during the climb. Other witnesses closer to the accident site reported hearing the engine sound suddenly cut out before the aircraft banked left and descended steeply towards the ground. The aircraft wreckage was located amongst sand dunes, about 880 m beyond the upwind runway threshold. The aircraft was destroyed and the pilot sustained fatal injuries.

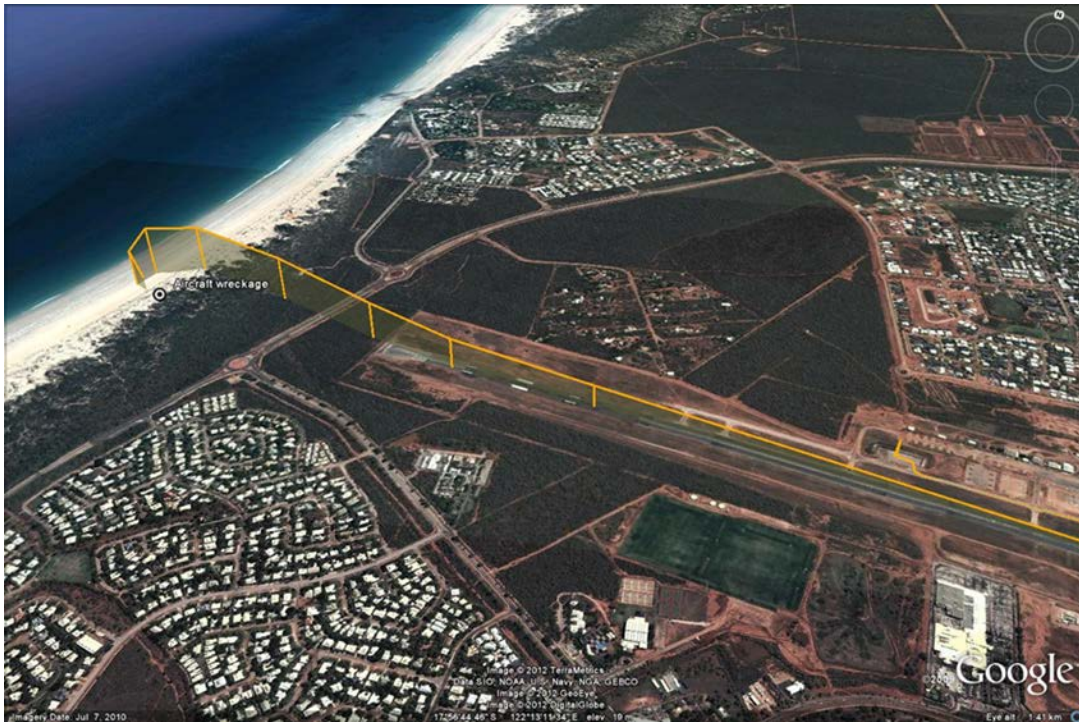
**Figure 1: GPS track log for the flight**

The point-to-point speed recorded by the aircraft's global positioning system (GPS) receiver immediately before the aircraft started to descend was 59 kt, which in the calm wind conditions was close to the 60 kt aerodynamic stall speed derived from data published by the aircraft manufacturer.<sup>14</sup> An aerodynamic stall occurs when the wing exceeds the critical angle of attack, disrupting the smooth airflow over the aerofoil, rapidly reducing lift and resulting in a descent.

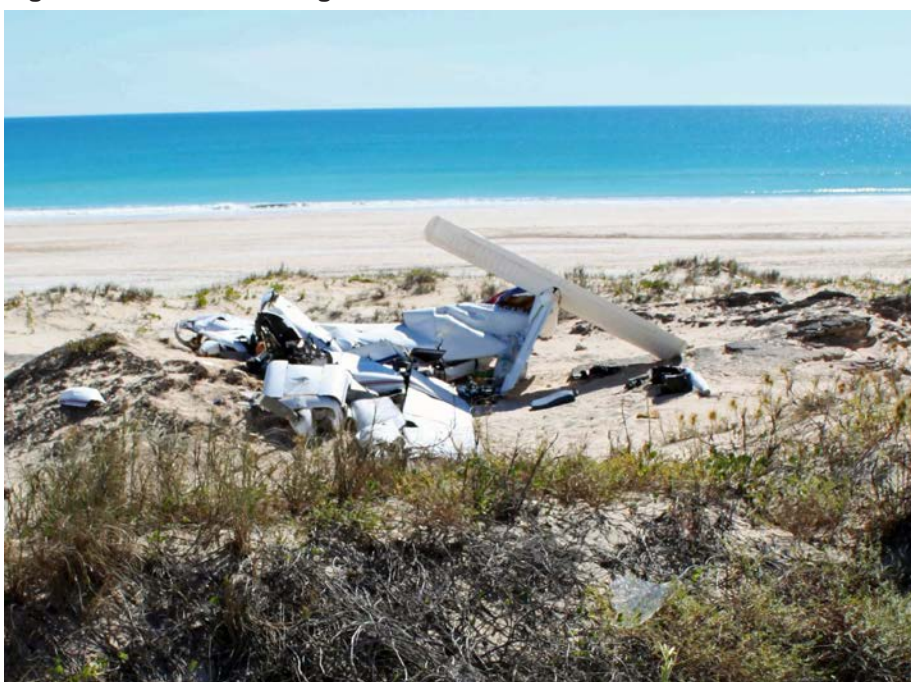
**Figure 2: Aircraft wreckage**

Air traffic control initiated search and rescue alerting action when the controller did not receive the pilot's departure report. Local witnesses also notified emergency services in the belief that the aircraft had crashed. Searchers found the aircraft wreckage at about 2330, in sand dunes about 880 m beyond the upwind end of runway 28 and close to the extended runway centre-line (Figure 2).

The pilot sustained fatal injuries and the aircraft was destroyed by impact forces. There was no fire.

Damage was consistent with the aircraft descending steeply into terrain in an upright, steep nose-down attitude, at low forward speed and with a high rate of descent. The force of the impact dislodged both engines at the firewall and the tail section was folded up and over the fuselage. The nose section was severely disrupted and the cockpit floor had been compressed upwards and rearwards.

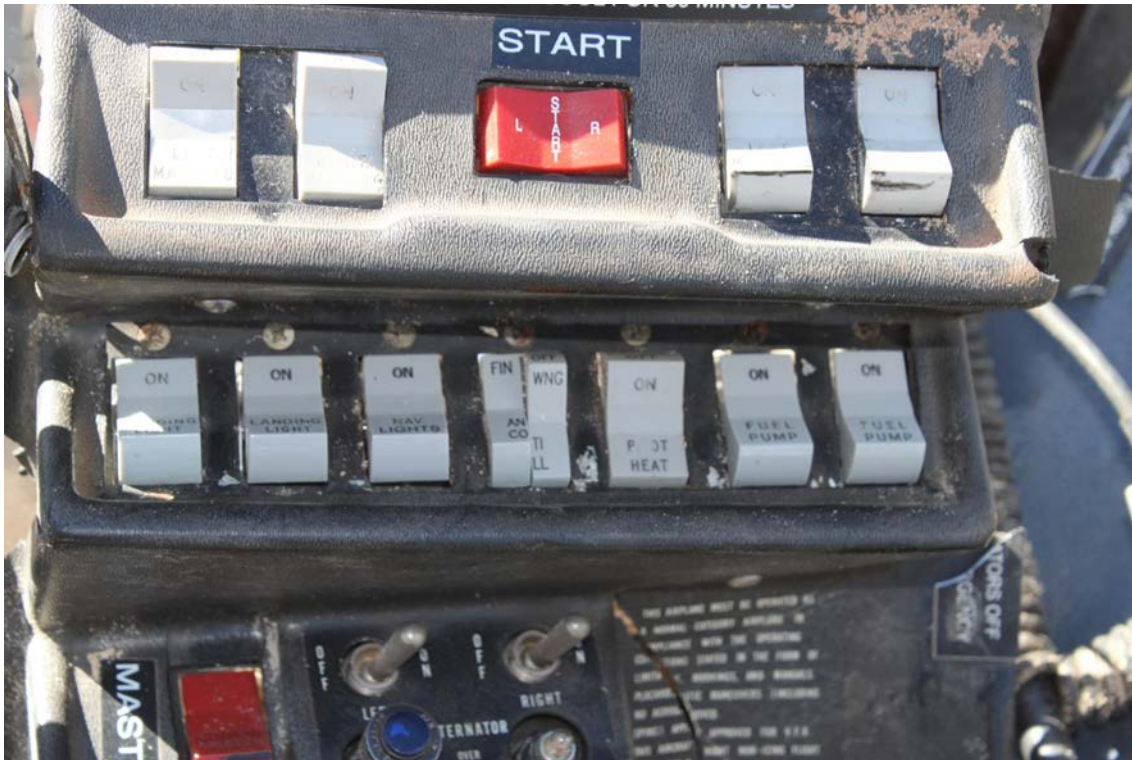
**Figure 4: Electrical switch panel**

Examination of the electrical switch panel on the left of the cockpit found the panel substantially intact, but dislodged from the sidewall of the cockpit (Figure 4).

The switches for the left engine's magnetos were in the OFF position. The right engine's magnetos switches were in the ON position. Photographs taken during the initial on-site response showed fine sand surrounding the magneto switches, consistent with them being in that position immediately after the accident. Those photographs also showed the guard cover for the magneto switches was intact, but had broken away from the switch panel at the forward hinge and was loosely attached at the rear hinge. Although this damage was consistent with the impact forces, the disruption of the guard cover meant that it was not possible to assess its pre-impact serviceability. All of the engines' magneto switches would normally be selected ON during flight.

With the minimal damage sustained to the guard cover for the magneto switches and the panel trim immediately surrounding the left engine's magneto switches, it was unlikely those switches

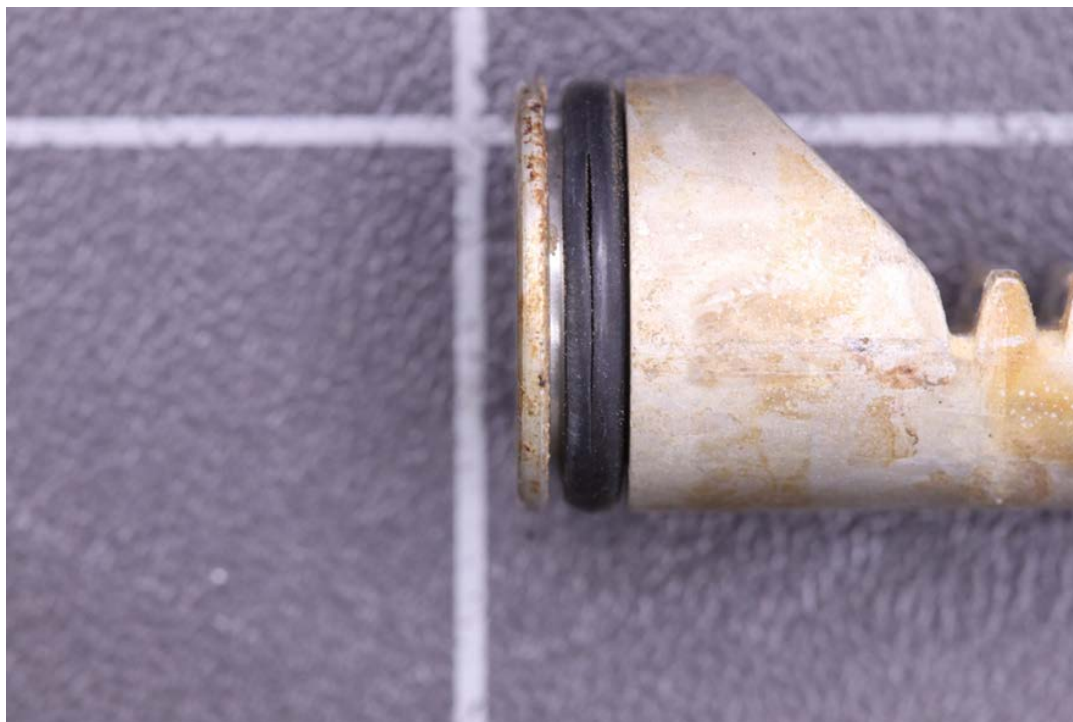
**Figure 5: O ring deterioration**

Although not identified as a factor contributing to this occurrence, post-accident examination of the aircraft's fuel selector valves found the internal seals had deteriorated and allowed fuel to flow to the engines when the valves were in the OFF position. A review of the aircraft manufacturer's maintenance instructions revealed this type of internal leakage may not be evident during routine maintenance, although a non-scheduled valve leak procedure was available.

Disassembly of the valves identified deterioration of the O rings on the internal assembly of each shuttle valve. With each valve partially disassembled, both shuttle valves were able to move freely. A close examination of the O rings found that they had aged, and were either worn and cracked, or had slightly shrunk (Figure 5).

The aircraft manufacturer has been advised that their maintenance instructions may not identify deteriorated fuel selector internal seals during routine maintenance. Airworthiness bulletin AWB 28-105, published by the Civil Aviation Safety Authority, recommended that owners and operators of Piper Seneca, and other aircraft fitted with similar fuel selector valves, regularly check their function.

New O rings were fitted to each shuttle valve and the selectors retested. In this configuration, neither valve bypassed fuel in the OFF position.
