Wirestrike involving Cessna 182A VH-SGB

Burrum River, Queensland | 17 December 2012

ATSB Transport Safety Report
Aviation Occurrence Investigation
AO-2012-170
Final – 5 June 2014

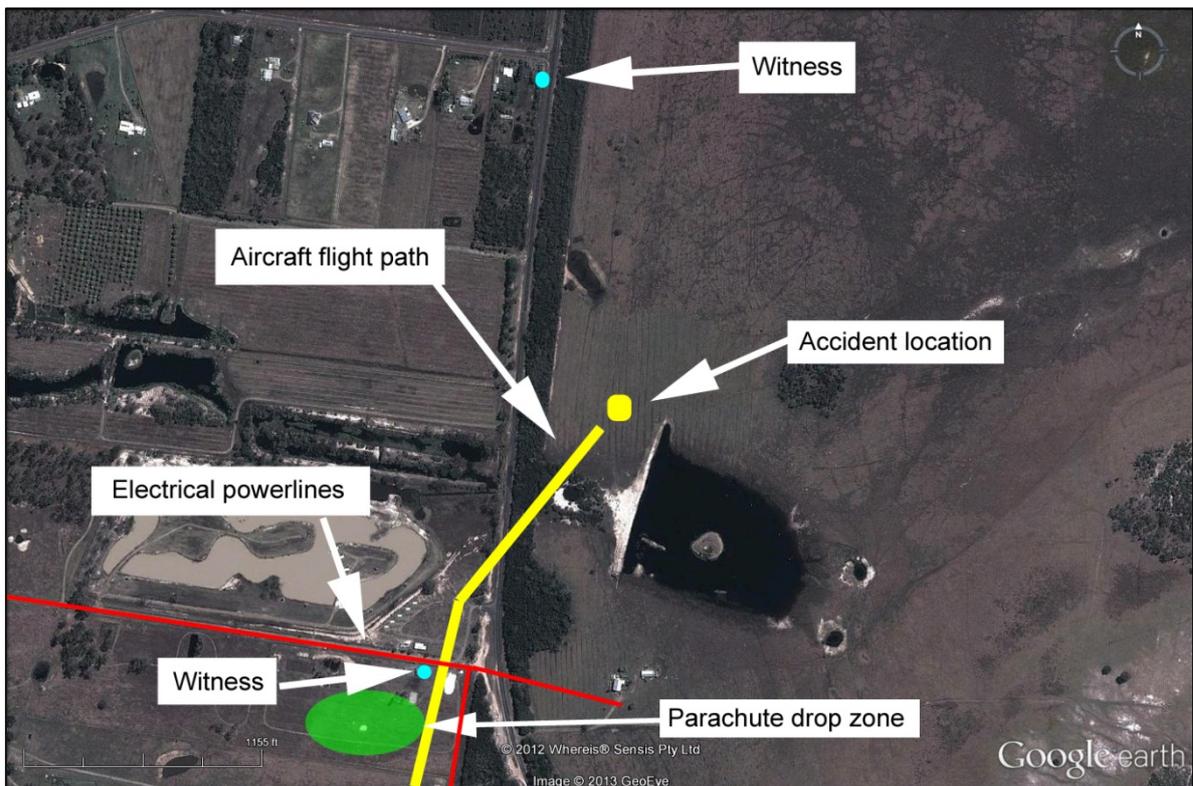
Figure 1: Accident and witness locations

The aircraft flew almost overhead the position of the witness at the drop zone and impacted two powerlines, which were at a height of about 9 m (30 ft) above ground level (AGL) and ran in an east-west direction. The aircraft was seen to climb, still trailing the powerlines. It then turned slightly to the right before it disappeared from sight behind trees (Figure 1). The aircraft subsequently impacted the ground and a post-impact fuel-fed fire consumed most of the wreckage. The pilot was fatally injured.

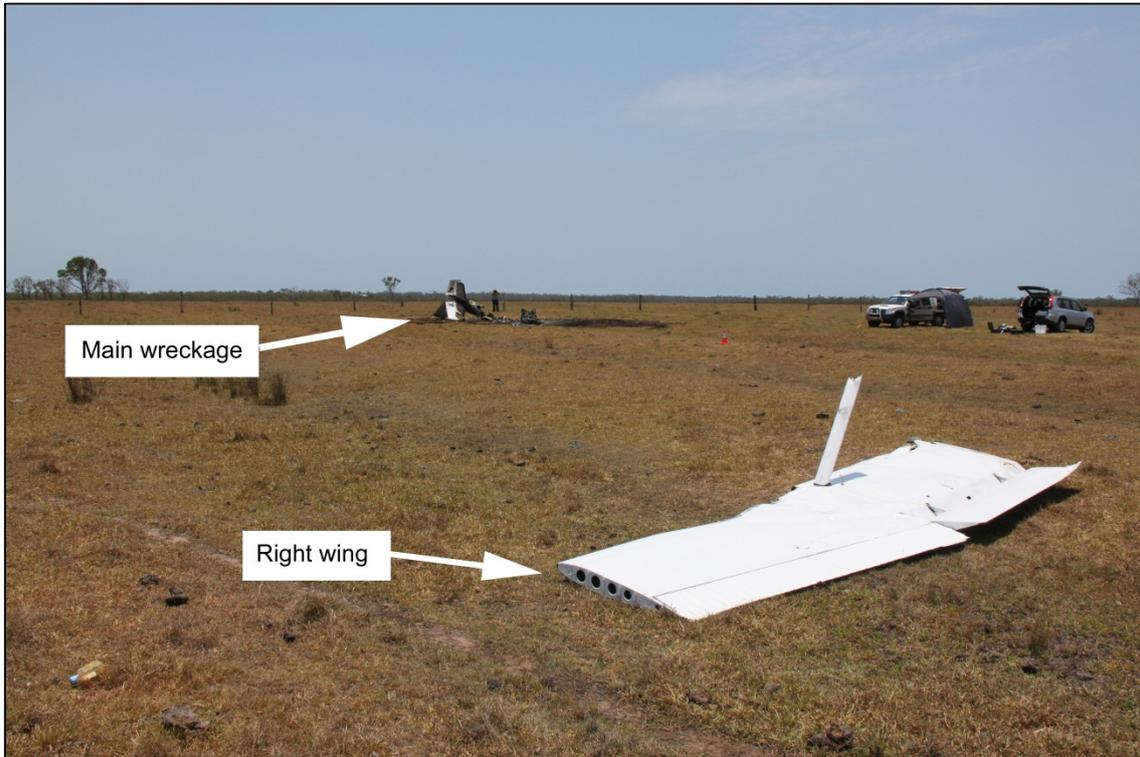
Figure 2 – Right wing in relation to main wreckage location

The aircraft had impacted the ground in a nose-down attitude of approximately 90 degrees with very little forward speed. All of the aircraft's primary structures and flight controls were accounted for either at the wreckage location or along the aircraft's flight path. The right wing had separated from the aircraft prior to its impact with the ground and was located approximately 40 m before the main wreckage of the aircraft (Figure 2).

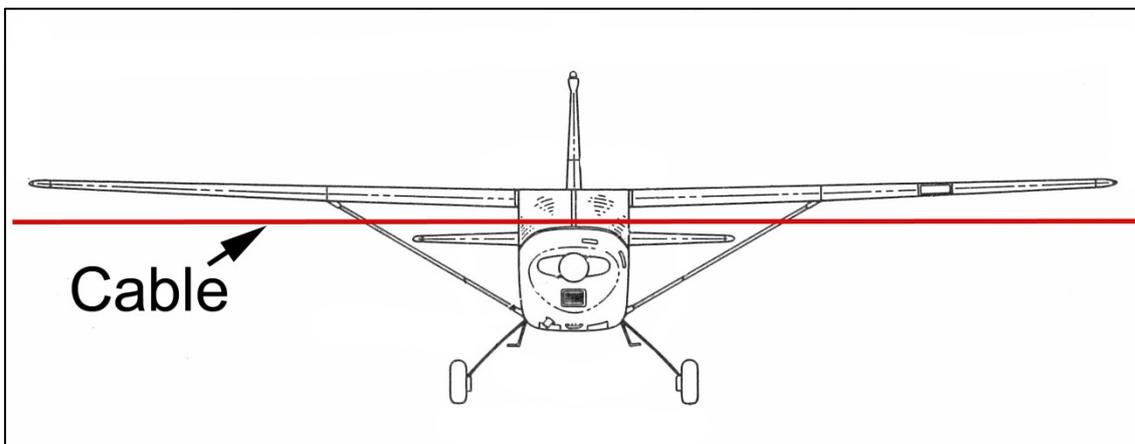
Figure 3 – Aircraft orientation to powerline at time of impact

The right wing strut displayed marks that were consistent with contact with a 3-strand electrical powerline. The start of those marks was located approximately 30 cm from the top of the strut. When that distance and orientation of the marks was transposed to a diagram of the aircraft, the position of the powerline at the point of impact was able to be determined (Figure 3).

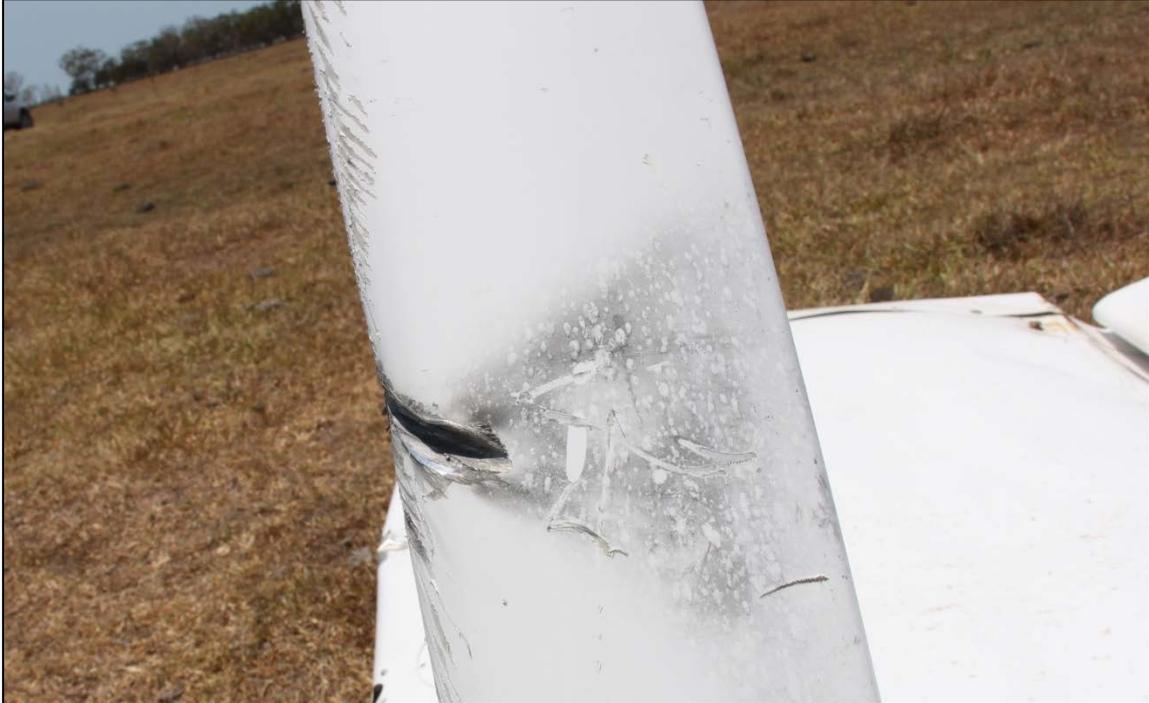
Figure 4 - Electrical arcing on strut

As the aircraft climbed, the powerline was drawn down the strut, where there was evidence of electrical arcing (Figure 4).

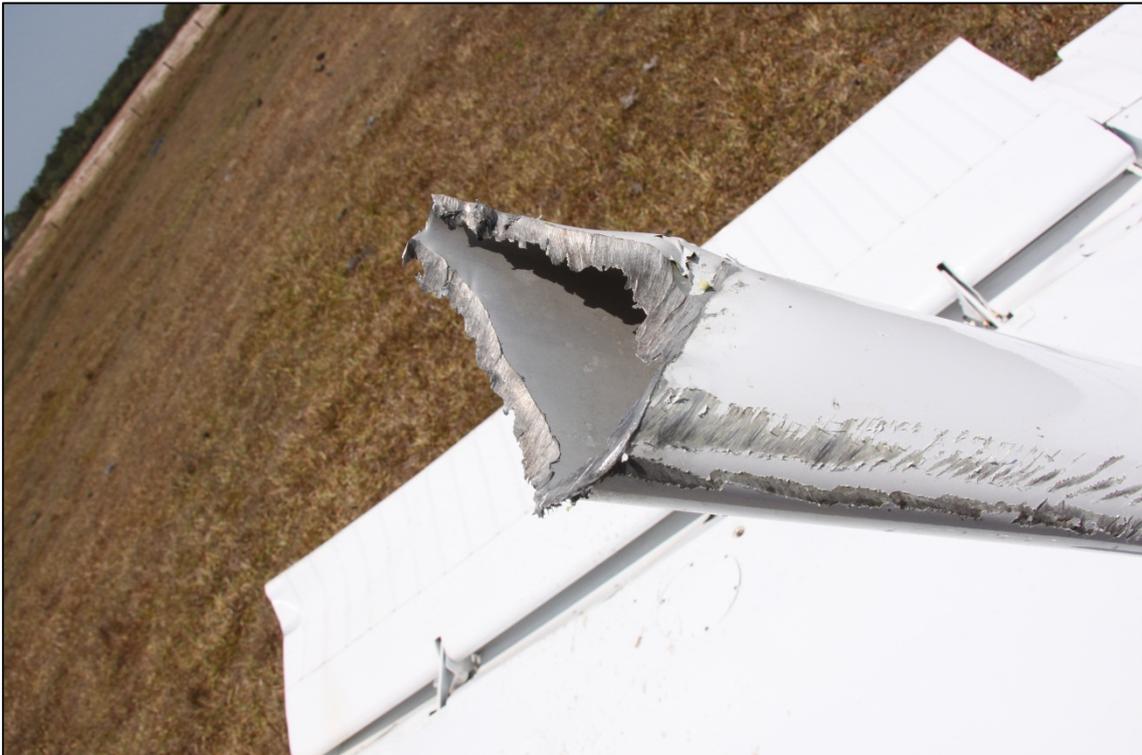
Figure 5 – Severed right wing strut

As the aircraft continued in flight, the powerline was further drawn down the strut and probably jammed against the strut step, severing the strut completely as the powerline cut through the structure (Figure 5). The result was the failure of the strut followed by failure of the right wing due to aerodynamic loading in an upwards direction at the wing root attachment points.

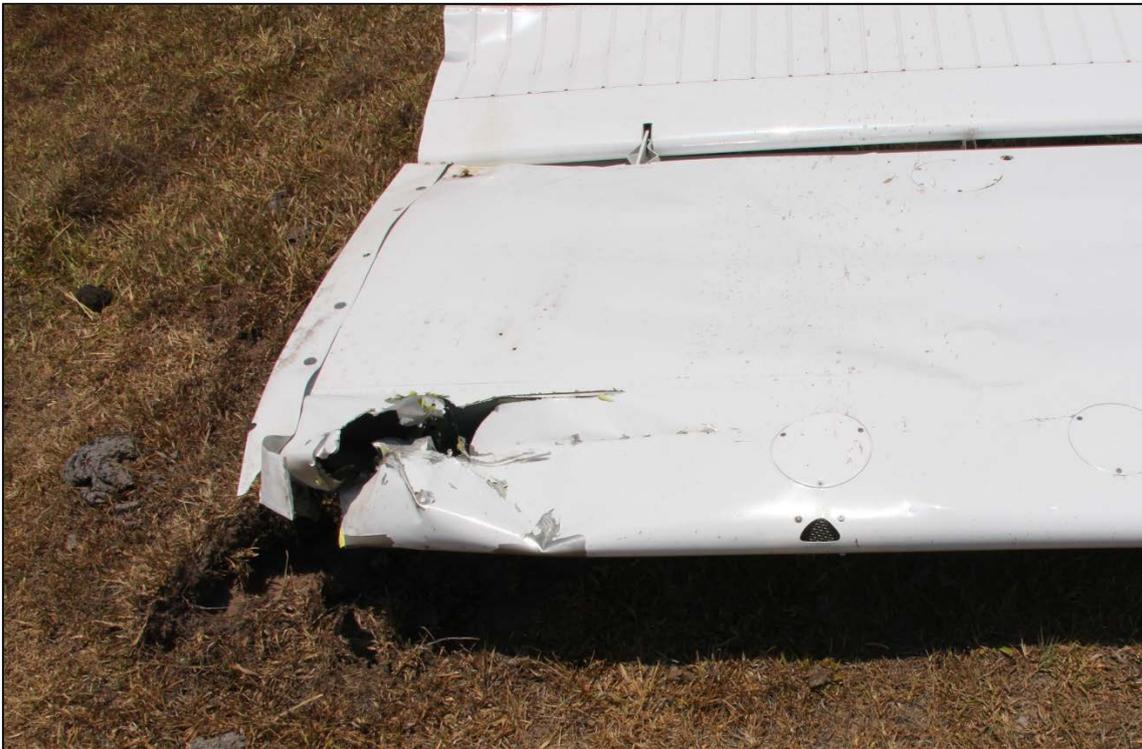
Figure 6 – Right wing root damage

Damage at the wing root was consistent with the powerline continuing to be drawn through the wing structure (Figure 6). Electrical powerline connectors were found in the wreckage trail, between the right wing and the main wreckage.
