Loss of control during initial climb, involving a Cessna 150, VH-RXM

Moorabbin Airport, Victoria, 18 February 2014

ATSB Transport Safety Report

AO-2014-023

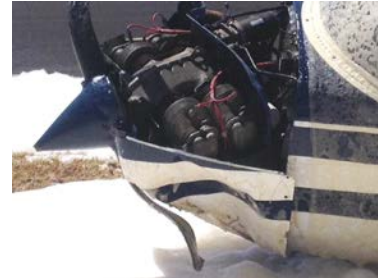
VH-RXM damage

The aircraft hit the ground hard, and bounced before coming to a stop on its left side. It came to rest just off the sealed section of the runway. The instructor closed the mixture control then exited through the right door. As the left door was jammed, he also assisted the student through the right side of the aircraft. They then moved a safe distance away.

Soon after, emergency services arrived. The pilot and passenger sustained minor injuries, and the aircraft was substantially damaged.
