# Collision with terrain involving a Cessna 210, VH-HGZ

50 km W of Numbulwar aerodrome, Northern Territory, 28 March 2014

**ATSB Transport Safety Report**  
Aviation Occurrence Investigation  
AO-2014-059  
Final – 17 June 2014

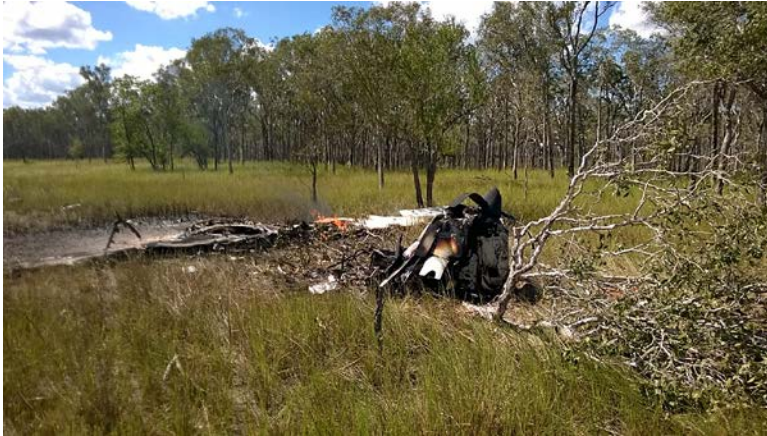
**Figure 1: Accident site and aircraft wreckage**

The pilot and passenger were rescued about 3 hours later by a helicopter crew. Both sustained serious injuries and the aircraft was destroyed (Figure 1). Due to memory loss incurred as a result of the accident, the pilot had limited recollection of the events.

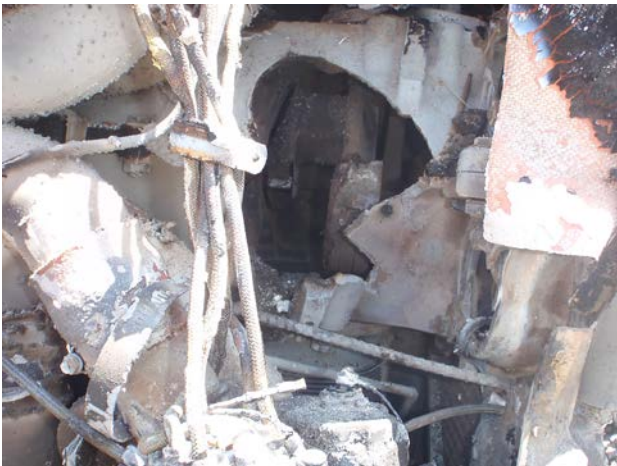
**Figure 2: Engine damage to VH-HGZ**

From the photographs provided by the operator (Figure 2), the ATSB assessed that a connecting rod appeared to have broken and separated from the crankshaft, resulting in a hole in the crankcase. This precipitated a catastrophic engine failure. The smoke entering the cockpit was likely to have been from burning oil.
