Hard landing involving a Robinson R22, VH-YZO

Toowoomba Airport, Queensland, 20 February 2014

ATSB Transport Safety Report
Aviation Occurrence Investigation
AO-2014-063
Final – 17 June 2014

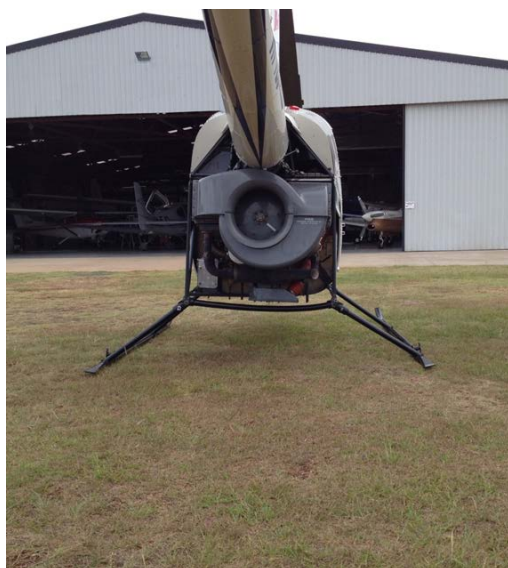
Figure 1: Damage to VH-YZO

The instructor again exited the helicopter and conducted a walk-around inspection with no damage observed. After a further demonstration by the instructor, the student completed the sequence twice more. The instructor and student then conducted further training exercises and subsequently concluded the flight. After landing, the instructor detected that the helicopter was leaning to the right. He exited the helicopter and observed that the landing skid was damaged (Figure 1). The instructor then taxied the helicopter to the hangar for an engineering inspection.

Company flight instructors have been advised that following a suspected hard landing or other possible damage to an aircraft, the aircraft is to be shut down. If damage is suspected, the aircraft should not be flown or relocated until a qualified engineer has deemed the aircraft to be airworthy.
