Fuel starvation event involving an Osborne Aviation OH-58A, VH-OSQ

Coffs Harbour Airport, New South Wales, 17 April 2014

ATSB Transport Safety Report
Aviation Occurrence Investigation
AO-2014-071
Final – 14 July 2014

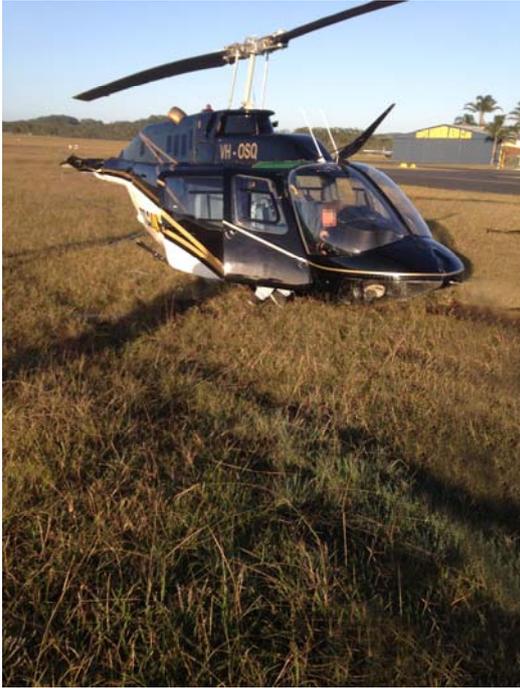
Figure 1: Damage to VH-OSQ

The pilot selected the master switch on, confirmed all indications were normal and started the engine. However, he had omitted to complete the pre-start checklist, in particular to select the fuel valve to 'ON'. The pilot lifted the helicopter off into the hover and obtained a clearance from air traffic control. The pilot commenced the transition to forward flight and, at about 35 ft above ground level, heard the turbine engine wind down, the red ENGINE OUT warning light illuminated and the helicopter descended in an autorotation.

The pilot attempted to run the helicopter onto the ground, however, the helicopter touched down on soft grass and the landing skids detached. The helicopter then pitched forwards and the pilot pulled the cyclic¹ control back, resulting in the main rotor blades severing the tail boom and the helicopter landed heavily. The pilot immediately exited the helicopter to confirm that the fuel bladder was intact and that there was no fire, then re-entered the cockpit and shut off the switches. He then observed that the fuel valve was selected to 'OFF'.

The helicopter was substantially damaged (Figure 1), the pilot sustained serious injury and the passenger was uninjured.

The pilot reported that this incident provided a reminder of the effect a change in routine can have, particularly on completing checklists. Research conducted by the ATSB found that distractions, or a change in routine, were an everyday part of flying and that pilots generally responded quickly and efficiently. The report, *Dangerous Distraction: An examination of accidents and incidents involving pilot distraction in Australia between 1997 and 2004* is available at: www.atsb.gov.au/publications/2005/distraction_report.aspx.
