Wirestrike involving a Kavanagh Balloons B-350, VH-JDI

Broke, New South Wales, 6 December 2013

ATSB Transport Safety Report
Aviation Occurrence Investigation
AO-2013-218
Final – 14 July 2014

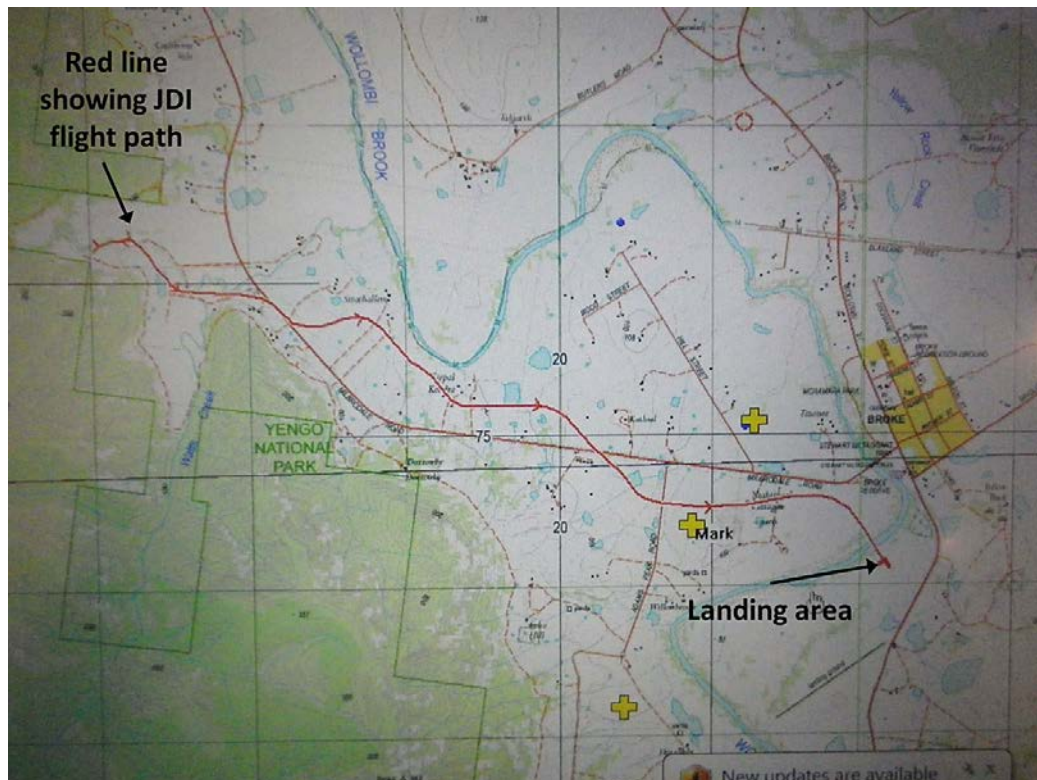
Figure 1: Map showing flight path and landing area of VH-JDI

On 6 December 2013, a Kavanagh Balloons B-350 balloon, registered VH-JDI, was on final approach to land near Broke, New South Wales. At a height of about 50 ft, as the balloon flew over a river and a line of trees (Figure 1), the pilot observed the sun glistening off a power line on the left of the landing area and looked for the poles associated with that power line. The pilot did not observe any other power lines coming off the poles. The pilot instructed the passengers to get into the landing position. The landing area looked to be clear of obstacles. As the balloon came over the end of the tree line the pilot slowly vented the hot air in the envelope to descend to the landing area. The pilot then noticed that there was a pole to the right that had been in the shadows and that a power line stretched horizontally in front of the balloon flight path. The pilot opened the envelope ventilation system so the balloon would descend quicker. The basket touched the ground gently and came to rest just under the power line at about 0630 Eastern Daylight-saving time (EDT). The envelope folded over the three power lines, resulting in them contacting each other and sparking. The pilot instructed the passengers to remain in the basket and, when he considered that it was safe, he exited the basket. The pilot telephoned the electrical company who confirmed that the system was isolated and that a technician would be dispatched. The passengers then disembarked the basket. The pilot and 15 passengers were not injured. The balloon envelope had a small area of heat damage to the fabric where it had contacted the power lines.

The pilot reported that, during the landing, he was focused on the power line on the left that was glistening in the sun, although looking for wires coming off that power line. The power line that stretched across the flight path was hidden by the tree line. The balloon was also flying at a similar height of the power line, making the wires more difficult to see as only one wire was visible. The pilot also reported that the sun was not high above the horizon and he was looking directly into the sun for the landing.
