Controlled flight into terrain, involving PA34, VH-COU

Denmark ALA, Western Australia, 13 March 2014

ATSB Transport Safety Report
Aviation Occurrence Investigation
AO-2014-051
Final – 6 August 2014

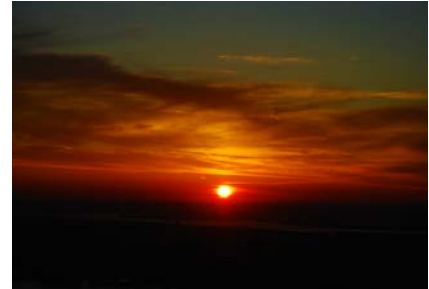
Sunset

At about 1820, COU arrived over the top of Denmark, and the pilot noted a westerly wind of about 15 knots. The wind was blowing straight down runway 27. The pilot regularly flies to Denmark, and knows that at this time of day, the setting sun can restrict visibility when landing on 27. However, to land to the east on runway 09 would have meant accepting a significant tailwind.

- Had he departed Jandakot about 15 minutes earlier, the sun would not have been an issue
- He had been influenced by a successful landing on runway 27 at Denmark about two weeks earlier, but had not made an allowance for the sun being lower on the horizon

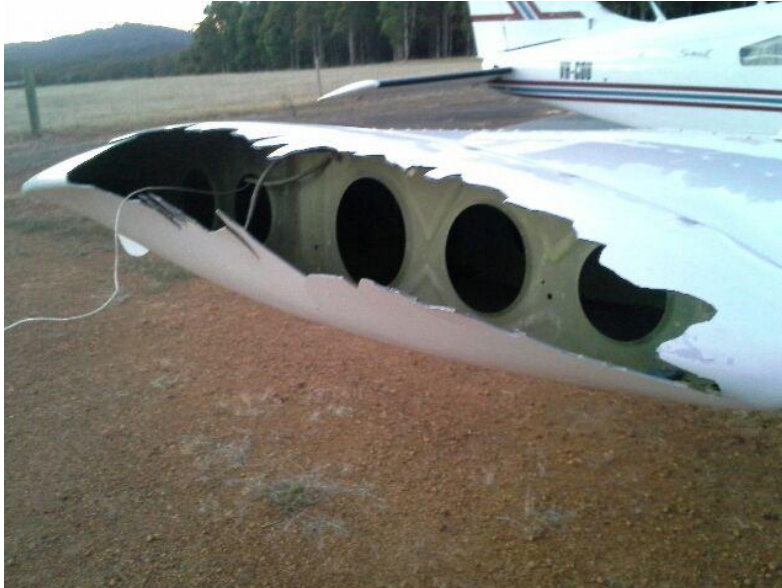
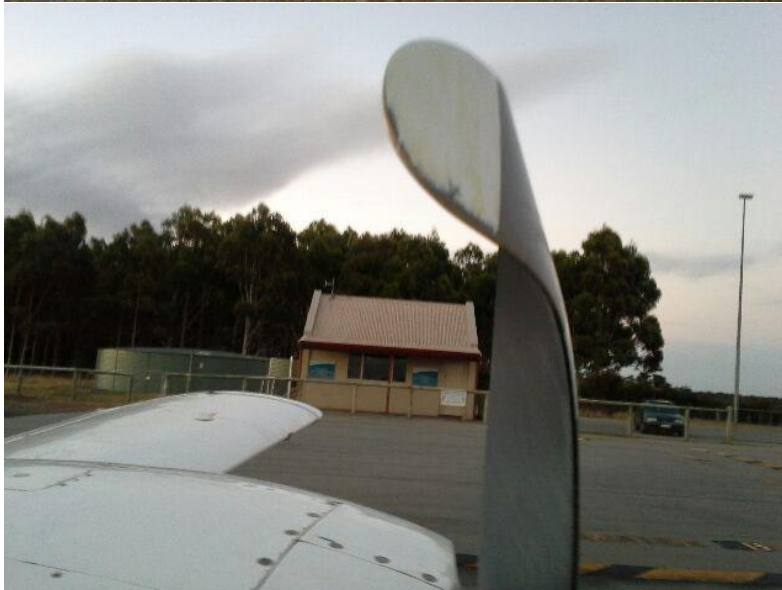
Figure 1 and 2: VH-COU damage

The pilot joined the circuit for 27. When on final approach, with the aircraft configured for landing with the landing gear extended and two stages of flap selected, the visibility was normal. A few seconds later, as the aircraft descended below 700 ft, the visibility both inside and outside the aircraft went instantaneously to zero. Totally blinded by the sun glare, the pilot applied full power to initiate a go-around. A few moments later, the aircraft struck the canopy of the rainforest along the right side of the runway.

After completing a normal landing, the pilot shut down the aircraft then egressed safely. The pilot was not injured; however, the aircraft was substantially damaged.
