Landing on a closed runway, involving PA28 VH-FEZ

Wangaratta Airport, Victoria, 12 April, 2014

ATSB Transport Safety Report
Aviation Occurrence Investigation
AO-2014-069
Final – 6 August 2014

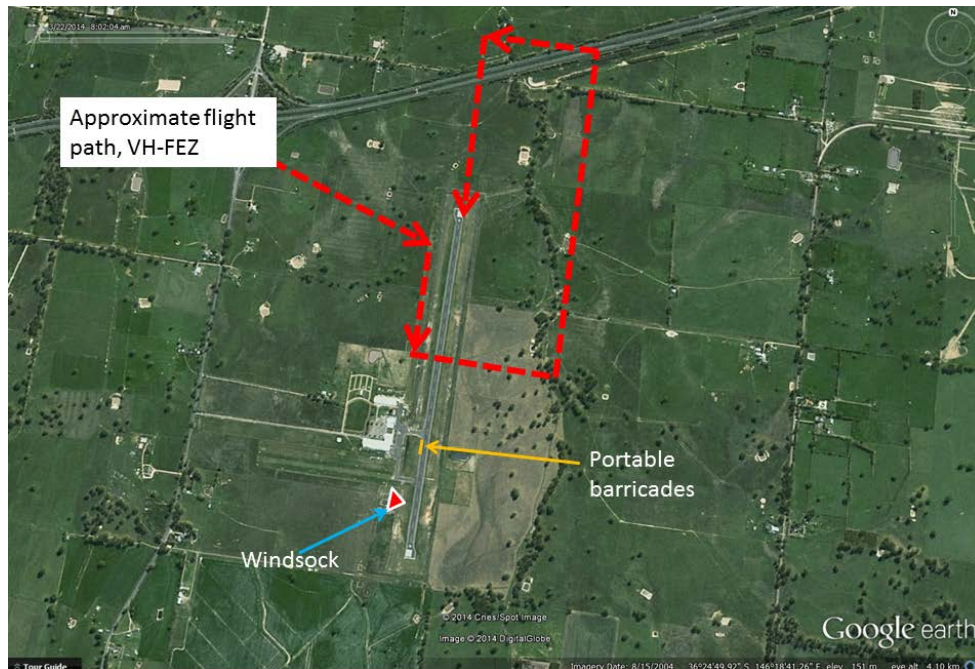
Figure 1: FEZ approach profile at Wangaratta airport

As FEZ approached the circuit, the student flew the aircraft parallel to runway 18 for a short time, before turning crosswind. Neither the instructor nor student noticed the white cross near the windsock (Figure 1).

The operator also suggested a positive action for future closures maybe to place a white cross at each threshold to further alert pilots that the runway is closed.

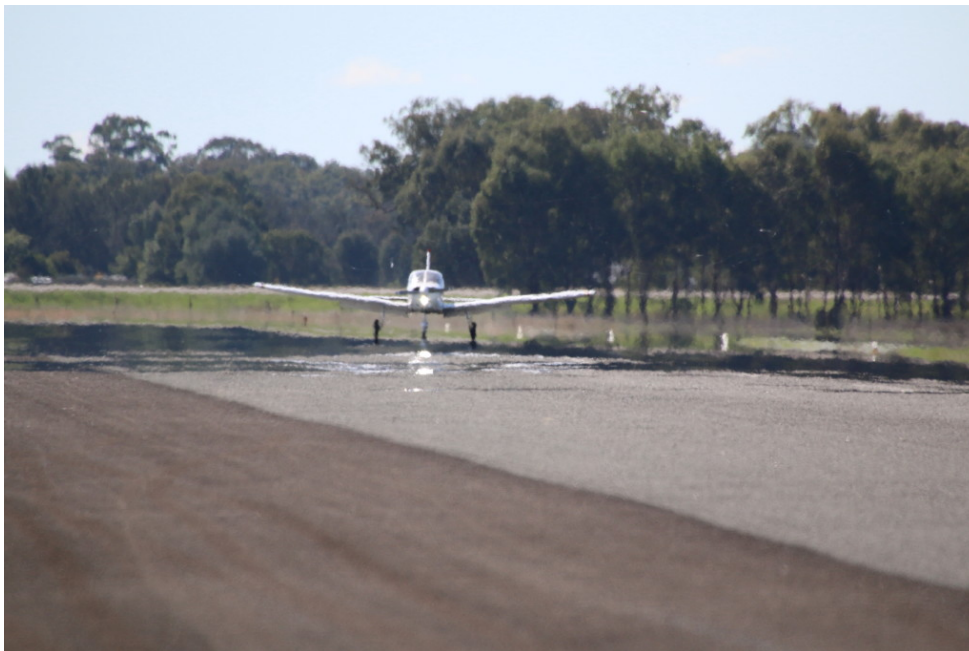
Figure 2: The aircraft touchdown

FEZ touched down near the threshold on runway 18 (Figure 2). As FEZ became airborne following the touch and go, the instructor then noticed some barricades off the right side of the runway (Figure 3). The instructor took over control of the aircraft and vacated the area, departing to Mangalore.
