# Collision with terrain involving a Robinson R22 helicopter, VH-WDB

90 km N of Bourke, New South Wales, 23 May 2014

**ATSB Transport Safety Report**  
Aviation Occurrence Investigation  
AO-2014-093  
Final – 6 August 2014

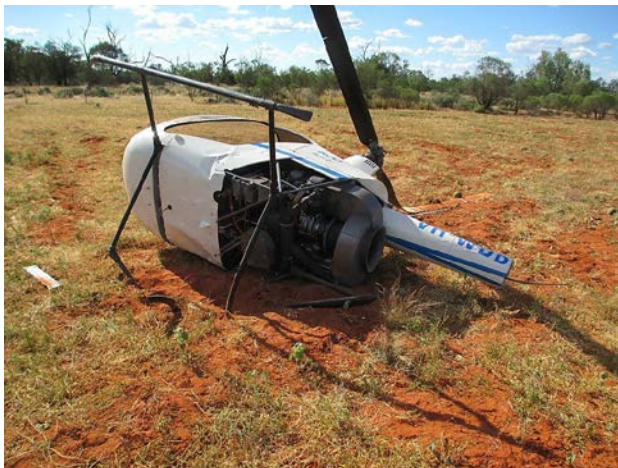
**Figure 1: Damage to WDB**

As the helicopter turned left, the pilot felt a violent shudder through the cyclic<sup>2</sup> control. The pilot reported that the helicopter continued to yaw<sup>3</sup> and he applied opposite pedal in an attempt to counteract the yaw, however the pedal was ineffective and the yaw accelerated. The pilot rolled the throttle off, moved the cyclic forward and lowered the collective<sup>4</sup>. As the helicopter descended rapidly, the pilot then raised the collective to cushion the landing. The right skid touched down first and the helicopter rolled to the right, coming to rest on the right side (Figure 1).

The helicopter was substantially damaged and the pilot was uninjured.

- Damage to the helicopter was consistent with high vertical impact loads.
- Damage to the skid attach points was consistent with the aircraft rotating at touchdown.
- No aircraft unserviceabilities, including in the tail rotor control system were found other than those sustained in the accident.
- The drive belts were found intact and had moved forward one groove on the upper sheave consistent with a power-on main rotor strike.
