# Collision with terrain involving a Bell 412, VH-ESD

72 km WNW of Townsville, Queensland, 23 May 2014

**ATSB Transport Safety Report**  
Aviation Occurrence Investigation  
AO-2014-095  
Final – 6 August 2014

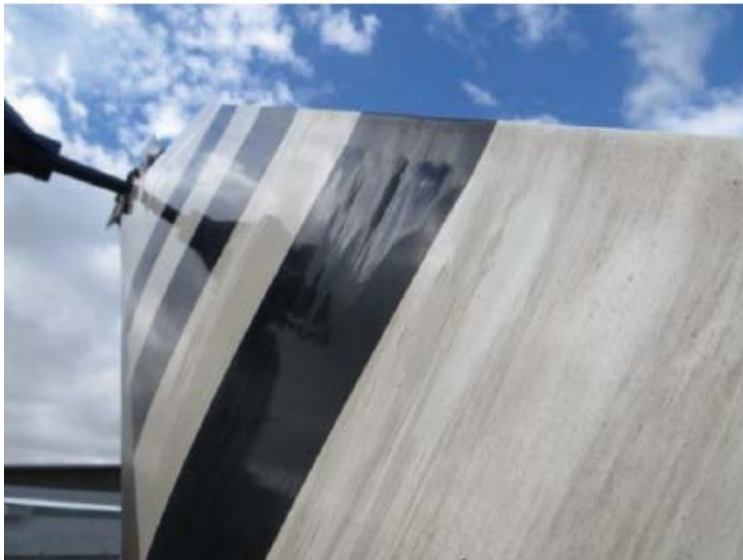
**Figure 1: Damage to ESD tail rotor**

About 1 minute later, the ACO returned to the door and observed that the helicopter had drifted back and left and he immediately directed the pilot to manoeuvre up and to the right, however the tail rotor collided with the foliage of a tree. The RCO attempted to alert the pilot to the proximity of vegetation to the tail of the helicopter over the radio but the radios in the helicopter were deselected. The pilot advised that he was again about 4 minutes into the 5 minute hover power limit and had to go around prior to picking up the RCO and paramedic. The ACO advised that the helicopter had collided with some light foliage and the pilot assumed it was the main rotor blades that had struck the vegetation. The ACO pointed out to the pilot some vegetation similar to that which the helicopter had collided with. The pilot had not detected any strike, there were no abnormal indications or vibrations and the helicopter was operating normally.

After landing at the hospital, the pilot exited the helicopter and inspected the main rotor blades. The ACO then advised that it was the tail rotor not the main rotor that had struck the foliage and the pilot observed some ripples on the tail rotor blades and called the base engineer to inspect the helicopter (Figure 1).

The engineering inspection revealed that the tail rotor blades required replacement and the tail rotor gear boxes and hub assembly required inspection.

- Operational staff will be reminded of the importance of applying the controls listed in the winching task risk analysis (TRA), possibly via a Safety Bulletin.
- Senior staff are to provide advice to crew regarding actions to be taken following any event or incident, specifically the desirability of conducting a safe out-landing.
- The currency requirements for management and training and checking pilots are to be reviewed, in particular with respect to operational tasks.
- Technical staff will review the compatibility between the Bell 412s and the radios used by the RCOs.
- In-cockpit reminder lists of any treatments or controls mandated by Task Risk Analyses are to be provided.
- The next crew resource management (CRM) training is to focus on information sharing, feedback loops and cockpit gradients.
