Collision between *Royal Pescadores* and *Da Heng Shan* at anchor

Gage Roads Anchorage, Fremantle, Western Australia | 8 May 2014

ATSB Transport Safety Report
Marine Occurrence Investigation
308-MO-2014-003
Preliminary – 27 August 2014

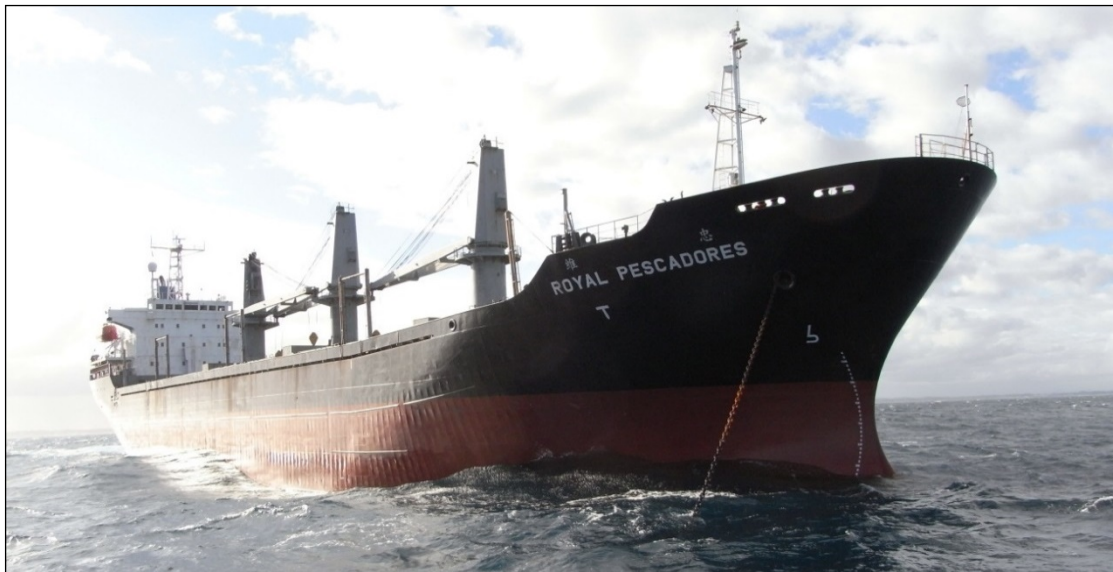
Figure 1: *Royal Pescadores*

On 28 April 2014, the 148 m geared bulk carrier *Royal Pescadores* (Figure 1) anchored at Kwinana 'No 5' anchorage, about 4 miles from Fremantle Port (Figure 2). While at anchor, the ship's cargo holds were surveyed and found to be unfit for the carriage of its next cargo.

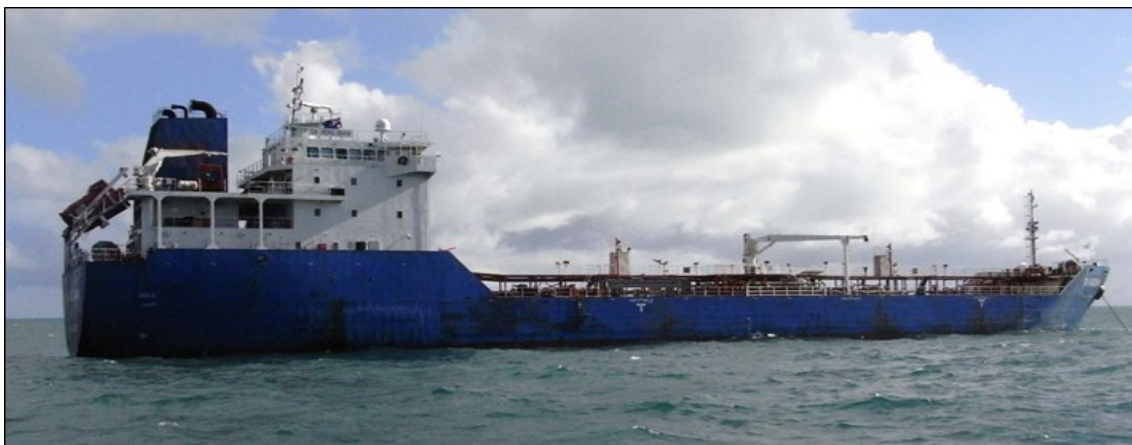
Figure 3: Da Heng Shan

At about 0800 on 7 May, the 106 m asphalt / bitumen tanker *Da Heng Shan* (Figure 3) anchored in Gage Roads 'B' anchorage, about 0.5 miles³ east of *Royal Pescadores*.

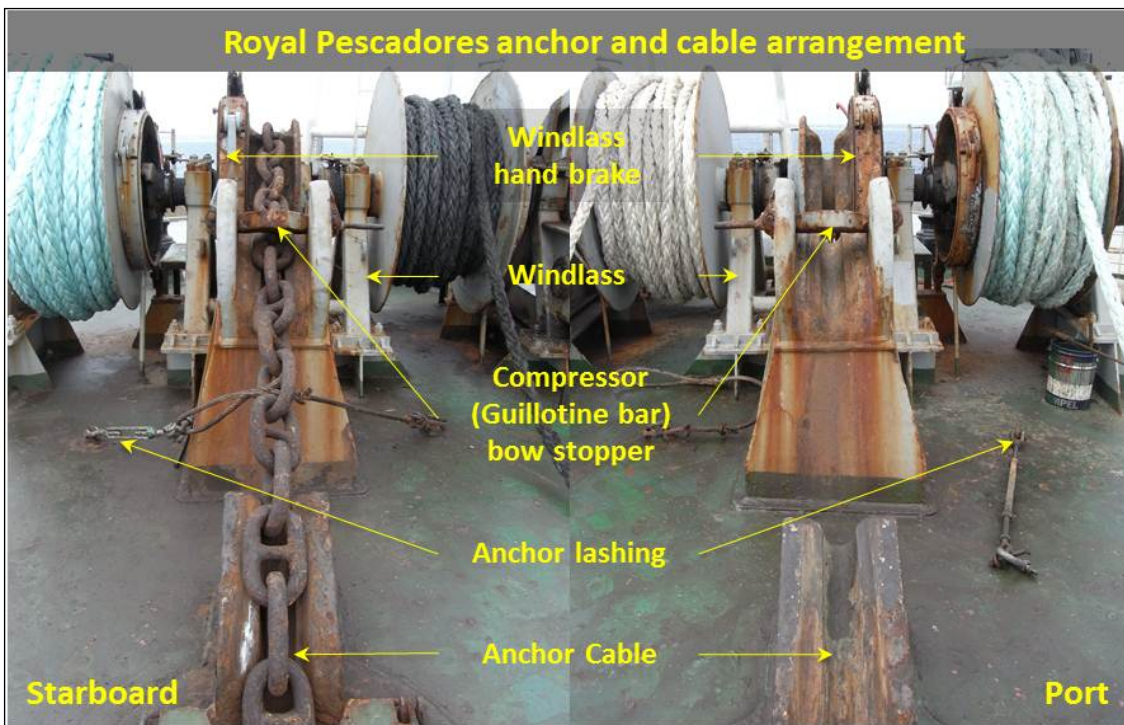
Figure 4: Royal Pescadores forecastle head anchor and cable arrangement

The anchor cable passed up the spurling⁸ pipe, over the windlass gypsy⁹ and through the hawse¹⁰ pipe over the side of the ship (Figure 4).

Sometime between 0500 and 0530 on 8 May 2014, *Royal Pescadores*'s port anchor windlass cable guillotine bar securing pin worked free and the bar opened. In the prevailing conditions, the windlass brake alone was not sufficient to hold the port anchor in place.

As a result, the anchor cable paid out until it was being held by the bitter end. At about 0535, the bitter end was ripped out as a result of the strain placed on it and the anchor and cable were lost overboard.
